# **NORTHCOTE GOLF COURSE**

## **COURSE MASTERPLAN REPORT**

PREPARED BY  
CONTOUR GOLF DESIGN GROUP FOR THE CITY OF DAREBIN

NOVEMBER 2023

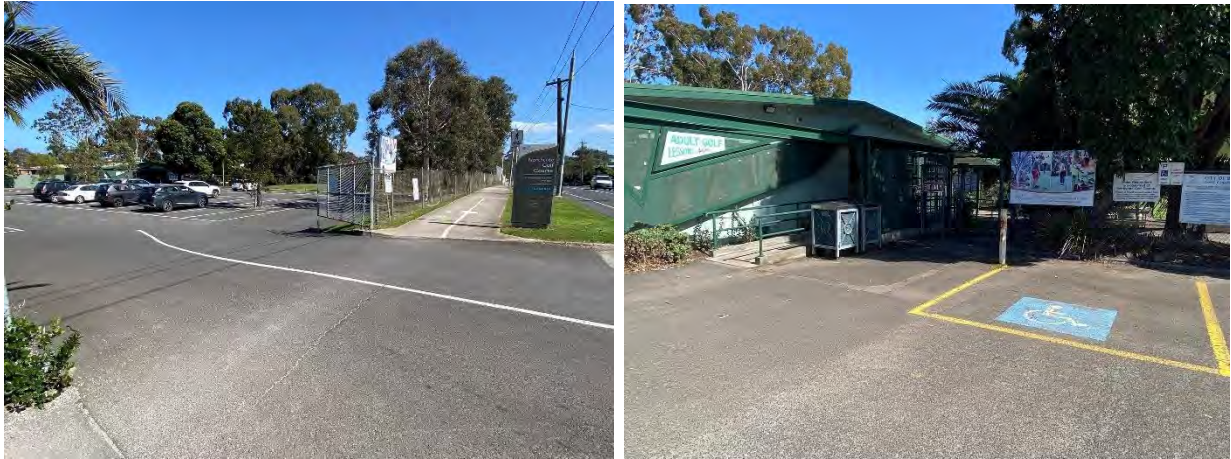
The existing arrival experience is underwhelming. The vehicular front entry gate off Normanby Road is made of inexpensive and dilapidated, industrial style wire mesh. The carpark space caters for approximately 55 cars, which is adequate, and the asphalt surface is in good condition. Tree planting in the carpark is adequate and in time as these trees mature further, they will improve the amenity of the carpark and provide additional shade. Some of the planter holes have been damaged and tree replacement is required.

*Figures 2 and 3: The vehicular arrival from Normanby Road through poor quality wire mesh gates, and the pedestrian arrival that takes golfers to the pro-shop.*

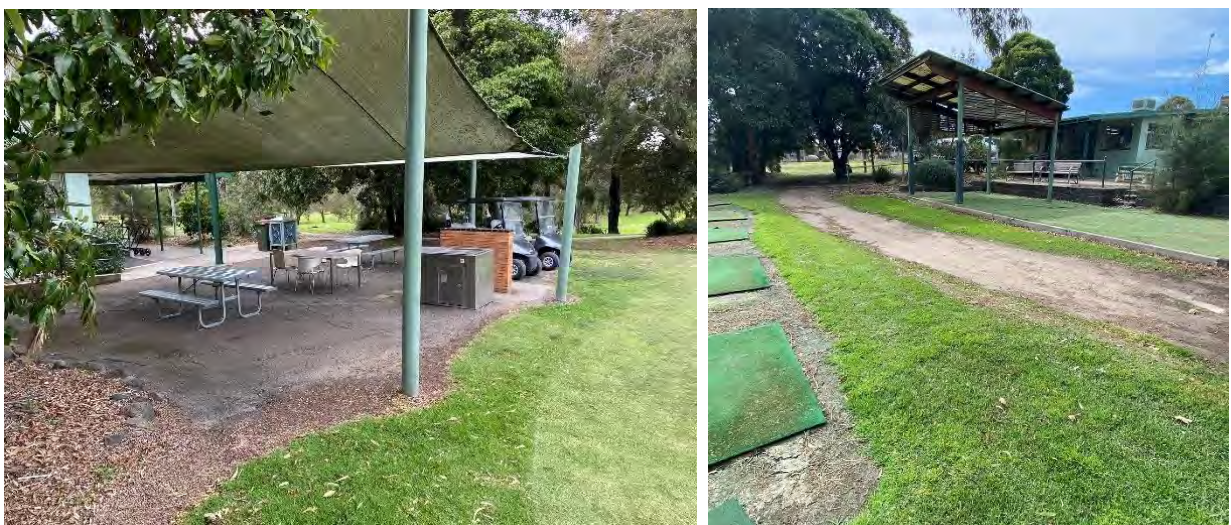
*Figures 4 and 5: The shade sails-covered sitting area with a barbeque (left) and practice tee area.*

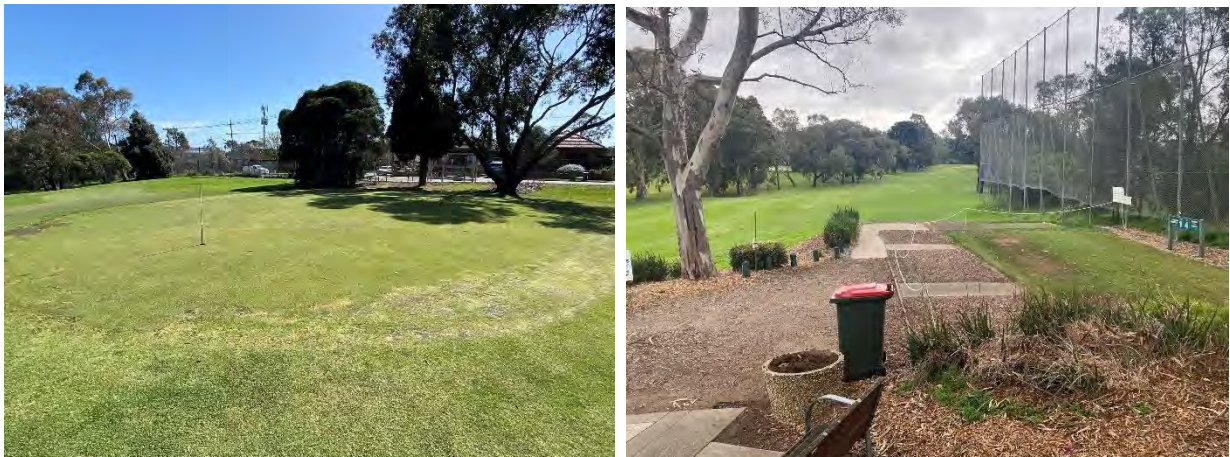
A concrete pathway leads to those 'new' 1<sup>st</sup> tees, which are located downhill, an awkward 50 metre walk from the clubhouse. The spatial and visual connection between the pro-shop, clubrooms and 1<sup>st</sup> tees is poor.

Figure 6 and 7: The small practice green in front of the pro-shop and the very poor quality 1<sup>st</sup> tees.

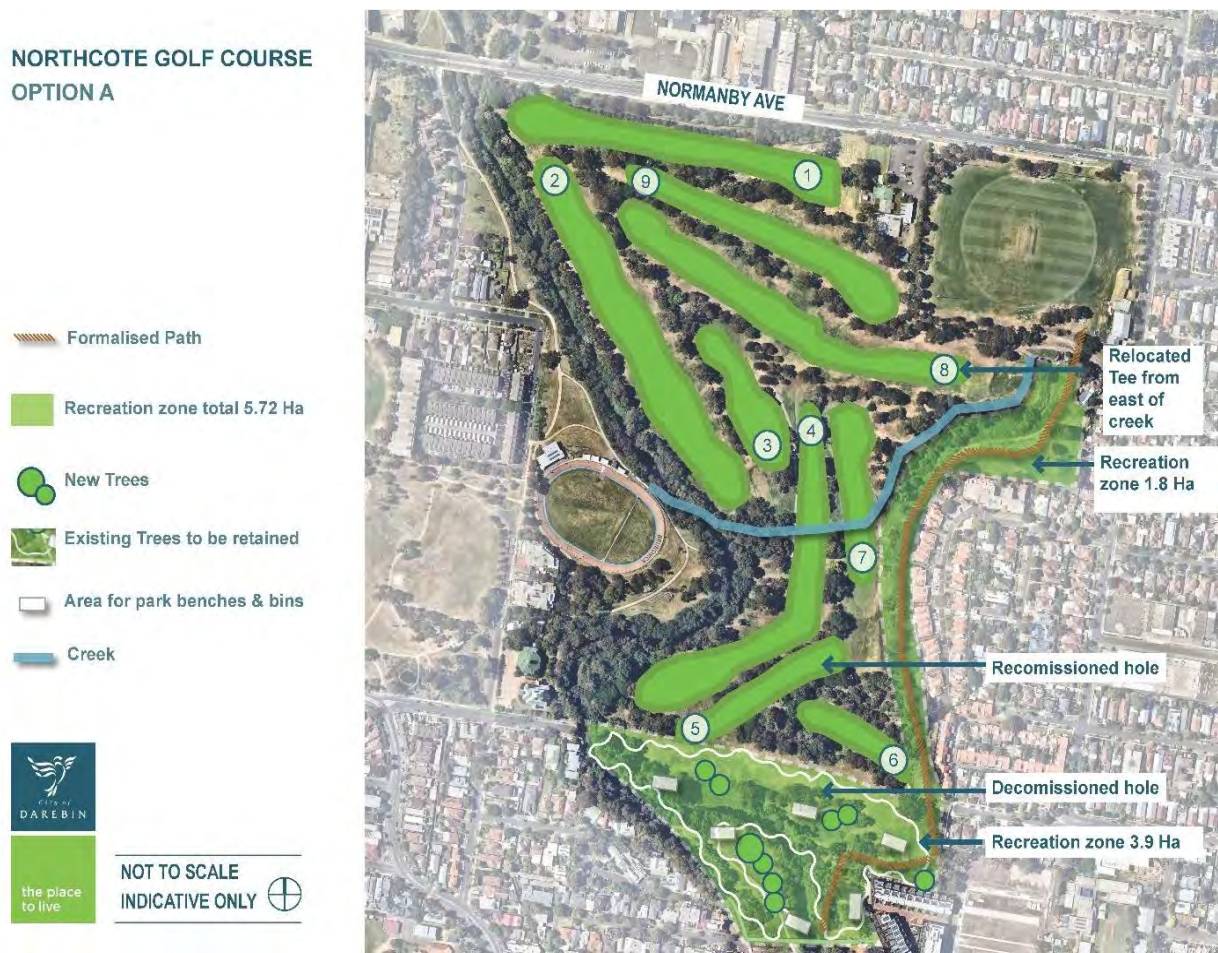
What it also means though, is that with the old 5<sup>th</sup> hole removed, the current 6<sup>th</sup> tees now sit atop a hill, somewhat isolated from the rest of the golf course. And while there are still 9-holes of golf, the transition from the current 5<sup>th</sup> green to the 6<sup>th</sup> tees, is not as good as it should be. Addressing this issue is one of the primary objectives of this Masterplan.

Figure 8: The current course layout with the challenging arrangement of holes 5, 6 and 7. Other than this small section of the golf course, the remainder of the course flows well, and the layout of the holes is generally good.

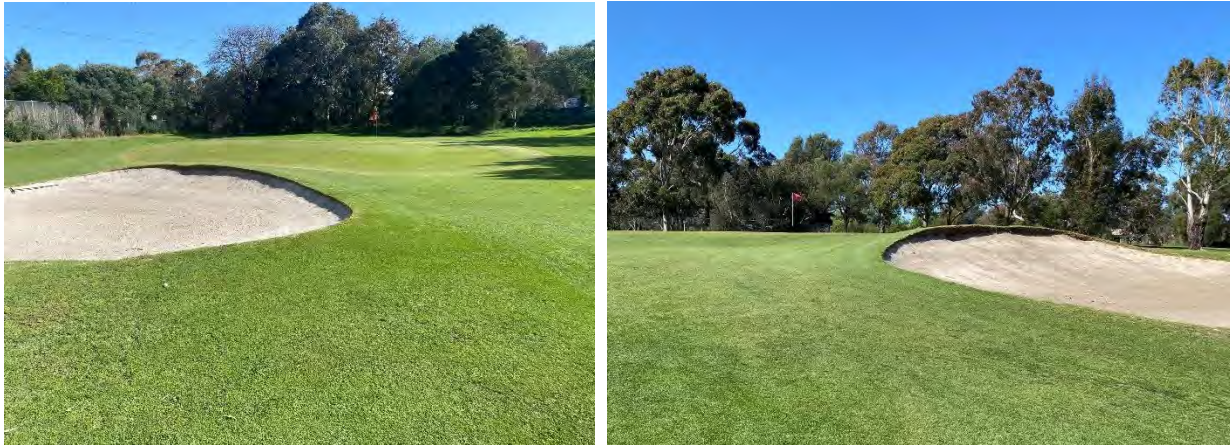
Figures 10 and 11: The 1<sup>st</sup> green (left) with a single shallow bunker at its front left, and the 9<sup>th</sup> green (right).

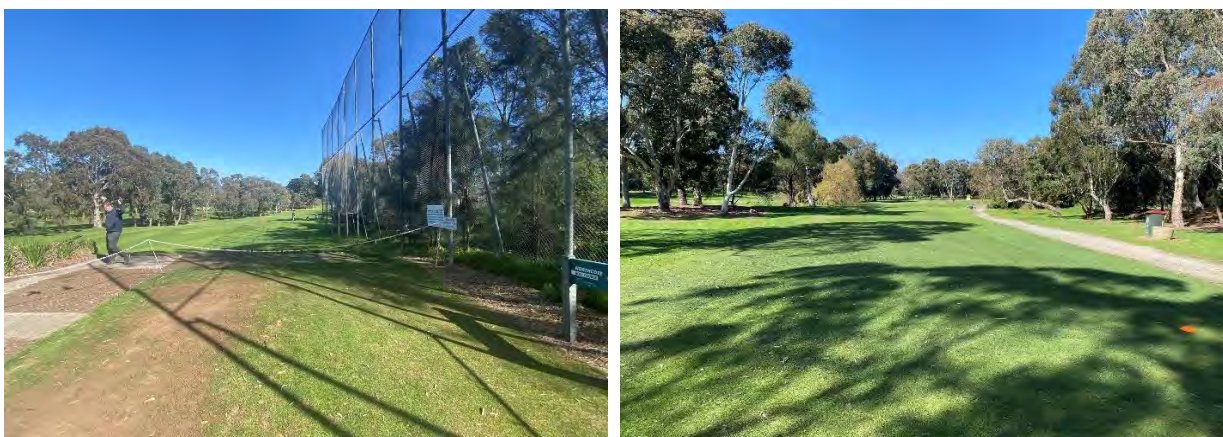
The tees are generally in poor condition. While most of the tees are, in principle, large enough in area to spread wear across them, in reality they are often so uneven and lumpy that golfers tend to concentrate divots into the same spots across the tees, meaning the useable space is reduced. Currently the golf course uses two sets of tees. The back tees are intended for use by men and the forward tees used by women.

Figures 12 and 13: The 1<sup>st</sup> tees are in very poor condition (left), the 4<sup>th</sup> tees (right) are large enough but require levelling.

All of the tees need to be rebuilt to some extent, and on several holes additional tees are also recommended. This will be explained in more detail in Part 2 of this report. It is also recommended that a three tee system be adopted and that the new tees be described in gender neutral terms. We have simply described them as back, middle, and forward tees, however any name or colour could be adopted, but perhaps not colours traditionally associated with one gender – ie. blue for men and red for women. There has increasingly been a movement towards encouraging golfers to use tee positions best suited to their golfing ability or age, rather than their gender.

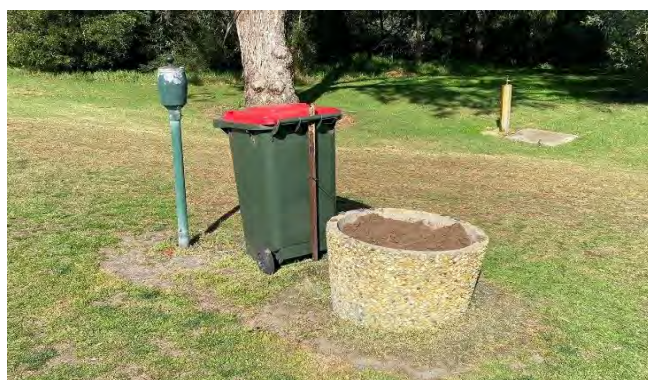
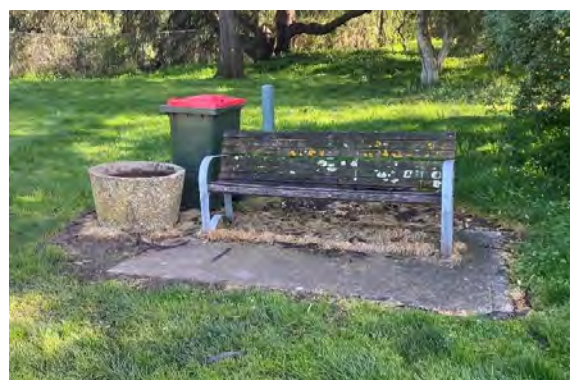
Course furnishings are items such as seats, signage, rubbish bins, sand dispensers, golf ball washers, drinking fountains, retaining walls and flags are all essential items that are an underrated part of the golf experience. Done well they should be hardly noticed. Done poorly they can make a course feel cluttered and messy. Unfortunately, at Northcote Public Golf Course, in most cases it's the latter.

Figures 14, 15 and 16: Tired furnishings, and standard residential rubbish bins. Below, the practice tee area.

A replacement program should be put in place to upgrade items such as seating, rubbish bins, ball washers and signage. The existing course furnishings are tired, and their replacement will be relatively inexpensive but reduce clutter across the course. Their upgrade will significantly improve the amenity of the golf course especially the surrounds to the tees where such furnishings are usually located. The residential style street rubbish bins are perhaps the priority for replacement, with a commercially available alternative. This could potentially be undertaken adjacent to each tee, as that tee is being rebuilt.

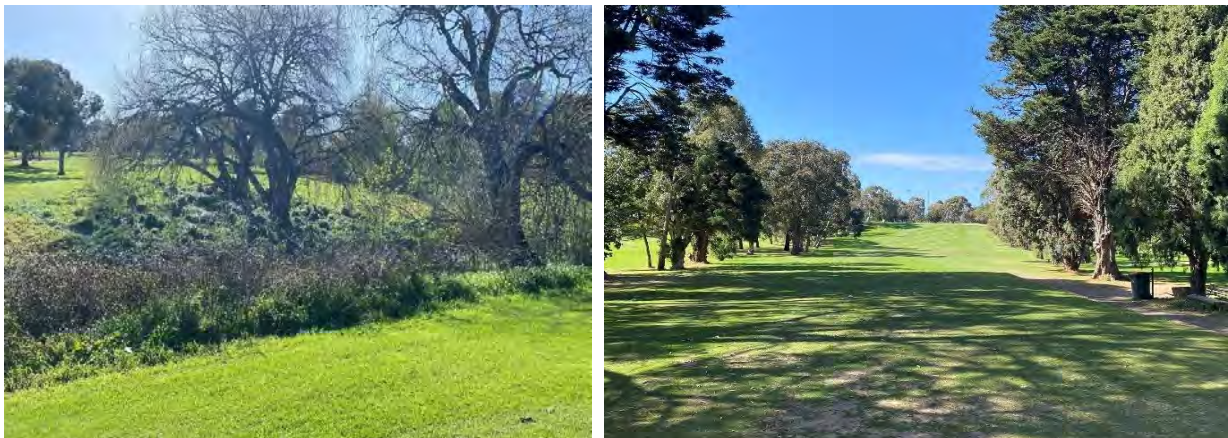
The Merri and Bracken Creeks are densely vegetated, but there are a large number of weed species that have invaded the creek corridors, including Elms and Willows. There are also a large number of ground cover weeds such as Vinca. We understand these corridors are the responsibility of Melbourne Water and not Darebin Council.

Figures 17 and 18: Bracken Creek infested with weeds (left), and planted trees on either side of the 9<sup>th</sup> hole.

- Council should also prioritise working with Melbourne Water to clean up the weeds in and along the creek corridor and revegetating this area.
- New tree planting, with an appropriate indigenous species, to the right of the new green will also screen public areas on the eastern side of the creek from view.

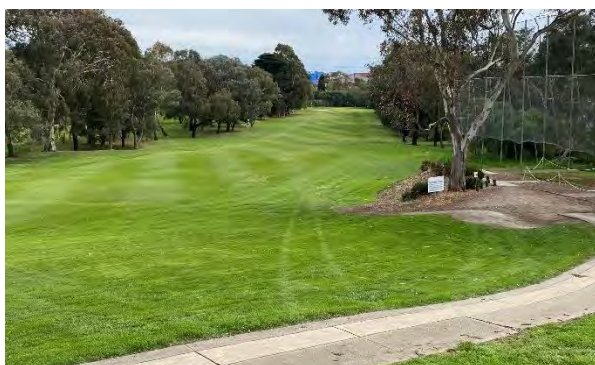
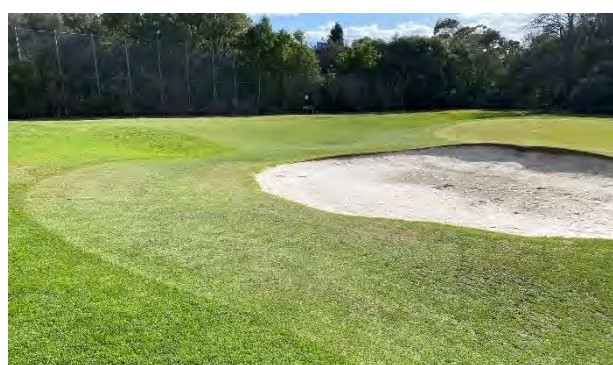
Figures 19 and 20: The tees on the 1<sup>st</sup> hole should be moved up the hill closer to the pro-shop (left), and the 1<sup>st</sup> green (right).

- The tees need to be rebuilt. In the interests of the long term benefit of the golf course, the best solution is to rebuild the tees completely further up the hill, closer to the pro-shop.
- Because of the slope, the tees will need to be on several different levels, stepping down the hill. A new and inviting pathway connection is required between the pro-shop/clubhouse and 1<sup>st</sup> tees.
- A new screen fence to replace the current fence will be required, but it should be located further from the tee so it does not impact so negatively on the tee shot, and be made of nylon, not wire mesh.
- New 1<sup>st</sup> tees will enhance the arrival experience and dramatically improve the clubhouse landscape precinct, along with other works proposed to enhance this area. If this was done though, the new screen fence to protect Normanby Road will be essential.

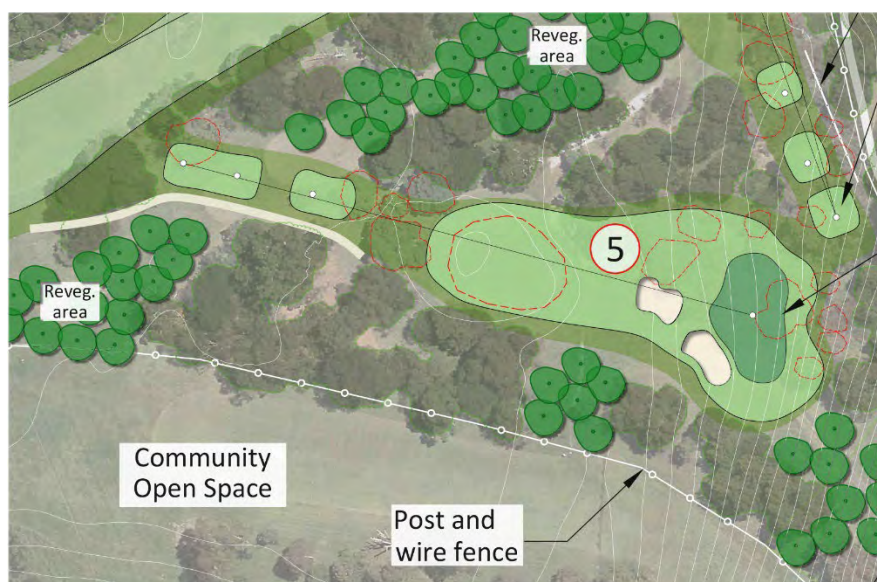
Figure 23: The proposed new 5<sup>th</sup> hole, playing into the space currently occupied by the 6<sup>th</sup> hole.

- Construct new tees in the location as shown, aiming at the new green site. The tees should at least 500m<sup>2</sup> in area for par 3's, to spread wear caused by divots. There is a native Silky Oak that needs to be removed to create space for the new tees.

- Remove several immature, planted River Red Gums in the location of the new hole.
- Construct a new 6<sup>th</sup> green in the location as shown on the Masterplan, just on the upslope, well away from the new pathway to its rear and complying with setback standards to boundaries used by Australian Golf Course Architects. The new green construction will require a small cut and fill, and drainage run-off behind the green will need to be directed either side of the new green. This is subject to detailed design.

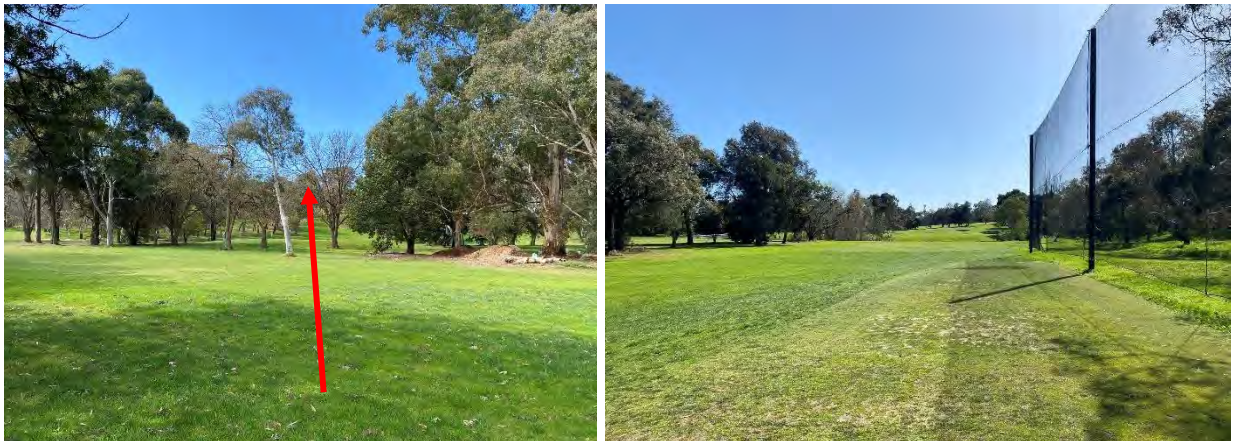
As was done on the 1<sup>st</sup> hole, the location and height of the fence was at the time considered an appropriate mitigation measure to resolving the boundary issue. As with the 1<sup>st</sup> hole, the fence was located hard up against the edge of the tees, inevitably meaning golfers only use the left half of the tee. In this instance, I also question

*Figures 24 and 25: The new 5<sup>th</sup> hole will play in the direction shown above (the red arrow). The current 7<sup>th</sup> tees (right) with the screen fence adjacent to them, showing the concentration of divots on the left side of the tee.*

- Our preferred recommendation is to construct a new set of tees, about 60 metres further back, very close to where the new 5<sup>th</sup> green will be located. From here the tees can be aimed further left, and existing trees to their right will protect the boundary. It may be that only a low screen fence will be required just to protect users of the new shared pathway from ‘shanked’ shots, but this may be something that can be managed without a fence as well. The addition of 60 metres to the carry will make it over 200 metres, which is only achievable by long hitters. Far more golfers will therefore be unable to reach creek, from the tee.

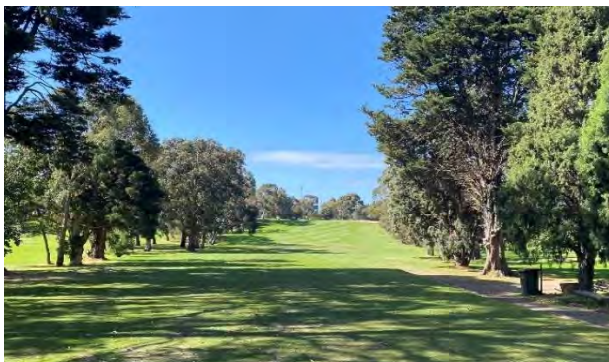
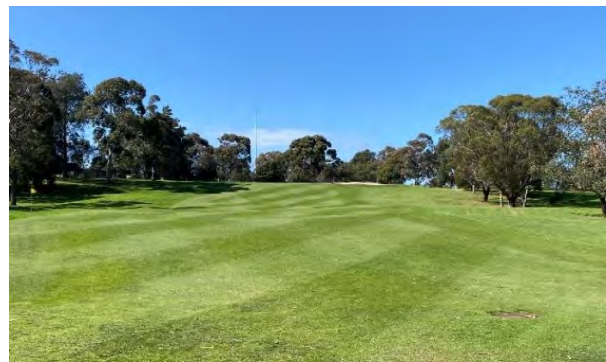
The 9<sup>th</sup> hole is a short par 4 that plays firstly along the flat, and then climbs steeply uphill back towards the clubhouse. The transition from the previous green to the 9<sup>th</sup> tees is poor, and the 9<sup>th</sup> tees are also in poor condition with shade issues from large trees.

Figures 29 and 30: The tee shot on the 9<sup>th</sup> hole (left) and the uphill approach to the green.

- Remove several trees around the tees, including a large Cypress, several other conifers and a Melaleuca.
- Once the trees are removed, demolish the pathway and the timber edging adjacent to the tees.
- Convert the transition zone between the 8<sup>th</sup> green and 9<sup>th</sup> tees to turf.
- Rebuild the 9<sup>th</sup> tees, making them level
- Mow the fairway wider on the left, up near the green.
- No other changes to the hole are required.
