Tree Assessment
for
Darebin City Council

Assessment of Trees for VPO Update in Mount Cooper
Estate, Bundoora.

3 December 2009

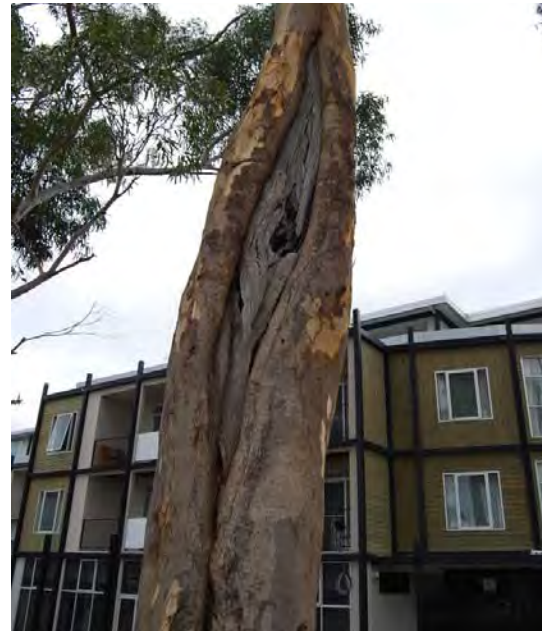
Figure 5. Decay along stem

Many of the *Eucalyptus cladocalyx* along Mount Cooper Drive have suffered decay, usually of the trunk or major scaffold branches. See Figure 5.

In many cases the decay is very advanced which has contributed to other defects such as hollow formation and increased failure rates.

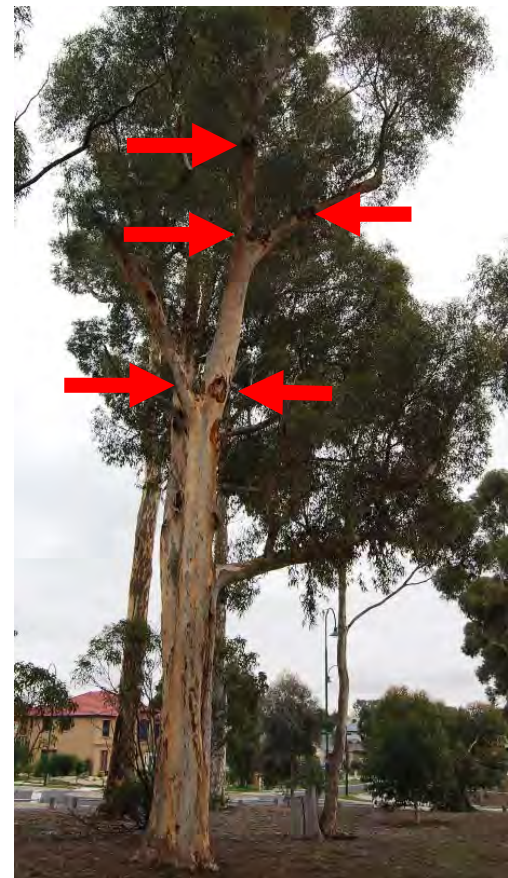
Figure 6. Multiple events of bird damage

The second form of damage actively degrades the tree. This is usually caused by birds in the Psittacine group. This group of birds contains the parrots, galahs and cockatoos. In this case, most damage has been caused by galahs and lorikeets (Council emblem). The birds chew at the bark and wood of branch unions. See Figure 6.

Over time the area becomes necrotic and ultimately forms a hollow. Whilst this is good for bird habitat, it also destabilises the branch and makes it prone to failure. Many of the *Eucalyptus cladocalyx* have suffered from bird damage. The size of the branches where this has occurred can exceed 300–400mm.

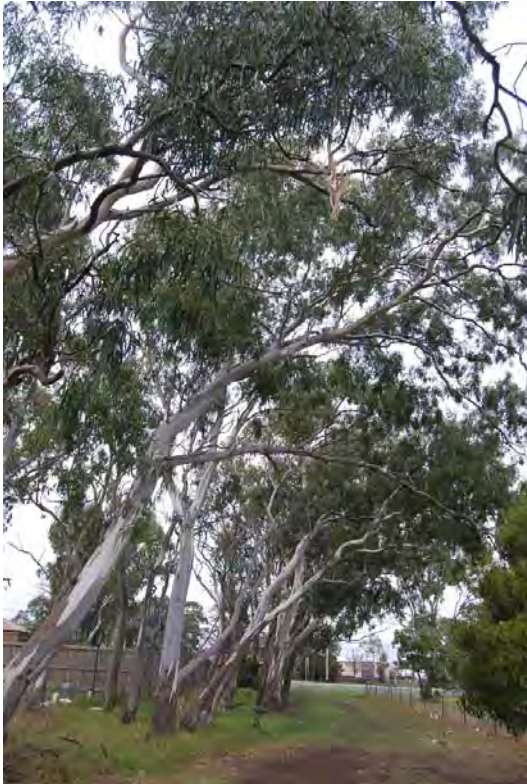
Figure 9. River Red Gums near Snake Gully Drive

In the case of the Council owned trees at Mt Cooper Estate, those of highest concern are the River Red Gums (*Eucalyptus camaldulensis*, See Figure 9) near the south end of Snake Gully Drive and the original homestead and the Sugar Gums (*Eucalyptus cladocalyx*, See Figure 10) located along Mt Cooper Drive. If left unattended, these trees will fail in the future, with potentially catastrophic circumstances.

It is envisaged that walking paths may need to be realigned created or removed, access to the trees minimised and pruning and removal of some of the trees. This should be addressed in a formal management plan for these two groups of trees. Properly managed, the vast majority of these trees can be maintained in the landscape for the next 20-50 years.

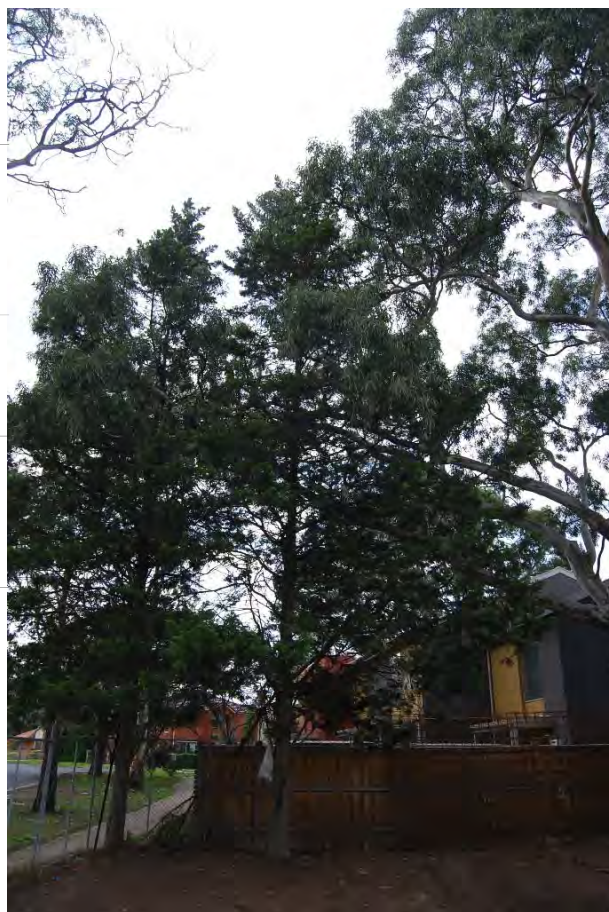
Tree Number: 389

Comments Significant root damage.
Excavation 2m from tree.
