Tree Assessment
for
Darebin City Council

Assessment of trees for VPO update in
Springthorpe Estate, Macleod.

Homewood Consulting Pty Ltd

16 May 2010

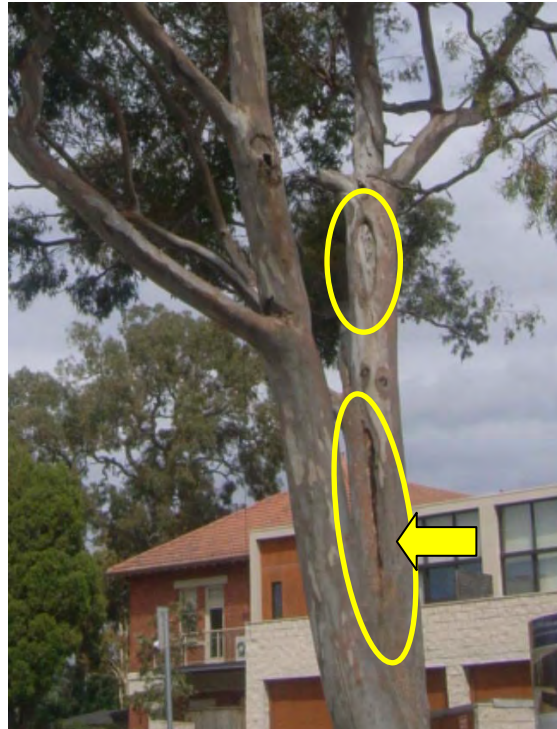
Figure 6. Decay along the trunk of Tree 284 (*Eucalyptus cladocalyx*) (Homewood photo catalogue)

There are two trees with 'Very Poor' structure, Tree 4 (a dead *Cupressus lusitanica*) and Tree 284 (a *Eucalyptus cladocalyx* with extensive decay).

Many of the *Eucalyptus cladocalyx* and several of the older *Eucalyptus camaldulensis* have suffered decay, particularly of the trunk or major scaffold branches. See Figure 6.

In many cases the decay is very advanced which has contributed to other defects such as hollow formation and increased failure rates. Decay has had the effect of making many of the trees within the estate valuable habitat trees. Birdlife was observed in many hollows across many areas of the estate.

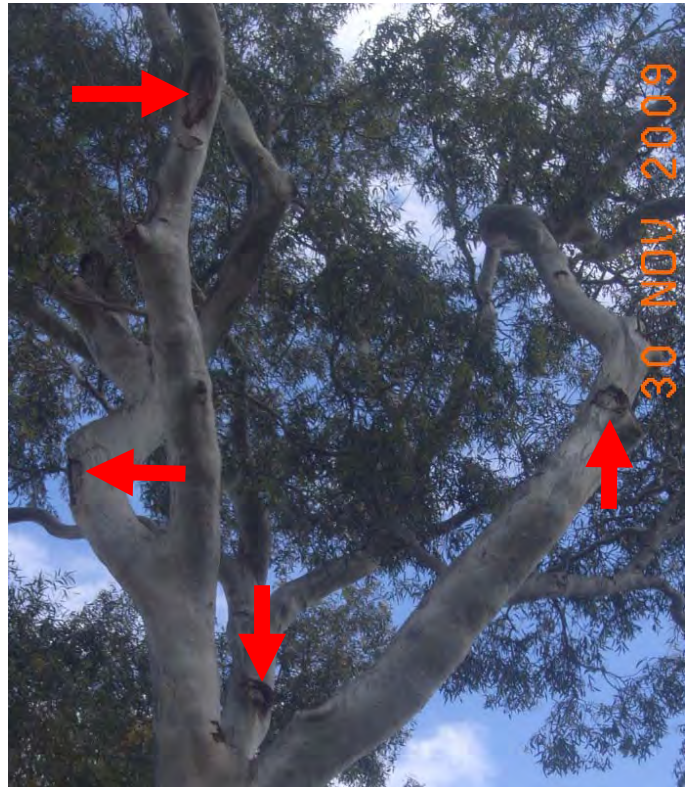
Figure 7. Example of multiple bird damage events (Homewood photo catalogue)

The second form of damage actively degrades the tree and is commonly caused by birds in the *Psittacine* group. This bird group contains parrots, galahs and cockatoos. The birds chew at the bark and wood of branch unions. See Figure 7.

Over time the area becomes necrotic and cracked before ultimately forming a hollow. Whilst this is good for bird habitat, it also destabilises the branch and makes it prone to failure. Many *Eucalyptus cladocalyx* and several older *Eucalyptus camaldulensis* have suffered bird damage. The size of the branches where this has occurred can exceed 300–400mm.

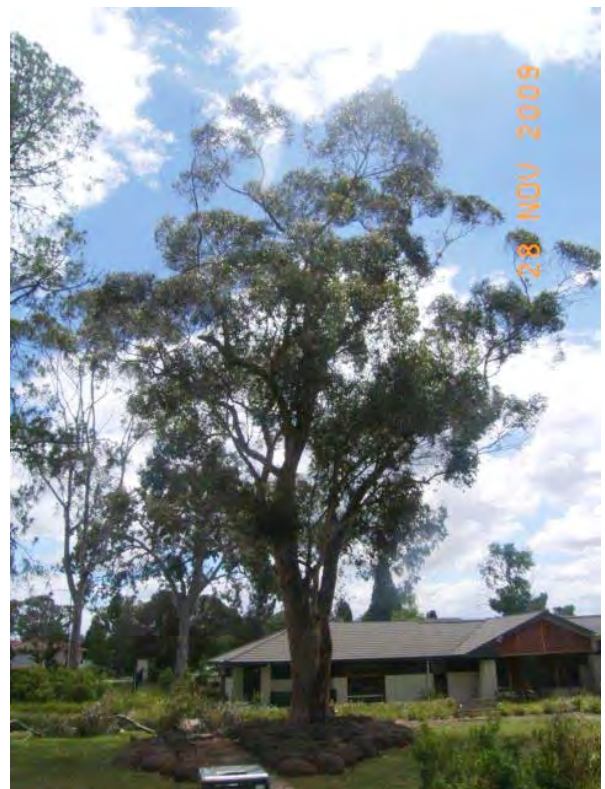
Tree Number 63 **Address:** 64 SPRINGTHORPE BOULEVARD MACLEOD 30
Map No: Sheet 1 **Location** Front of Private Property

ID	Botanical Name	Common Name	Canopy Dimensions (HxW)	DBH (mm)	ULE	Recommended Works	Comments	Address	Location
63	<i>Eucalyptus cladocalyx</i>	Sugar Gum	21m x 15m	760	10 to 20 years	Aerial Inspection, Reinspection every 2yrs	Parrot damage, bus shelter beneath canopy, possible to convert to habitat	64 SPRINGTHORPE BOULEVARD MACLEOD	Front of Private Property
105	<i>Cupressus macrocarpa</i>	Monterey Cypress	18m x 13m	1470	20 to 40 years	Broken branch	Active split in branch	81 SPRINGTHORPE BOULEVARD MACLEOD	Front of Private Property
128	<i>Eucalyptus camaldulensis</i>	River Red Gum	25m x 20m	1510	20 to 40 years	Aerial Inspection, Deadwood removal, Weight reduction, Annual inspection	Multiple bee hives, multiple hollows	11 LINAKER DRIVE MACLEOD	Rear of Private Property
295	<i>Eucalyptus cladocalyx</i>	Sugar Gum	20m x 17m	1050	20 to 40 years	Weight reduction, Reinspection every 2yrs	Evidence of previous branch failure	4 GARNER COURT MACLEOD	Rear of Private Property

Risk of Harm: 1 in 1,440
Risk Category Very high
Works: Aerial Inspection, Reinspection every 2yrs
Comments Parrot damage, bus shelter beneath canopy, possible to convert to habitat

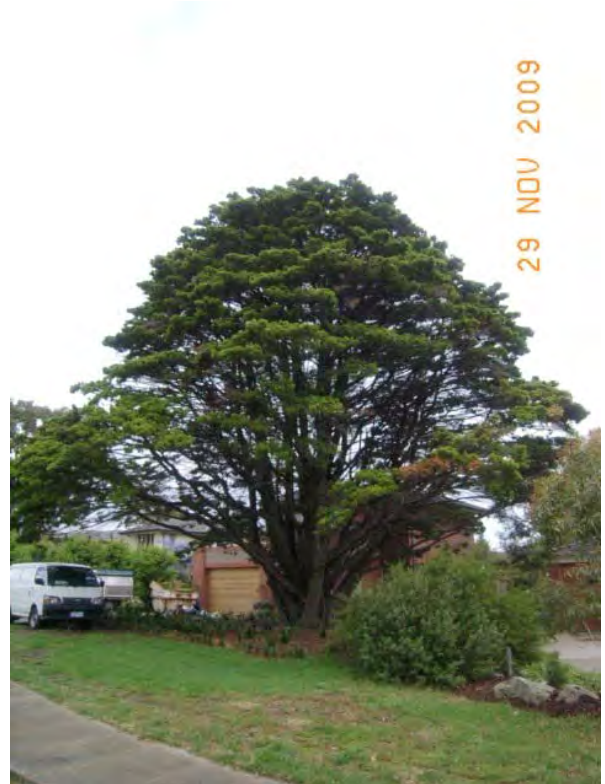
Tree Number 106 **Address:** 30 THE COMMON MACLEOD 3085
Map No: Sheet 2 **Location** Front of Private Property

Risk of Harm: 1 in 1,440
Risk Category Very high
Works: Broken branch
Comments Active split in branch

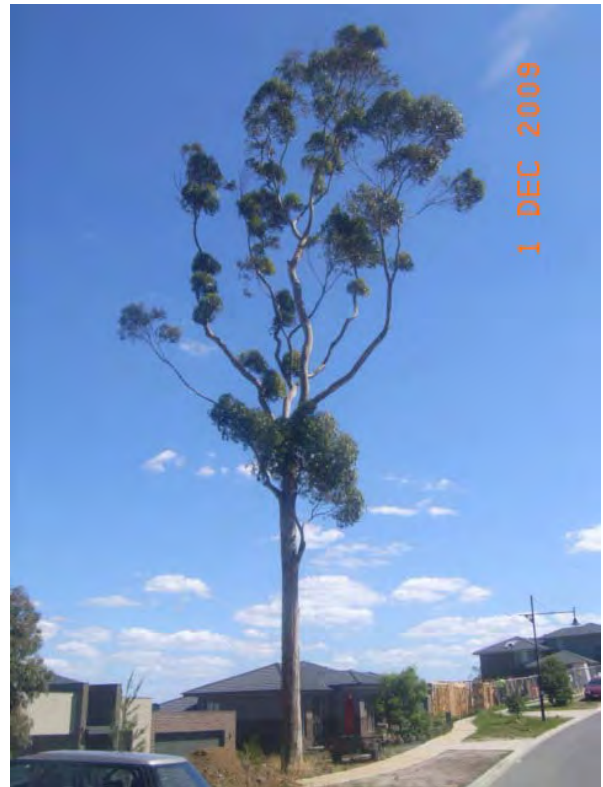
Tree Number 216 **Address:** 137 ERNEST JONES DRIVE MACLEOD 3085

ID	Botanical Name	Common Name	Canopy Dimensions (HxW)	DBH (mm)	ULE	Recommended Works	Comments	Address	Location
216	<i>Eucalyptus camaldulensis</i>	River Red Gum	27m x 20m	1500	20 to 40 years	Aerial Inspection, Reinspection every 2yrs	Parrot damage, multiple hollows	137 ERNEST JONES DRIVE MACLEOD	Council Property
228	<i>Eucalyptus camaldulensis</i>	River Red Gum	21m x 18m	790	10 to 20 years	Weight reduction, Deadwood removal, Reinspection every 2yrs	Road approximately 1m from trunk	ERNEST JONES DRIVE MACLEOD	Council Property
284	<i>Eucalyptus cladocalyx</i>	Sugar Gum	23m x 16m	1310	10 to 20 years	Heavy reduction	Convert tree to habitat, birds are currently nesting in hollows	ERNEST JONES DRIVE MACLEOD	Council Property
