**Geotechnical Investigation:
Northcote Golf Course
143 Normanby Avenue, THORNBURY**

Report Prepared by A.S. James Pty Ltd

14 April 2023

Report No: 122226

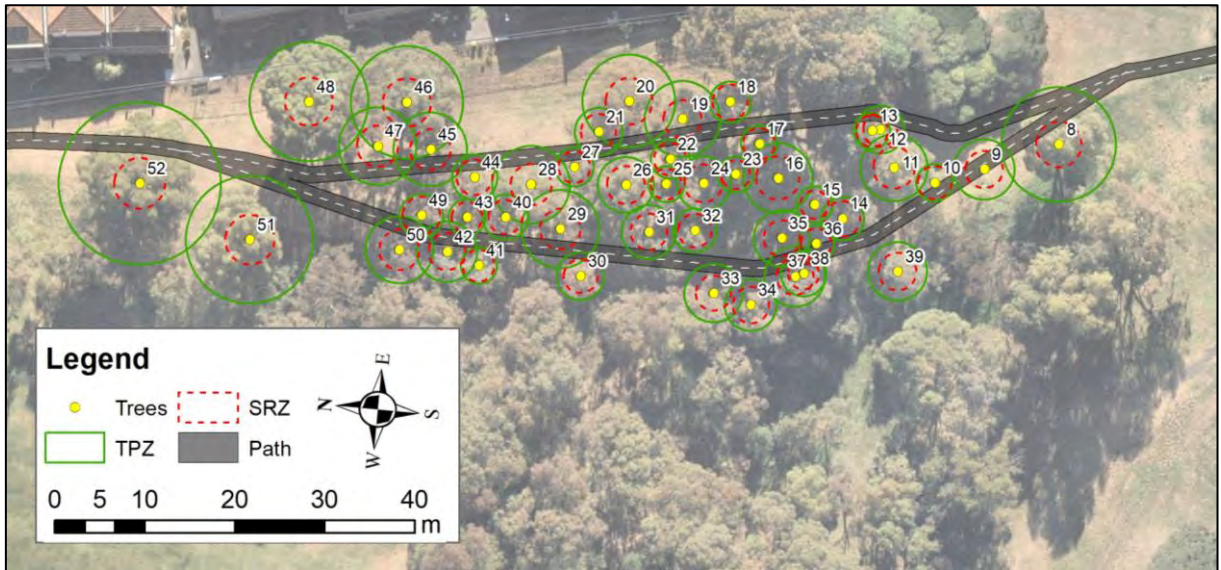
Figure 5: 2 potential alignments are located between Tree 8 and Tree 52.

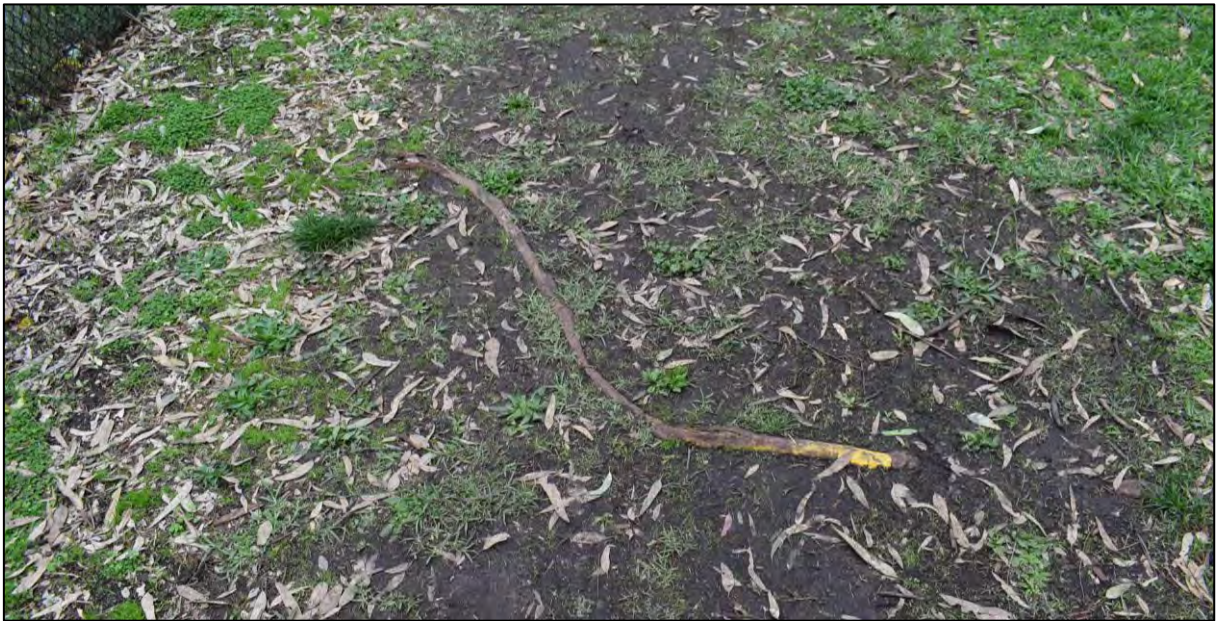
Much of the proposed alignment is currently utilised by pedestrians and there is some level of compaction to soil as a result. Erosion of the grass surface and some soil was consistent along the entirety of the unformed track from foot traffic, exposing surface roots (Figure 6).

Figure 6: Surface root adjacent Tree 65

Given the proximity of the proposed path to existing trees which generally have significant structural roots and expansive root networks, sensitive construction methods will be required to minimise and avoid root damage to the trees.

In areas where the path is close to trees, consideration will need to be given to constructing the path on top of the existing soil level and battering off the sides. Trees 64-68 are located in an area where alignment of the path is inflexible due to boundary fencing and large trees (Figure 7) and the path will likely require installation above grade in this area.

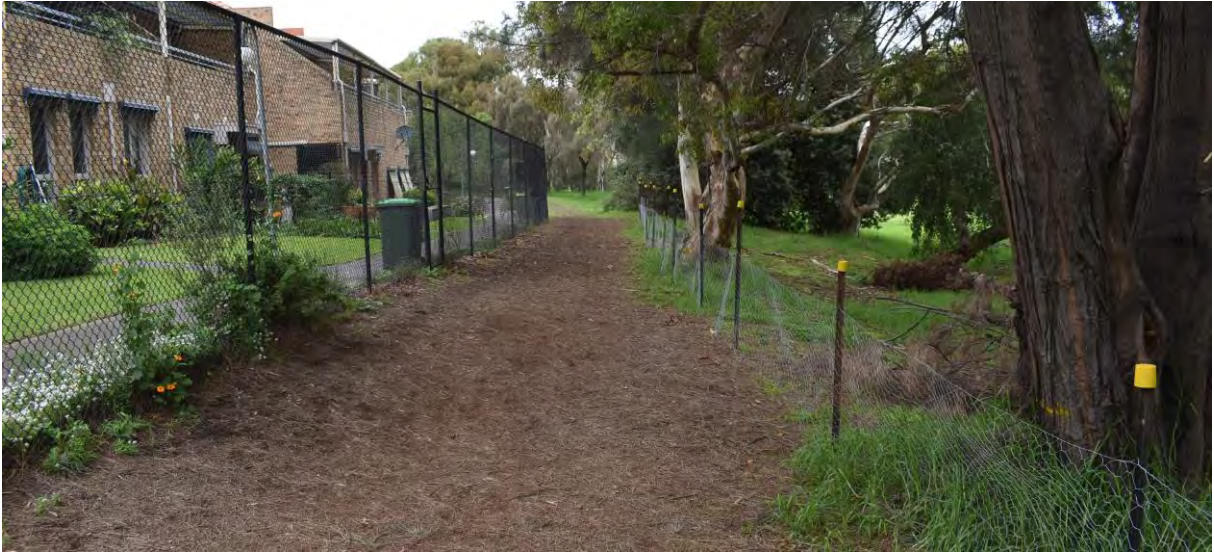
Figure 7: Path alignment near trees 64-68 is inflexible due to boundary fencing and trees.

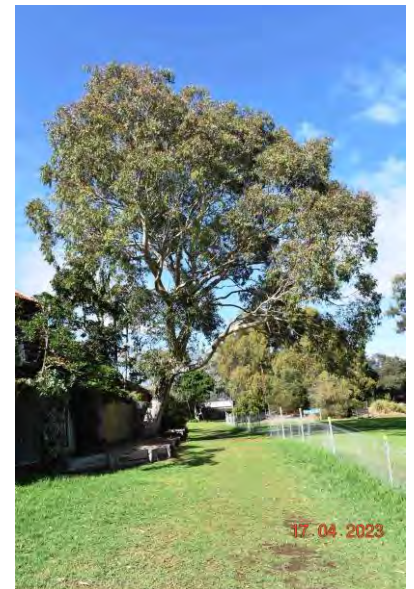
Tree ID 8

Comments: Tree is on lean over path

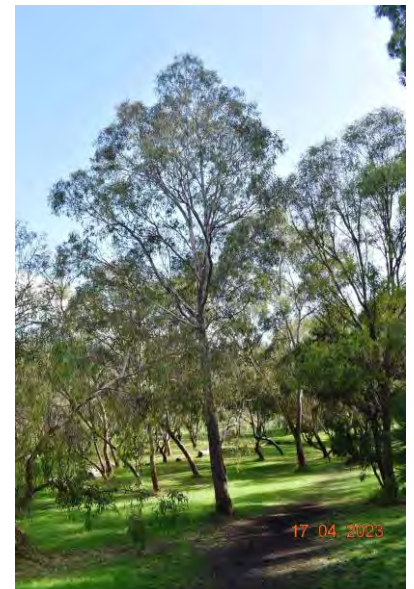
Tree ID 11

Comments: Trunk on significant lean, poor canopy structure, low branches over western path

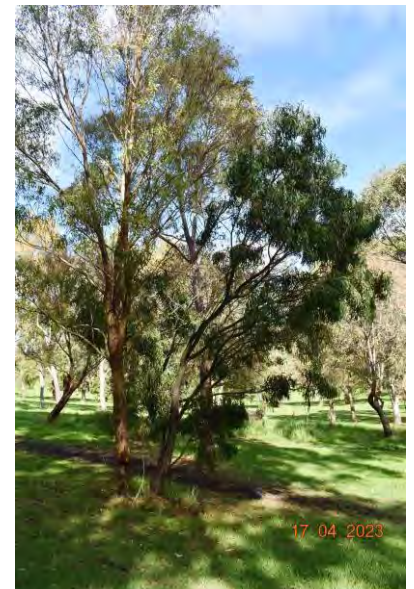
Tree ID 14

Common Name River Red Gum **Origin:** Indigenous
Height (m): 6 **Health:** Fair
Width (m): 3 **Structure:** Poor
DBH (cm): 10 **ULE:** 20+
Dia. @ base (cm): 17
Tree Significance: Low
Retention Value: Low
TPZ Radius (m): 2 **TPZ encroachment %:**0
SRZ Radius (m): 1.6 **SRZ intrusion:** No
Encroachment Level: None **Outcome:** Retained
Comments: Juvenile specimen with kinked trunk

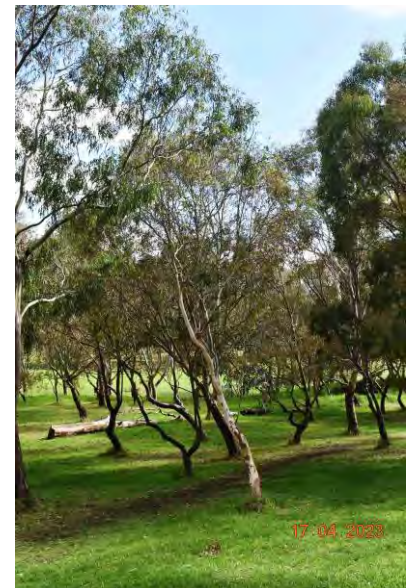
Tree ID 18

Comments: Trunk lean with several kinks

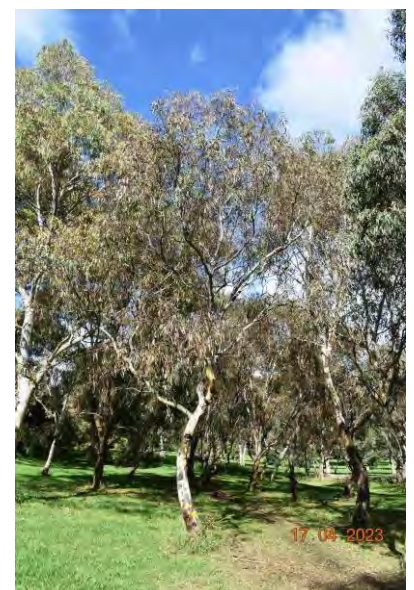
Tree ID 22

Comments: Minor decline in health. directly next to foot pad. Visible surface root adjacent in middle of path

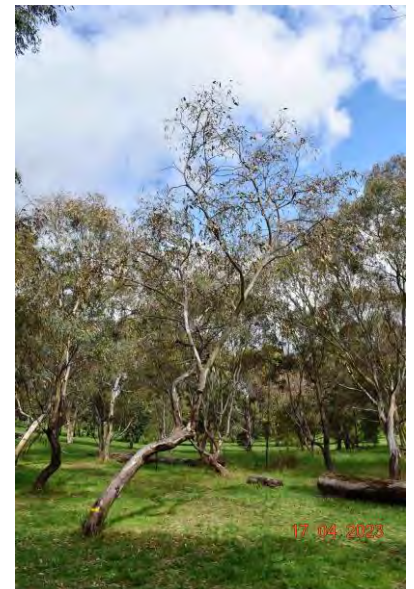
Tree ID 32

Comments: Trunk on heavy lean over foot pad

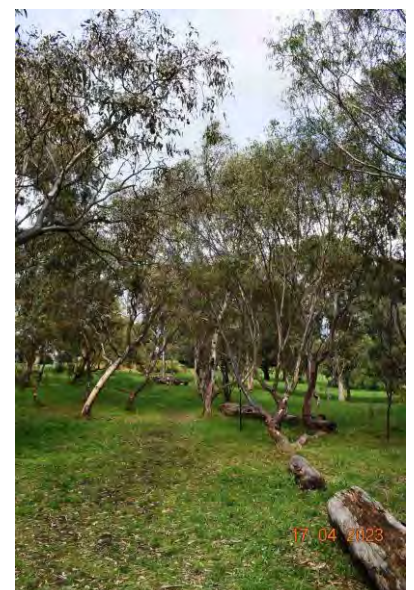
Tree ID 34

Comments: Heavy lean from base towards path, multi-stemmed

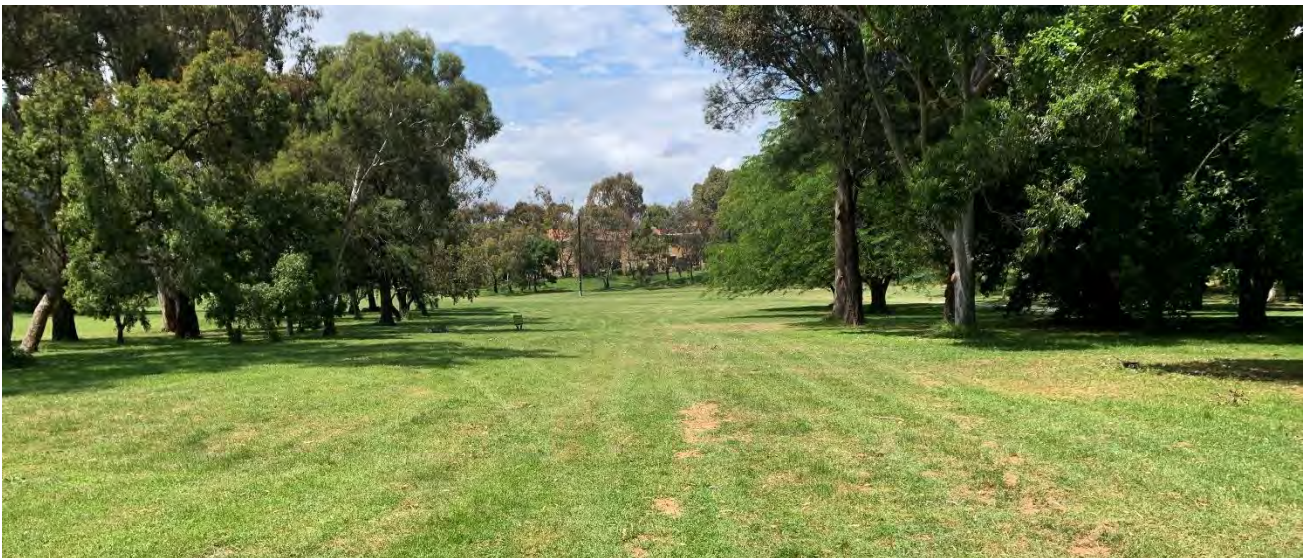
Depending upon the height of the overhead powerlines, the new 5th tees should not be directly underneath them as this could be hazardous during construction. Based upon the approximate boundary line as shown on the plan, the angle from the 5th tee to the public park is sufficient to ensure a properly struck but wayward shot will not be a danger. However, a mis-struck shot off the 'toe' of the club could result in a golf ball shooting low and fast almost at right angles to the line of play so installing lower fencing or netting to prevent this would be advisable.

Figure 12– View of proposed 5th hole from potential tee location
