25 November 2022

640.30578.00100-L02-v1.0-LOA-20221128.docx

**Letter of Advice**  
**Melbourne Innovation Centre**  
**2 Wingrove Street, Alphington Victoria 3078**

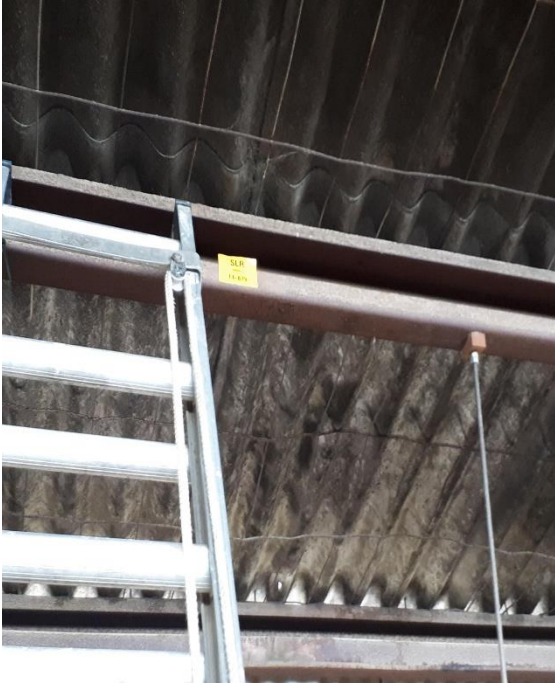
**Photo 1: Sample 11-879**

Client Sample ID	Eurofins Sample No.	Date Sampled	Sample Description	Result
11-879 - Building 2A	22-No0055689	Nov 23, 2022	Approximate Sample <1g Sample consisted of: Dust	Chrysotile asbestos detected in the form of loose fibres of approximate size 10 x 5 x 2mm. Synthetic mineral fibres detected. Organic fibres detected. No trace asbestos detected.
11-880 - Building 2A	22-No0055690	Nov 23, 2022	Approximate Sample <1g Sample consisted of: Dust	Chrysotile asbestos detected in the form of loose fibres of approximate size 5 x 5 x 2mm. Synthetic mineral fibres detected. Organic fibres detected. No trace asbestos detected.
11-881 - Building 2A	22-No0055691	Nov 23, 2022	Approximate Sample <1g Sample consisted of: Dust	No asbestos detected at the reporting limit of 0.01% w/w. Synthetic mineral fibres detected. Organic fibres detected. No trace asbestos detected.
11-882 - Building 2A	22-No0055692	Dec 23, 2022	Approximate Sample <1g Sample consisted of: Dust	No asbestos detected at the reporting limit of 0.01% w/w. Synthetic mineral fibres detected. Organic fibres detected. No trace asbestos detected.

- Asbestos contaminated dust was identified at the time of the inspection at 2 Wingrove Street, Alphington Victoria 3078. The friable asbestos/ACD was confirmed through laboratory analysis to be present in various locations, and should be assumed to be present to the general surface area(s) of the property.
- ACD is dust that is, or is assumed to be, contaminated with asbestos.
- Access to locations containing friable asbestos/ACD should be appropriately restricted (i.e. barricaded, etc). Persons wishing to access the areas must complete a suitable and sufficient risk assessment, the results of which include the use of appropriate Personal Protective Equipment (PPE) which include disposable coveralls and respiratory protection.

- Due to the potential of the friable asbestos in the dust becoming airborne, it is strongly recommended that access be restricted to the building until the area has been environmentally cleaned by a Class A asbestos removal contractor.

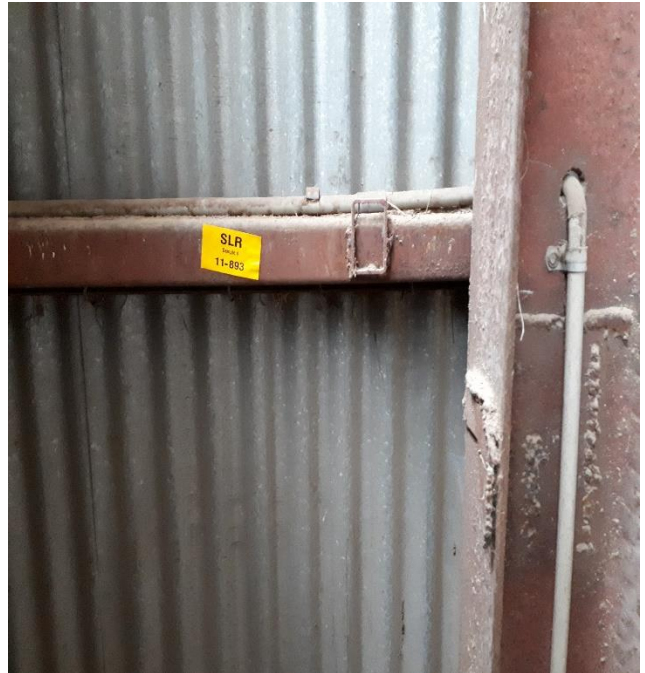
**Photo 4: Sample 11-893**

Client Sample ID	Eurofins Sample No.	Date Sampled	Sample Description	Result
11-893 - Building 2A	22-No0055706	Nov 23, 2022	Approximate Sample 8g Sample consisted of: Dust	Chrysotile asbestos detected in fibre cement fragments of approximate size 5 x 2 x 2mm. Synthetic mineral fibres detected. Organic fibres detected. No trace asbestos detected.
11-894 - Building 2A	22-No0055707	Nov 23, 2022	Approximate Sample 3g Sample consisted of: Dust	Chrysotile asbestos detected in the form of loose fibres of approximate size 5 x 5 x 2mm. Synthetic mineral fibres detected. Organic fibres detected. No trace asbestos detected.
11-895 - Building 2A	22-No0055708	Nov 23, 2022	Approximate Sample <1g Sample consisted of: Dust	No asbestos detected at the reporting limit of 0.01% w/w. Synthetic mineral fibres detected. Organic fibres detected. No trace asbestos detected.
11-896 - Building 2A	22-No0055709	Nov 23, 2022	Approximate Sample 4g Sample consisted of: Dust	No asbestos detected at the reporting limit of 0.01% w/w. Synthetic mineral fibres detected. Organic fibres detected. No trace asbestos detected.

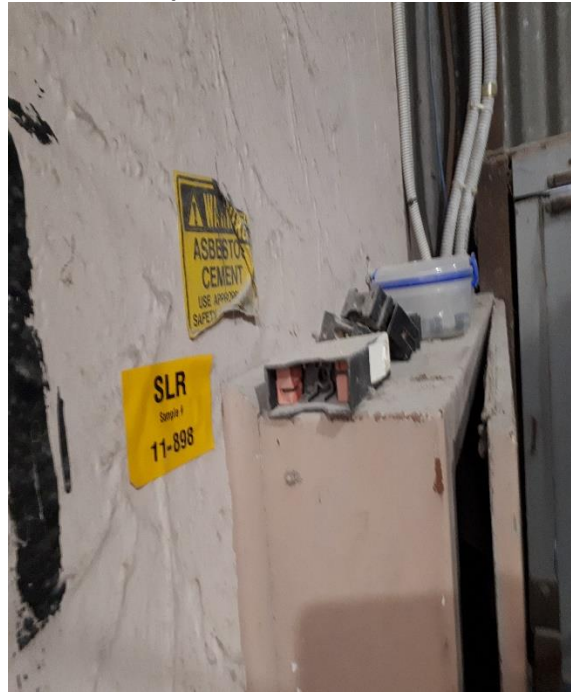
Photo 6: Sample 11-898

Client Sample ID	Eurofins Sample No.	Date Sampled	Sample Description	Result
11-898 - Building 2A	22-No0055711	Nov 23, 2022	Approximate Sample 4g Sample consisted of: Dust	Chrysotile asbestos detected in the form of loose fibres of approximate size 5 x 5 x 2mm. Synthetic mineral fibres detected. Organic fibres detected. No trace asbestos detected.
11-899 - Building 2A	22-No0055712	Nov 23, 2022	Approximate Sample 4g Sample consisted of: Dust	No asbestos detected at the reporting limit of 0.01% w/w. Synthetic mineral fibres detected. Organic fibres detected. No trace asbestos detected.
11-900- Building 2A	22-No0055713	Nov 23, 2022	Approximate Sample 2g Sample consisted of: Dust	No asbestos detected at the reporting limit of 0.01% w/w. Synthetic mineral fibres detected. Organic fibres detected. No trace asbestos detected.
11-901- Building 2A	22-No0055714	Nov 23, 2022	Approximate Sample <1g Sample consisted of: Dust	No asbestos detected at the reporting limit of 0.01% w/w. Synthetic mineral fibres detected. Organic fibres detected. No trace asbestos detected.

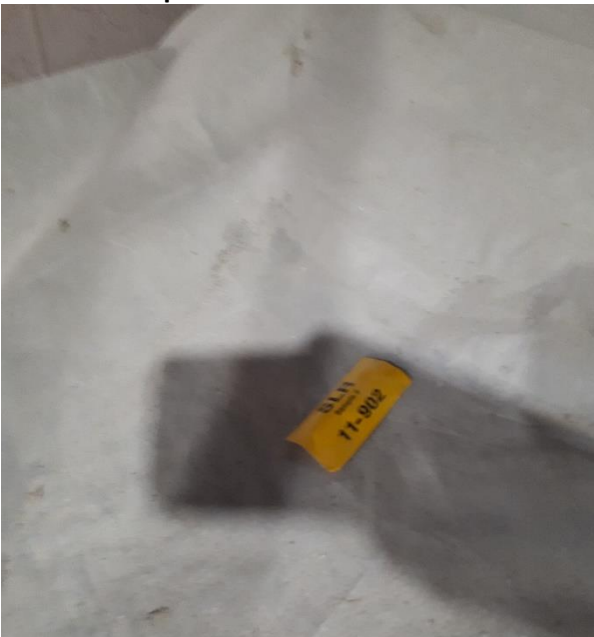
Photo 7: Sample 11-902

11-902	Building 2A – Shelf – Centre (at 1 meter height)	Approximate Sample 2g Sample consisted of: Dust	Chrysotile asbestos detected in the form of loose fibres of approximate size 10 x 5 x 2mm. Synthetic mineral fibres detected. Organic fibres detected. No trace asbestos detected.

11-902 - Building 2A	22-No0055715	Dec 23, 2022	Approximate Sample 2g Sample consisted of: Dust	Chrysotile asbestos detected in the form of loose fibres of approximate size 10 x 5 x 2mm. Synthetic mineral fibres detected. Organic fibres detected. No trace asbestos detected.
