### Letter of Advice Melbourne Innovation Centre Building 3, 2 Wingrove Street, Alphington Victoria 3078

SLR Consulting Australia Pty Ltd (SLR) was requested by Daniel DeSimone of Darebin City Council to conduct sampling of surface dusts for asbestos content, and to undertake background air monitoring during sampling at Building 3, 2 Wingrove Street, Alphington Victoria 3078 to ascertain extent of potential Asbestos Containing Dust (ACD) and to determine the extent of removal works required. The assessment was conducted on 23-27 November 2022 by Krishna Kadali/James Bracken from SLR.

Melbourne Innovation Centre Building 3, 2 Wingrove Street, Alphington Victoria 3078 Dust Sampling

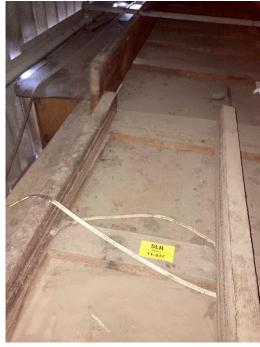
## Photo 1: Sample 11-917

Sample No.	Sample Location	Sample Description (including Weight/Size)	Analysis Results
11-917	Building 3A-3D – Above Mezzanine Level – Ceiling Void	Approximate Sample 4g Sample consisted of: Dust	Chrysotile asbestos detected in the form of loose fibres of approximate size 10 x 5 x 2mm.
			Synthetic mineral fibres detected. Organic fibres detected.
11-918	Building 3A-3D – Above Mezzanine Level – Ceiling Void	Approximate Sample 3g Sample consisted of: Dust	Chrysotile asbestos detected in the form of loose fibres of approximate size 5 x 5 x 1mm. Synthetic mineral fibres detected. Organic fibres detected.
11-919	Building 3A-3D – Above Mezzanine Level – Ceiling Void	Approximate Sample 3g Sample consisted of: Dust	Chrysotile asbestos detected in the form of loose fibres of approximate size 10 x 2 x 2mm. Synthetic mineral fibres detected. Organic fibres detected.
11-920	Building 3A-3D – Above Mezzanine Level – Ceiling Void	Approximate Sample 1g Sample consisted of: Dust	Chrysotile asbestos detected in the form of loose fibres of approximate size 5 x 5 x 2mm. Synthetic mineral fibres detected. Organic fibres detected.

- Due to the potential of the friable asbestos in the dust becoming airborne, it is strongly recommended that access be restricted to the building until the area has been environmentally cleaned by a Class A asbestos removal contractor.

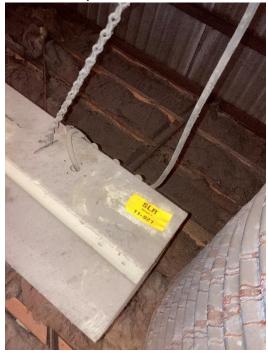
Photo 5: Sample 11-921

11-921	Building 3A-3D – Above Mezzanine Level – Ceiling Void	Approximate Sample 2g Sample consisted of: Dust	Chrysotile asbestos detected in the form of loose fibres of approximate size 5 x 5 x 2mm. Synthetic mineral fibres detected. Organic fibres detected.
11-922	Building 3A-3D – Above Mezzanine Level – Ceiling Void	Approximate Sample 5g Sample consisted of: Dust	Chrysotile asbestos detected in the form of loose fibres of approximate size 10 x 2 x 2mm. Synthetic mineral fibres detected. Organic fibres detected.
11-923	Building 3A-3D – Above Mezzanine Level – Ceiling Void	Approximate Sample 1g Sample consisted of: Dust	No asbestos detected at the reporting limit of 0.01% w/w. Synthetic mineral fibres detected. Organic fibres detected. No trace asbestos detected.

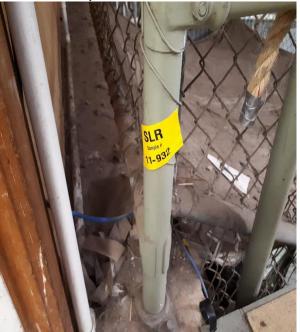
Photo 11: Sample 11-932

Sample No.	Sample Location	Sample Description (including Weight/Size)	Analysis Results
11-932	Building 3A-3D – Mezzanine Level – Above Caged Area - Wall – Adjacent Stairs	Approximate Sample 3g Sample consisted of: Dust	<ul> <li>Chrysotile asbestos detected in the form of loose fibres of approximate size 5 x 5 x 2mm.</li> <li>Synthetic mineral fibres detected.</li> <li>Organic fibres detected.</li> </ul>
11-933	Building 3A-3D – Canopy – Caged Area - Adjacent Stairs	Approximate Sample 4g / - mm Sample consisted of: Dust	No asbestos detected at the reporting limit of 0.01% w/w. Synthetic mineral fibre detected. Organic fibre detected. No trace asbestos detected.
11-934	Building 3A-3D – Above Temperature Room – Adjacent Farm Wall (at 3 meter height)	Approximate Sample 3g / - mm Sample consisted of: Dust	<ul> <li>Chrysotile asbestos detected in the form of cement sheet fragment.</li> <li>Approximate dimensions: 6 x 3 x 1mm.</li> <li>Organic fibre detected.</li> <li>Synthetic mineral fibre detected.</li> <li>No trace asbestos detected.</li> </ul>

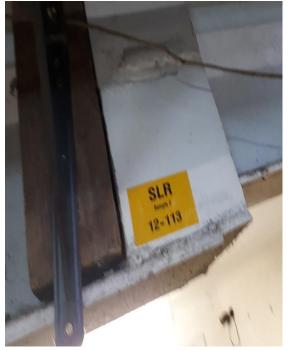
Photo 21: Sample 12-113

Sample No.	Sample Location	Sample Description (including Weight/Size)	Analysis Results
12-113	Building 3A-3D – Brewery – Fermentation - East Wall – Adjacent Office (at 2 meter height)	Approximate Sample g Sample consisted of: Dust	<ul> <li>Chrysotile asbestos detected in the form of loose fibre bundle</li> <li>approximate size: 10 x 2 x</li> <li>1mm.</li> <li>Organic fibre detected.</li> <li>Synthetic mineral fibre detected.</li> <li>No trace asbestos detected.</li> </ul>
12-114	Building 3A-3D – Brewery – Fermentation - Shelf – Adjacent Office (at 2 meter height)	Approximate Sample g Sample consisted of: Dus	Chrysotile asbestos detected in the form of loose fibre bundle approximate size: 5 x 5 x 1mm. Organic fibre detected. No trace asbestos detected.
12-115	Building 3A-3D – Brewery – Fermentation - Above Office (at 2 meter height)	Approximate Sample g Sample consisted of: Dust	Chrysotile asbestos detected in the form of fibre cement fragments approximate size: 10 x 5 x 2mm. Organic fibre detected. Synthetic mineral fibre detected. No trace asbestos detected.

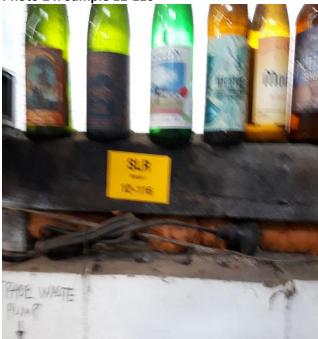
Photo 24: Sample 12-116

12-116	Building 3A-3D – Brewery – Fermentation – North Wall – Right (at 1.5 meter height)	Approximate Sample g Sample consisted of: Dust	Chrysotile asbestos detected in the form of loose fibre bundle approximate size: 5 x 2 x 1mm. Organic fibre detected. Synthetic mineral fibre detected. No trace asbestos detected.
12-117	Building 3A-3D – Brewery – Fermentation – North Wall – Centre (at 1.5 meter height)	Approximate Sample g Sample consisted of: Dust	<ul> <li>Chrysotile asbestos detected in the form of loose fibre bundle</li> <li>approximate size: 5 x 5 x 1mm.</li> <li>Organic fibre detected.</li> <li>Synthetic mineral fibre detected.</li> <li>No trace asbestos detected.</li> </ul>
12-118	Building 3A-3D – Brewery – Fermentation – Above Walkin Fridge – North Side (at 2 meter height)	Approximate Sample g Sample consisted of: Dust	No asbestos detected at the reporting limit of 0.01% w/w. Synthetic mineral fibre detected. Organic fibre detected. No trace asbestos detected.

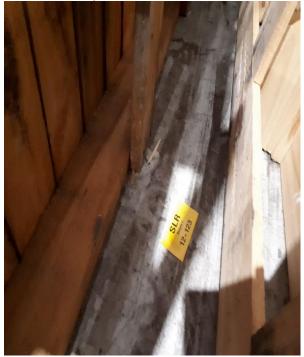
Photo 27: Sample 12-123

12-123	Building 3A-3D – Brewery – Fermentation – Floor - South	Approximate Sample 6g Sample consisted of: Dust	Chrysotile asbestos detected in the form of loose fibre bundle approximate size: 10 x 5 x 1mm. Organic fibre detected. No trace asbestos detected.
12-124	Building 3A-3D – Brewery – Fermentation – Above Walkin Fridge – South Side (at 2 meter height)	Approximate Sample 4g Sample consisted of: Dust	Chrysotile asbestos detected in the form of loose fibre bundle approximate size: 5 x 2 x 1mm. Organic fibre detected. Synthetic mineral fibre detected. No trace asbestos detected
12-125	Building 3A-3D – Brewery – Bar – East Wall – Left (at 1 meter height)	Approximate Sample <1g Sample consisted of: Dust	No asbestos detected at the reporting limit of 0.01% w/w. Synthetic mineral fibre detected. Organic fibre detected. No trace asbestos detected.

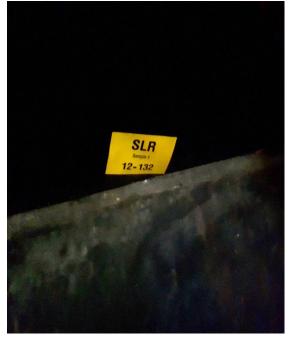
Photo 33: Sample 12-132

Sample No.	Sample Location	Sample Description (including Weight/Size)	Analysis Results
12-132	Building 3A-3D – Brewery – Bar – Floor - Central	Approximate Sample <1g Sample consisted of: Dust	<ul> <li>Chrysotile asbestos detected in the form of loose fibre bundle</li> <li>approximate size: 5 x 2 x 1mm.</li> <li>Organic fibre detected.</li> <li>Synthetic mineral fibre detected.</li> </ul>
12-133	Building 3A-3D – Brewery – Bar – South Wall – Adjacent Office (at 3 meter height)	Approximate Sample 2g Sample consisted of: Dust	<ul> <li>No trace asbestos detected.</li> <li>Chrysotile asbestos detected in the form of fibre cement fragments</li> <li>approximate size: 10 x 2 x</li> <li>1mm.</li> <li>Organic fibre detected.</li> <li>Synthetic mineral fibre detected.</li> <li>No trace asbestos detected.</li> </ul>
12-139	Building 3A – Workshop West– Windowsill - West (at 2 meter height)	Approximate Sample 1g / - mm Sample consisted of: Dust	No asbestos detected at the reporting limit of 0.01% w/w. Synthetic mineral fibre detected. Organic fibre detected. No trace asbestos detected.
