640.30612.00300-L02-v1.0-LOA-20221212.docx

Letter of Advice
Melbourne Innovation Centre
Building 2A & 3, 2 Wingrove Street, Alphington Victoria 3078

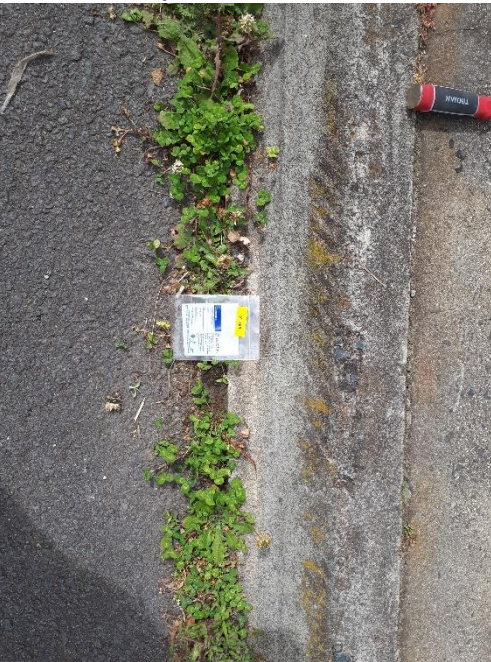
Photo 3: Sample 12-189

12-189	Building 3 – External – Ground Surface – North – (Left side – 4 meter from the building)	Approximate Sample 6g Sample consisted of: Dust	Chrysotile asbestos detected in the form of loose fibres of approximate size 5 x 5 x 1mm. Synthetic mineral fibres detected. Organic fibres detected. No trace asbestos detected.
12-190	Building 3 – External – Ground Surface – North – (Left side – 1 meter from the building)	Approximate Sample 4g Sample consisted of: Dust	Chrysotile asbestos detected in the form of loose fibres of approximate size 5 x 5 x 2mm. Synthetic mineral fibres detected. Organic fibres detected. No trace asbestos detected.
12-191	Building 3 – External – Ground Surface – North – (Centre – 3 meter from the building)	Approximate Sample 4g Sample consisted of: Dust	Chrysotile asbestos detected in the form of loose fibres of approximate size 5 x 2 x 1mm. Organic fibres detected. No trace asbestos detected.

- Due to the potential of the friable asbestos in the dust becoming airborne, it is strongly recommended that access be restricted to the external grounds adjacent the buildings until the area has been environmentally cleaned by a Class A asbestos removal contractor.

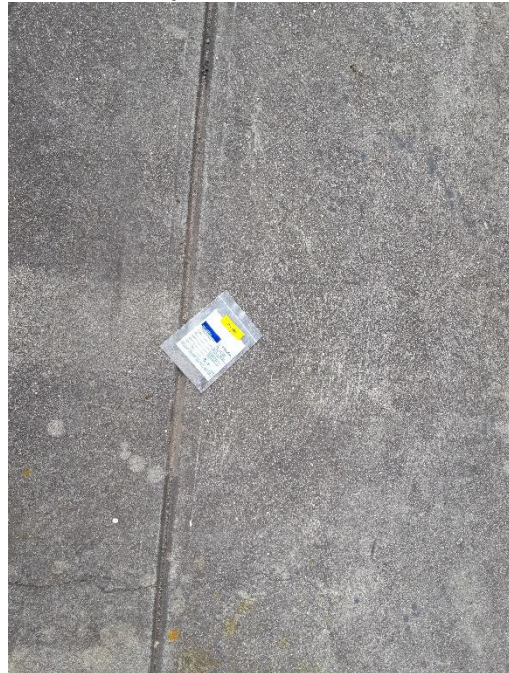
Photo 4: Sample 12-190

Client Sample ID	Eurofins Sample No.	Date Sampled	Sample Description	Result
12-190 - Building 3 - External - Ground Surface - North	22-De0015382	Dec 07, 2022	Approximate Sample 4g Sample consisted of: Dust	Chrysotile asbestos detected in the form of loose fibres of approximate size 5 x 5 x 2mm. Synthetic mineral fibres detected. Organic fibres detected. No trace asbestos detected.
12-191 - Building 3 - External - Ground Surface - North	22-De0015383	Dec 07, 2022	Approximate Sample 4g Sample consisted of: Dust	Chrysotile asbestos detected in the form of loose fibres of approximate size 5 x 2 x 1mm. Organic fibres detected. No trace asbestos detected.
12-192 - Building 3 - External - Ground Surface - North	22-De0015384	Dec 07, 2022	Approximate Sample 6g Sample consisted of: Dust	Chrysotile asbestos detected in the form of loose fibres of approximate size 5 x 5 x 1mm. Organic fibres detected. No trace asbestos detected.

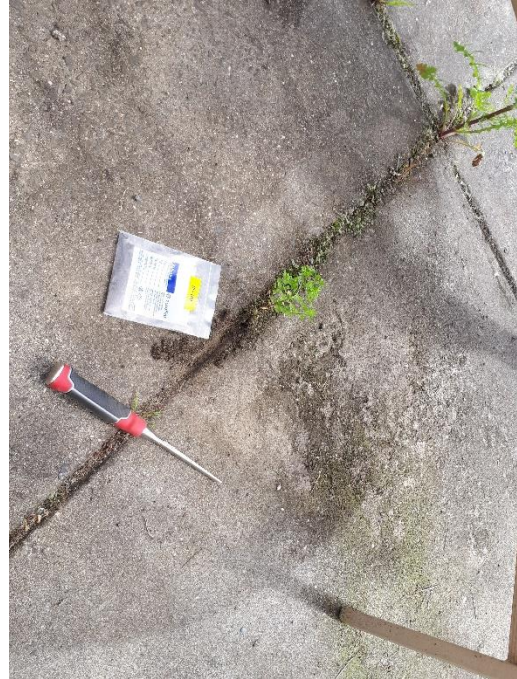
Photo 6: Sample 12-192

12-192	Building 3 – External – Ground Surface – North – (Centre – 1 meter from the building)	Approximate Sample 6g Sample consisted of: Dust	Chrysotile asbestos detected in the form of loose fibres of approximate size 5 x 5 x 1mm. Organic fibres detected. No trace asbestos detected.

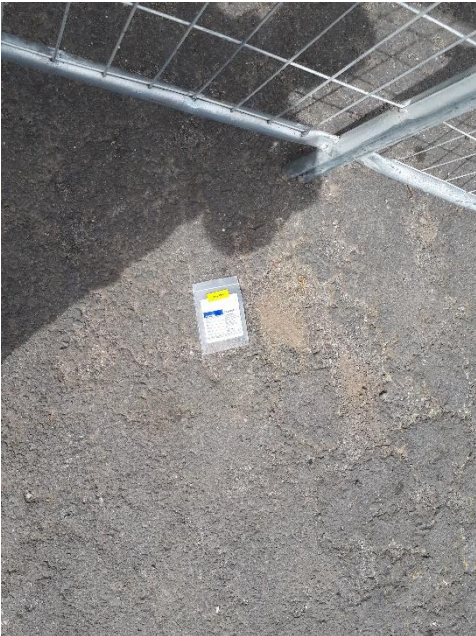
Photo 7: Sample 12-193

Sample No.	Sample Location	Sample Description (including Weight/Size)	Analysis Results
12-193	Building 3 – External – Ground Surface – North – (Right side – 6 meter from the building)	Approximate Sample 4g Sample consisted of: Dust	Chrysotile asbestos detected in the form of loose fibres of approximate size 5 x 2 x 2mm. Organic fibres detected. No trace asbestos detected.
12-194	Building 2A – External – Ground Surface – East – (Right side – 5 meter from the building)	Approximate Sample 6g / - mm Sample consisted of: Dust	Chrysotile asbestos detected in the form of loose fibre bundle. Approximate dimensions 10 x 5 x 2mm. Synthetic mineral fibres detected. Organic fibres detected. No trace asbestos detected.
12-195	Building 2A – External – Ground Surface – East – (Right side – 6 meter from the building)	Approximate Sample 8g / - mm Sample consisted of: Dust	Chrysotile asbestos detected in the form of loose fibre bundle. Approximate dimensions 10 x 5 x 1mm. Synthetic mineral fibres detected. Organic fibres detected. No trace asbestos detected.

12-193 - Building 3 - External - Ground Surface - North	22-De0015385	Dec 07, 2022	Approximate Sample 4g Sample consisted of: Dust	Chrysotile asbestos detected in the form of loose fibres of approximate size 5 x 2 x 2mm. Organic fibres detected. No trace asbestos detected.

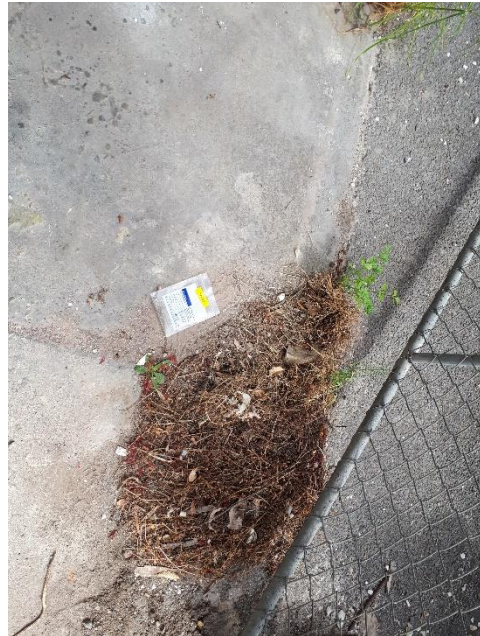
Photo 8: Sample 12-194

Client Sample ID	Eurofins Sample No.	Date Sampled	Sample Description	Result
12-194 - Building 2A - External - Ground Surface - East	22-De0015396	Dec 07, 2022	Approximate Sample 6g / -mm Sample consisted of: Dust	Chrysotile asbestos detected in the form of loose fibre bundle. Approximate dimensions 10 x 5 x 2mm. Synthetic mineral fibres detected. Organic fibres detected. No trace asbestos detected.
12-195 - Building 2A - External - Ground Surface - East	22-De0015397	Dec 07, 2022	Approximate Sample 8g / -mm Sample consisted of: Dust	Chrysotile asbestos detected in the form of loose fibre bundle. Approximate dimensions 10 x 5 x 1mm. Synthetic mineral fibres detected. Organic fibres detected. No trace asbestos detected.
12-196 - Building 2A - External - Ground Surface - East	22-De0015398	Dec 07, 2022	Approximate Sample 5g / -mm Sample consisted of: Dust	No asbestos detected at the reporting limit of 0.01% w/w. Synthetic mineral fibre detected. Organic fibre detected. No trace asbestos detected.

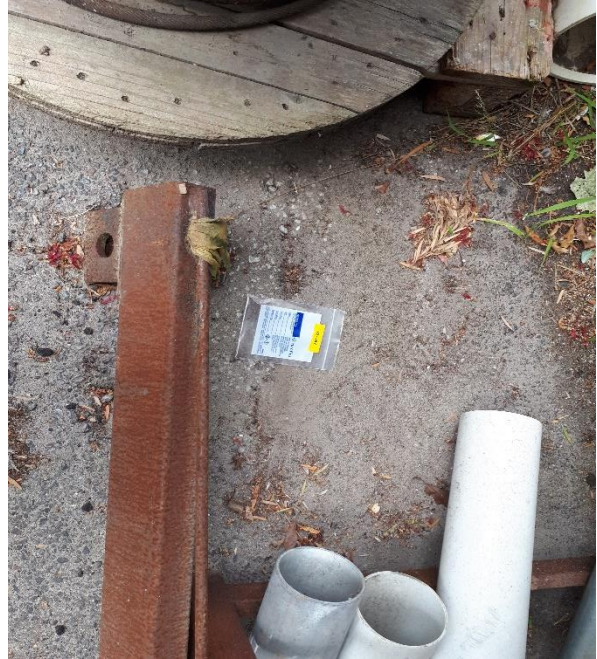
Photo 10: Sample 12-197

12-197 - Building 2A - External - Ground Surface - East	22-De0015399	Dec 07, 2022	Approximate Sample 5g / -mm Sample consisted of: Dust	Chrysotile asbestos detected in the form of loose fibre bundles. Approximate dimensions 5 x 5 x 2mm. Synthetic mineral fibres detected. Organic fibres detected. No trace asbestos detected.
12-198 - Building 2A - External - Ground Surface - East	22-De0015400	Dec 07, 2022	Approximate Sample 9g / -mm Sample consisted of: Dust	No asbestos detected at the reporting limit of 0.01% w/w. Synthetic mineral fibre detected. Organic fibre detected. No trace asbestos detected.

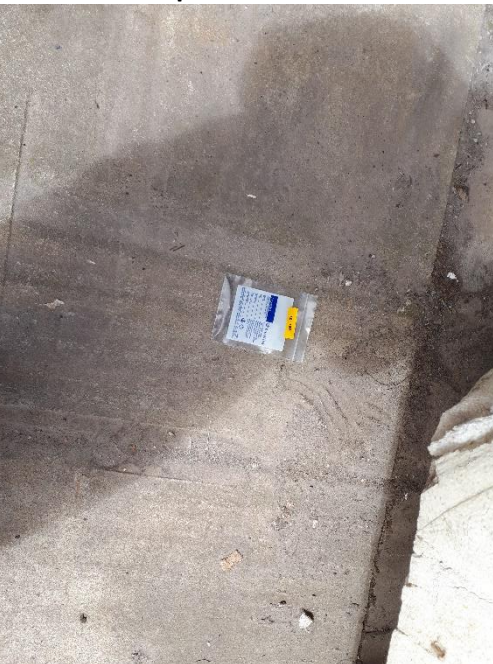
Photo 11: Sample 12-199

Sample No.	Sample Location	Sample Description (including Weight/Size)	Analysis Results
12-199	Building 2A – External – Ground Surface – North – (Left side – 1 meter from the building)	Approximate Sample 6g / - mm Sample consisted of: Dust	Chrysotile asbestos detected in the form of loose fibre bundle. Approximate dimensions 10 x 5 x 2mm. Synthetic mineral fibres detected. Organic fibres detected. No trace asbestos detected.
12-200	Building 2A – External – Ground Surface – North – (Left side – 6 meter from the building)	Approximate Sample 8g / - mm Sample consisted of: Dust	Chrysotile asbestos detected in the form of fibre cement fragment. Approximate dimensions 5 x 5 x 2mm. Synthetic mineral fibres detected. Organic fibres detected. No trace asbestos detected.
12-201	Building 2A – External – Ground Surface – North – (Centre – 4 meter from the building)	Approximate Sample 11g / - mm Sample consisted of: Dust	Chrysotile and amosite asbestos detected in the form of fibre cement fragment. Approximate dimensions 10 x 5 x 2mm. Synthetic mineral fibres detected. Organic fibres detected. No trace asbestos detected.

Client Sample ID	Eurofins Sample No.	Date Sampled	Sample Description	Result
12-199 - Building 2A - External - Ground Surface - North	22-De0015401	Dec 07, 2022	Approximate Sample 6g / -mm Sample consisted of: Dust	Chrysotile asbestos detected in the form of loose fibre bundle. Approximate dimensions 10 x 5 x 2mm. Synthetic mineral fibres detected. Organic fibres detected. No trace asbestos detected.
12-200 - Building 2A - External - Ground Surface - North	22-De0015402	Dec 07, 2022	Approximate Sample 8g / -mm Sample consisted of: Dust	Chrysotile asbestos detected in the form of fibre cement fragment. Approximate dimensions 5 x 5 x 2mm. Synthetic mineral fibres detected. Organic fibres detected. No trace asbestos detected.
12-201 - Building 2A - External - Ground Surface - North	22-De0015403	Dec 07, 2022	Approximate Sample 11g / -mm Sample consisted of: Dust	Chrysotile and amosite asbestos detected in the form of fibre cement fragment. Approximate dimensions 10 x 5 x 2mm. Synthetic mineral fibres detected. Organic fibres detected. No trace asbestos detected.

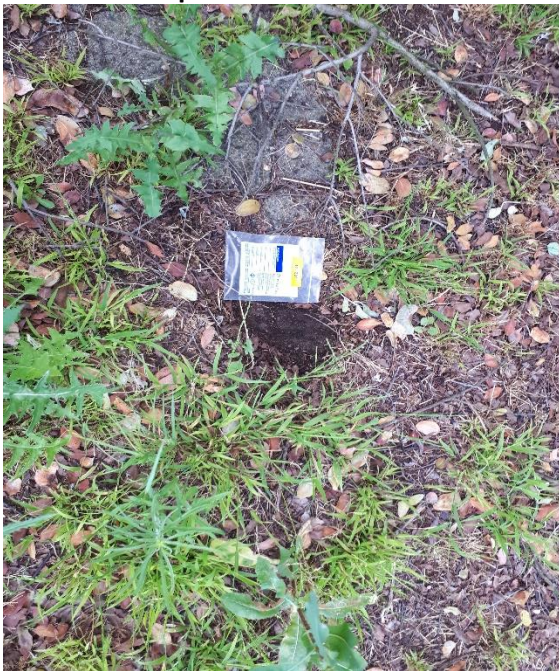
Photo 15: Sample 12-204

Sample No.	Sample Location	Sample Description (including Weight/Size)	Analysis Results
12-204	Building 2A – External – Ground Surface – West – (Centre – 1 meter from the building)	Approximate Sample 6g Sample consisted of: Dust	Chrysotile asbestos detected in the form of loose fibre bundle. Approximate dimensions 5 x 5 x 2mm. Organic fibres detected. No trace asbestos detected.
12-205	Building 2A – External – Ground Surface – West – (Centre – 2 meter from the building)	Approximate Sample 6g Sample consisted of: Dust	No asbestos detected at the reporting limit of 0.01% w/w. Organic fibre detected. No trace asbestos detected.
12-206	Building 2A – External – Ground Surface – West – (Left side – 4 meter from the building)	Approximate Sample 6g Sample consisted of: Dust	Chrysotile asbestos detected in the form of loose fibre bundle. Approximate dimensions 10 x 5 x 1mm. Synthetic mineral fibres detected. Organic fibres detected. No trace asbestos detected.

Client Sample ID	Eurofins Sample No.	Date Sampled	Sample Description	Result
12-204 - Building 2A - External - Ground Surface - West	22-De0015406	Dec 07, 2022	Approximate Sample 6g Sample consisted of: Dust	Chrysotile asbestos detected in the form of loose fibre bundle. Approximate dimensions 5 x 5 x 2mm. Organic fibres detected. No trace asbestos detected.
12-205 - Building 2A - External - Ground Surface - West	22-De0015407	Dec 07, 2022	Approximate Sample 6g Sample consisted of: Dust	No asbestos detected at the reporting limit of 0.01% w/w. Organic fibre detected. No trace asbestos detected.
12-206 - Building 2A - External - Ground Surface - West	22-De0015408	Dec 07, 2022	Approximate Sample 6g Sample consisted of: Dust	Chrysotile asbestos detected in the form of loose fibre bundle. Approximate dimensions 10 x 5 x 1mm. Synthetic mineral fibres detected. Organic fibres detected. No trace asbestos detected.

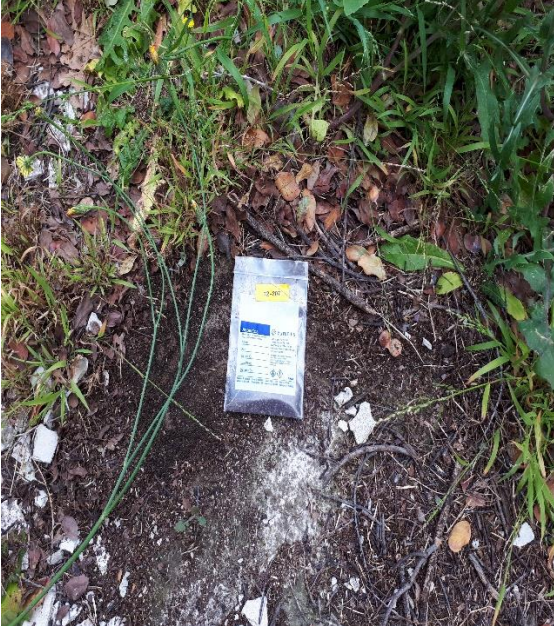
Photo 17: Sample 12-207

12-207	Building 2A – External – Ground Surface – West – (Right side – 1 meter from the building)	Approximate Sample 8g Sample consisted of: Dust	Chrysotile asbestos detected in the form of loose fibre bundle. Approximate dimensions 15 x 5 x 2mm. Organic fibres detected. No trace asbestos detected.
12-208	Building 2A – External – Ground Surface – West – (Right side – 3 meter from the building)	Approximate Sample 7g Sample consisted of: Dust	Chrysotile asbestos detected in the form of loose fibre bundle. Approximate dimensions 5 x 5 x 1mm. Synthetic mineral fibres detected. Organic fibres detected. No trace asbestos detected.
12-209	Building 2A – External – Ground Surface – South – (Left side – 3 meter from the building)	Approximate Sample 15g Sample consisted of: Dust	Chrysotile and crocidolite asbestos detected in the form of loose fibre bundles. Approximate dimensions 15 x 5 x 2mm. Organic fibres detected. Trace chrysotile and crocidolite asbestos detected.

12-207 - Building 2A - External - Ground Surface - West	22-De0015409	Dec 07, 2022	Approximate Sample 8g Sample consisted of: Dust	Chrysotile asbestos detected in the form of loose fibre bundle. Approximate dimensions 15 x 5 x 2mm. Organic fibres detected. No trace asbestos detected.
12-208 - Building 2A - External - Ground Surface - West	22-De0015410	Dec 07, 2022	Approximate Sample 7g Sample consisted of: Dust	Chrysotile asbestos detected in the form of loose fibre bundle. Approximate dimensions 5 x 5 x 1mm. Synthetic mineral fibres detected. Organic fibres detected. No trace asbestos detected.
12-209 - Building 2A - External - Ground Surface - South	22-De0015411	Dec 07, 2022	Approximate Sample 15g Sample consisted of: Dust	Chrysotile and crocidolite asbestos detected in the form of loose fibre bundles. Approximate dimensions 15 x 5 x 2mm. Organic fibres detected. Trace chrysotile and crocidolite asbestos detected.

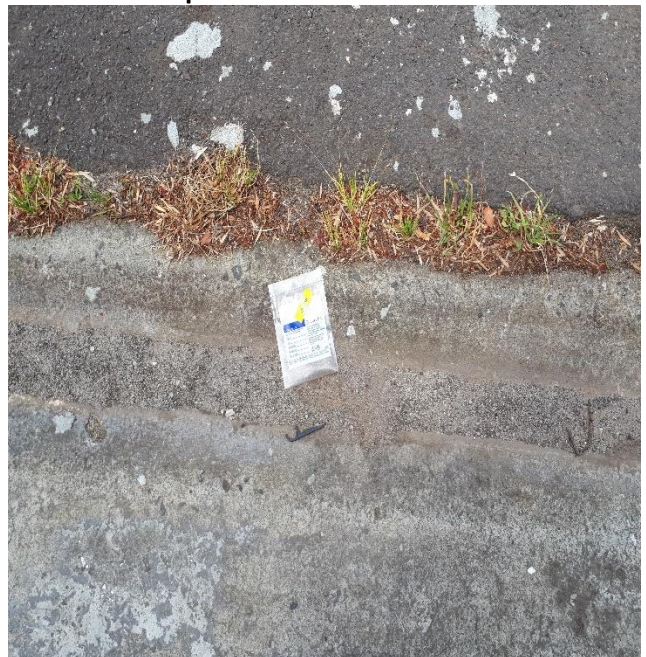
Photo 20: Sample 12-210

Sample No.	Sample Location	Sample Description (including Weight/Size)	Analysis Results
12-210	Building 2A – External – Ground Surface – South – (Centre – 3 meter from the building)	Approximate Sample 13g Sample consisted of: Dust	Chrysotile asbestos detected in the form of loose fibre bundle. Approximate dimensions 10 x 5 x 2mm. Synthetic mineral fibres detected. Organic fibres detected. No trace asbestos detected.
12-211	Building 2A – External – Ground Surface – South – (Right side – 1 meter from the building)	Approximate Sample 8g Sample consisted of: Dust	Chrysotile and crocidolite asbestos detected in the form of loose fibre bundles. Approximate dimensions 15 x 5 x 2mm. Synthetic mineral fibres detected. Organic fibres detected. Trace chrysotile and crocidolite asbestos detected.
11-212	Building 2A – External – Ground Surface – South – (Right side – 3 meter from the building)	Approximate Sample 12g Sample consisted of: Dust	Chrysotile and crocidolite asbestos detected in the form of loose fibre bundles. Approximate dimensions 15 x 5 x 2mm. Synthetic mineral fibres detected. Organic fibres detected. Trace chrysotile and crocidolite asbestos detected.

Client Sample ID	Eurofins Sample No.	Date Sampled	Sample Description	Result
12-210 - Building 2A - External - Ground Surface - South	22-De0015412	Dec 07, 2022	Approximate Sample 13g Sample consisted of: Dust	Chrysotile asbestos detected in the form of loose fibre bundle. Approximate dimensions 10 x 5 x 2mm. Synthetic mineral fibres detected. Organic fibres detected. No trace asbestos detected.
12-211 - Building 2A - External - Ground Surface - South	22-De0015413	Dec 07, 2022	Approximate Sample 8g Sample consisted of: Dust	Chrysotile and crocidolite asbestos detected in the form of loose fibre bundles. Approximate dimensions 15 x 5 x 2mm. Synthetic mineral fibres detected. Organic fibres detected. Trace chrysotile and crocidolite asbestos detected.
12-212 - Building 2A - External - Ground Surface - South	22-De0015414	Dec 07, 2022	Approximate Sample 12g Sample consisted of: Dust	Chrysotile and crocidolite asbestos detected in the form of loose fibre bundles. Approximate dimensions 15 x 5 x 2mm. Synthetic mineral fibres detected. Organic fibres detected. Trace chrysotile and crocidolite asbestos detected.

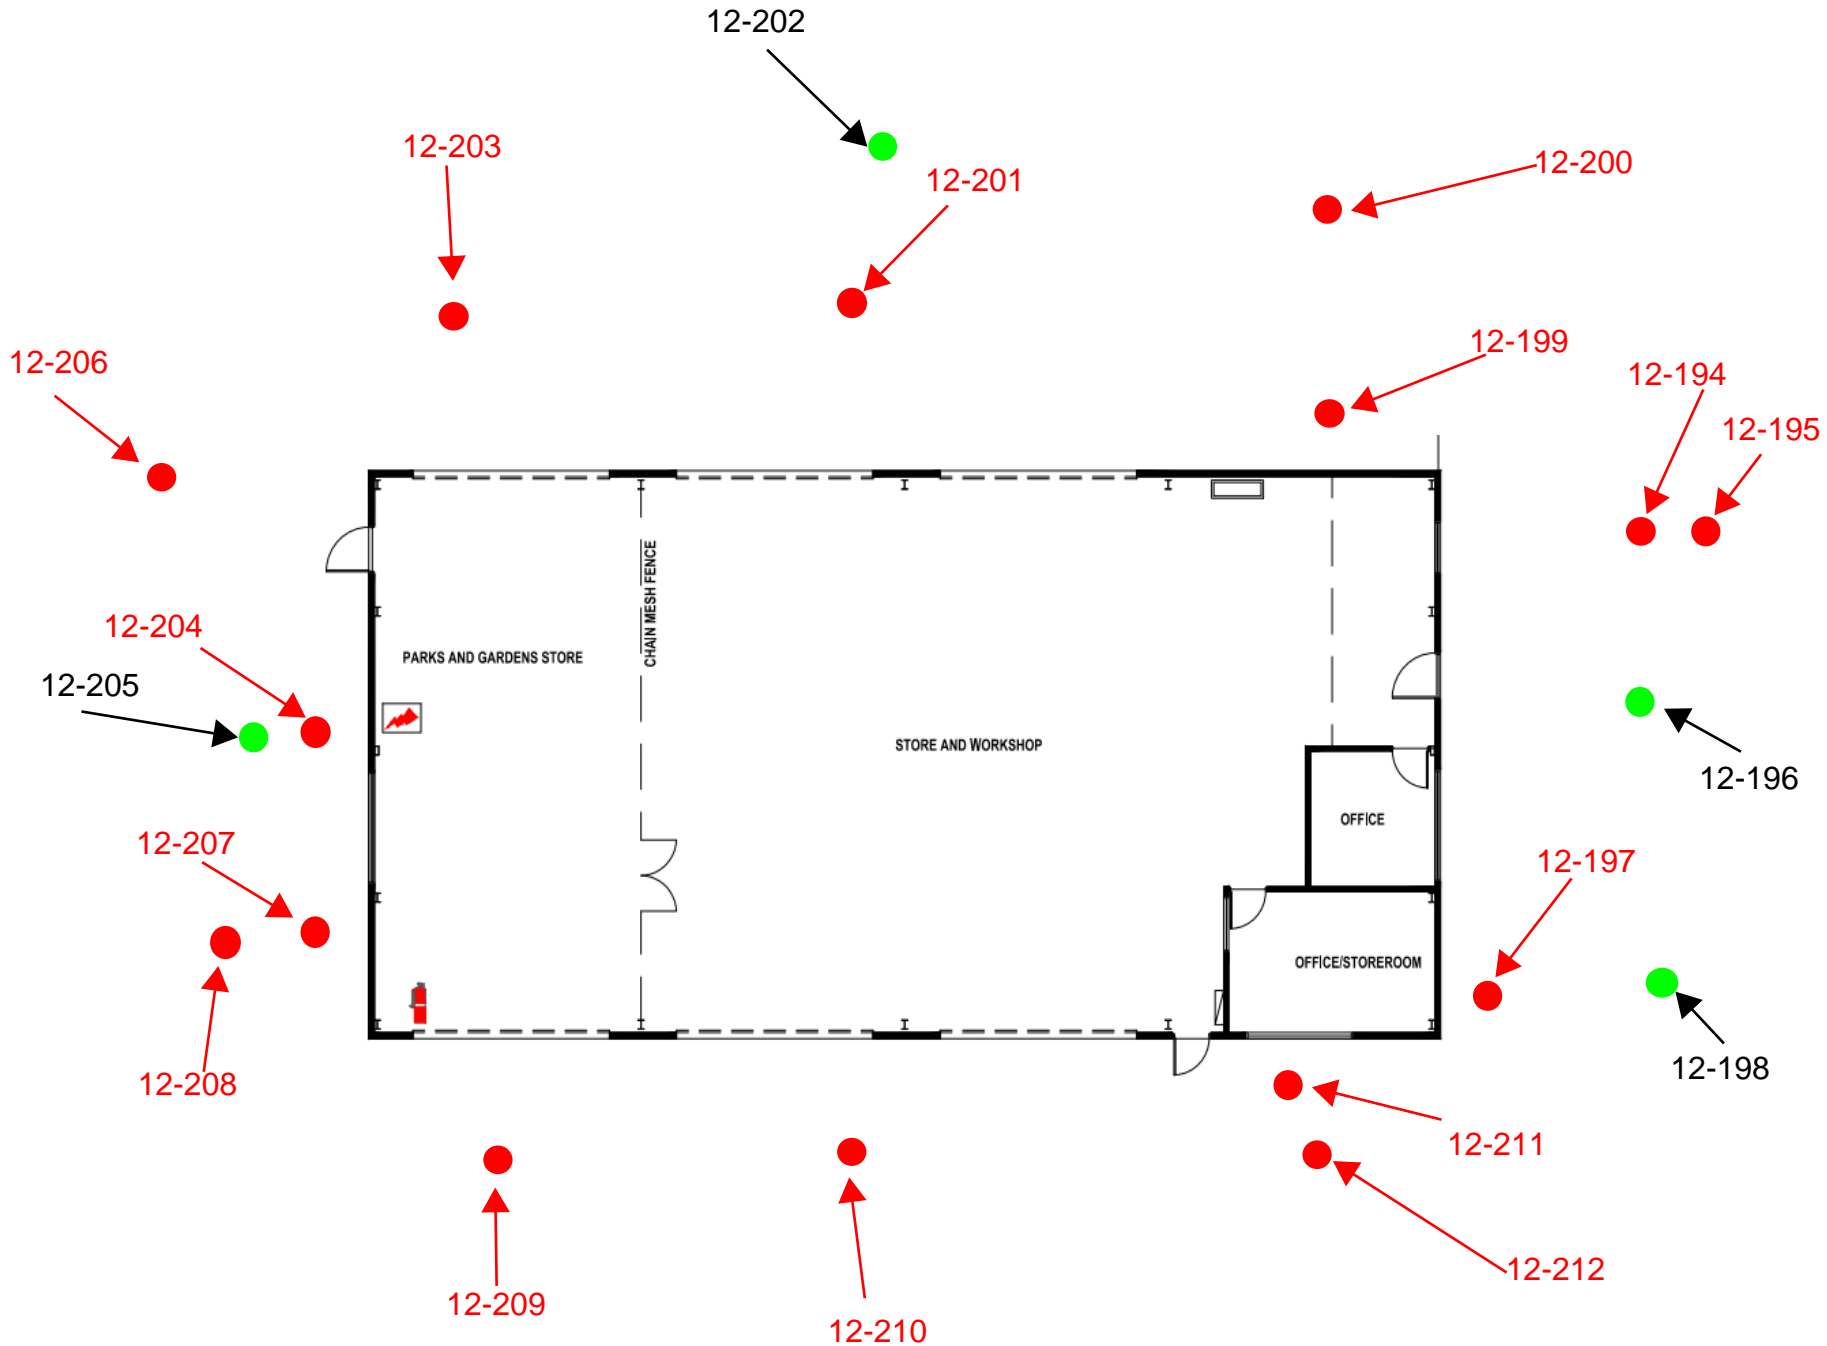
FIGURE 1

Sample Locations
