# **NORTHCOTE GOLF COURSE**

## **COURSE MASTERPLAN REPORT**

PREPARED BY  
CONTOUR GOLF DESIGN GROUP FOR THE CITY OF DAREBIN

NOVEMBER 2023

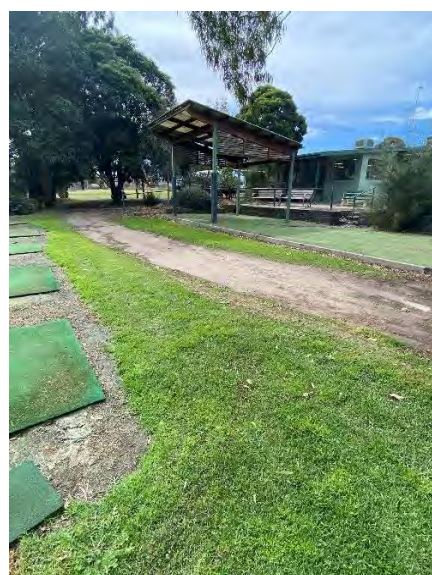
The course also has a short practice fairway that uses the first third of what used to be the 1<sup>st</sup> fairway. The practice tees are located on the original 1<sup>st</sup> tees in front of the clubhouse. The 1<sup>st</sup> tees were

moved due to the risk of errant golf balls being hit over the boundary fence onto Normanby Road. The bluestone retaining wall and steps down to the original tee remain.

The practice tee area has a number of synthetic grass hitting pads and a covered area, for giving lessons and for Junior Golf Clinics. This area will be considered as part of the Building Review currently underway.

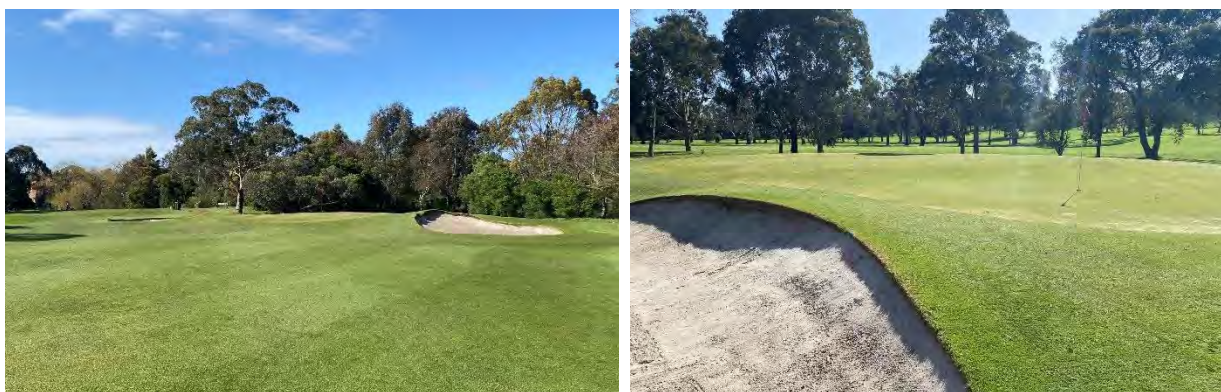
Figures 21 and 22: The approach shot into the long 2<sup>nd</sup> hole, and the 3<sup>rd</sup> green (right).

- Remove two trees behind the tee – a Gleditsia and a Peppercorn. Neither are native trees. Construct a new tee about 10 metres further back.
- Revegetate the area to the rear of and surrounding the new tee.
- Remove two trees back left of the current green – a Eucalyptus and a Pittosporum.
- Construct a new green and bunkers (as shown on the Masterplan drawing), moving it back by approximately 12 metres, still leaving adequate space between the rear of the new green and the embankment of Merri Creek.
- The new green and approach can be bunkered as shown, with the fairway widened on the right, leaving clear, broad access to the following tees to spread wear.
- Moving both the tees and putting green will give a hole length of about 440 metres, which is a good length for a par 5 on a public golf course.

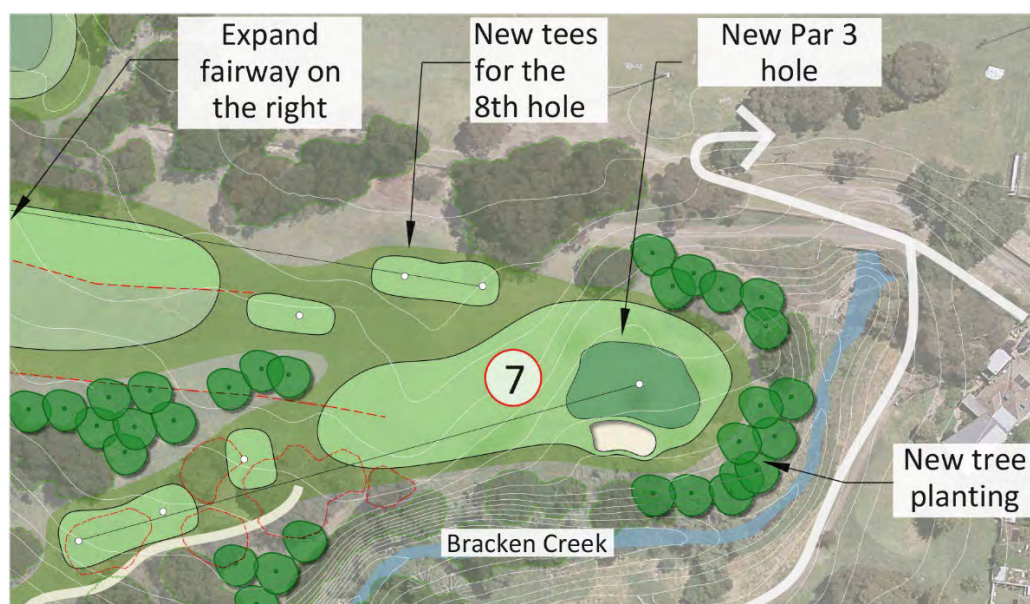
Figure 26: The recommended 125 metre par 3 7<sup>th</sup> hole, located in the space available between the current 7<sup>th</sup> and 8<sup>th</sup> holes. There is ample opportunity for new tree planting.

- The new hole will be a short par 3 of about 125 metres, but if well designed, will be a fun addition to the course, with easy walks to and from the new hole.

- Council should also prioritise working with Melbourne Water to clean up the weeds in and along the creek corridor and revegetating this area.
- New tree planting, with an appropriate indigenous species, to the right of the new green will also screen public areas on the eastern side of the creek from view.

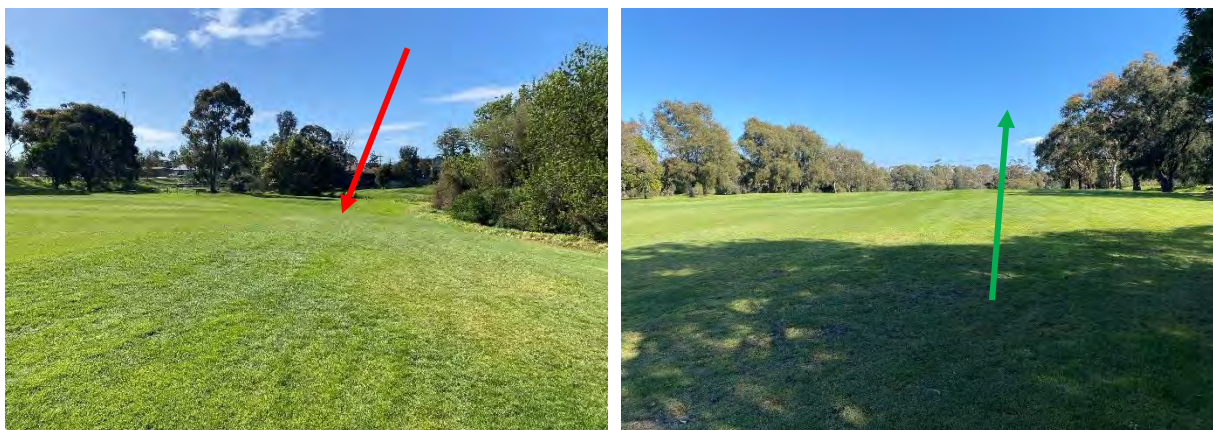
Figures 26 and 27: The site for the new par 3 7<sup>th</sup> hole from in front of where the new tees will be located. The arrow points to the proposed green site. The tee shot on the revised 8<sup>th</sup> hole (right).

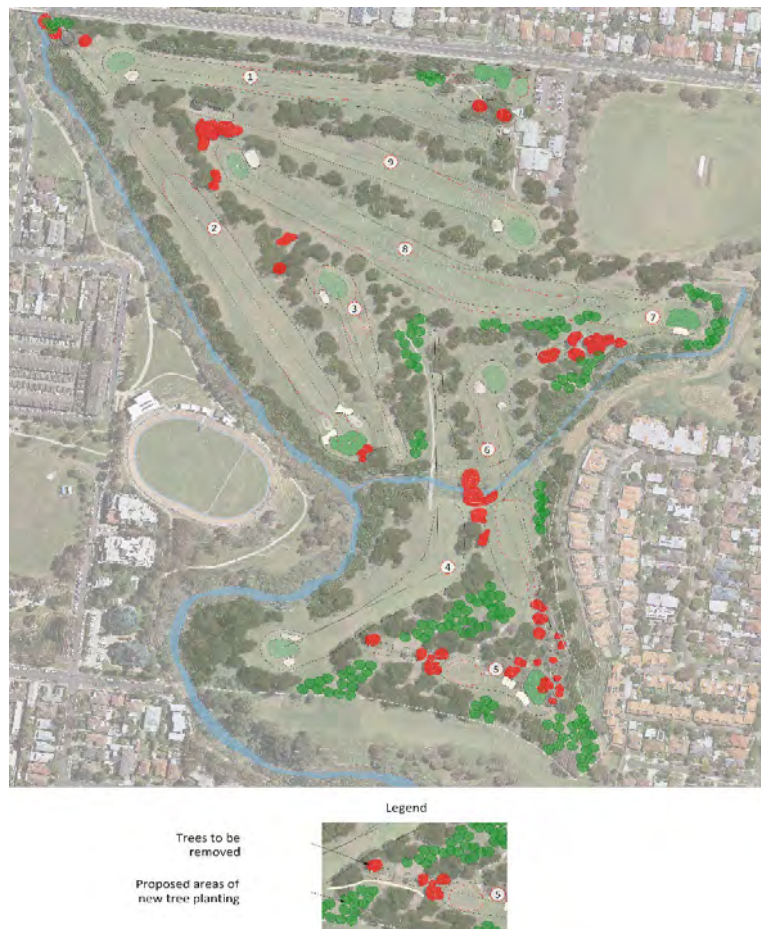
Figures 31: Indicative tree removal requirements and tree replacement – subject to detailed design and tree assessments.

We have estimated that approximately 150 new trees may be planted. All new trees should be locally indigenous species. Tree planting should be focussed into out-of-play areas, so that they can become very low maintenance areas. Tree planting should be supplemented with understorey planting of shrubs and grasses in areas that are out-of-play for golfers.

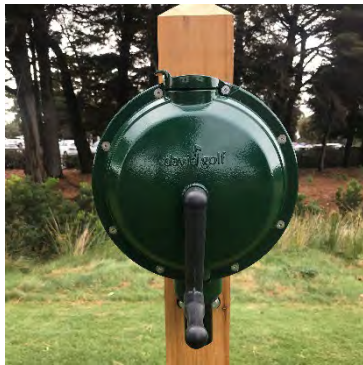
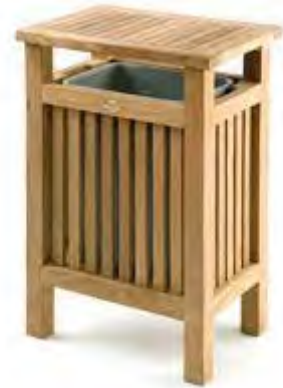
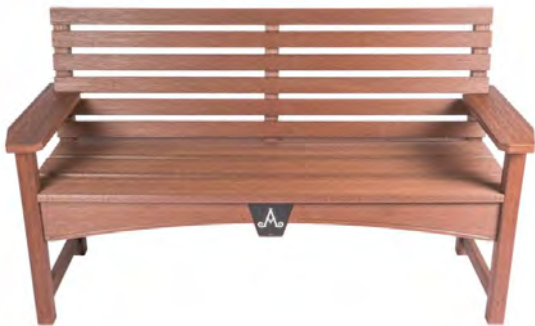
*Figures 32: Commercially available course furnishings that will improve the amenity of the golf course considerably.*

A replacement program should be put in place to upgrade items such as seating, rubbish bins, ball washers and signage. The existing course furnishings are tired, and their replacement will be relatively inexpensive but reduce clutter across the course. Their upgrade will significantly improve the amenity of the golf course especially the surrounds to the tees where such furnishings are usually located. The residential style street rubbish bins are perhaps the priority for replacement, with a commercially available alternative. This could potentially be undertaken adjacent to each tee, as that tee is being rebuilt.
