**Geotechnical Investigation:
Northcote Golf Course
143 Normanby Avenue, THORNBURY**

Report Prepared by A.S. James Pty Ltd

14 April 2023

Report No: 122226

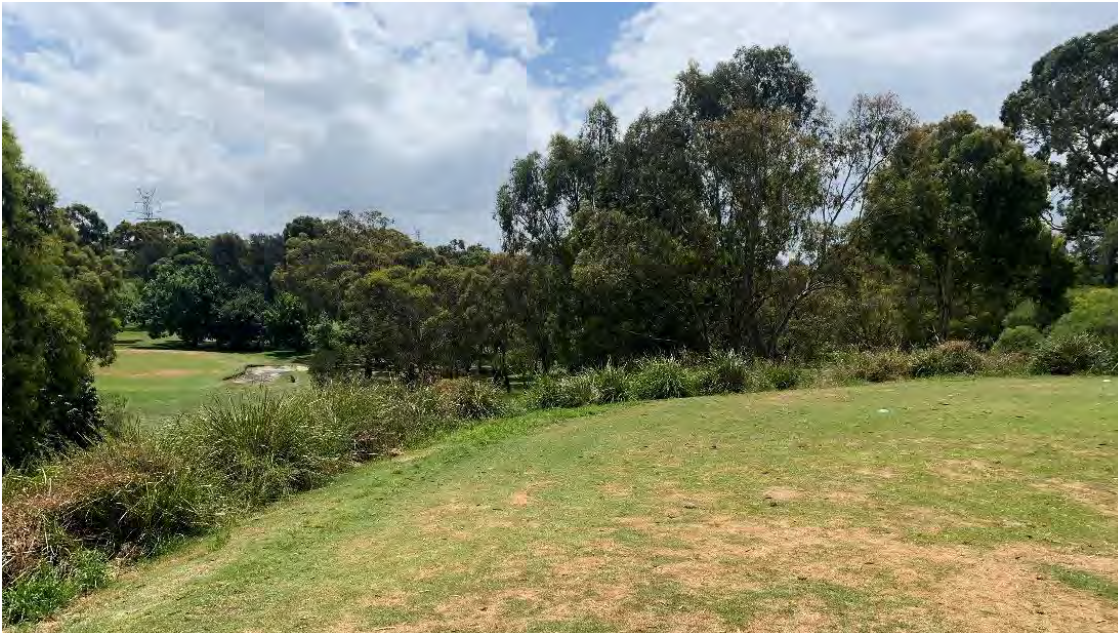
Figure 9 is a view from the 6th tee down towards the green and highlights the elevation change. The bunker short right of the green focusses tee shots further left.

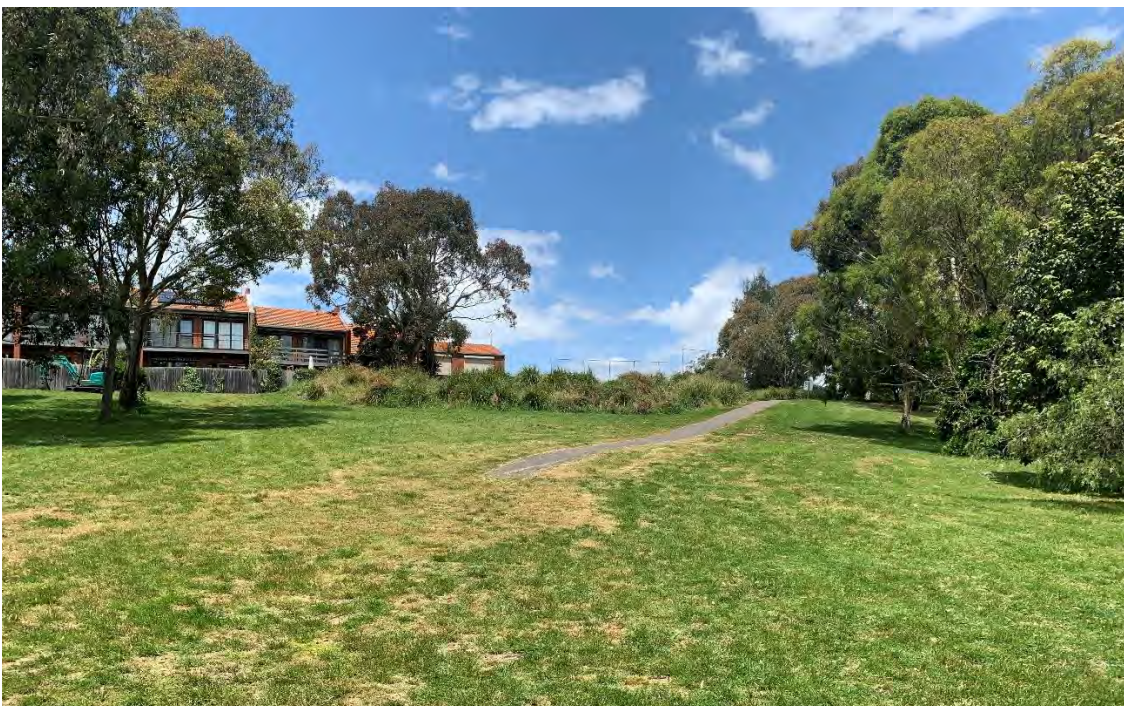
Figure 10 is a view back towards the 6th tees from the fairway and again, highlights the change in elevation down the line of the hole. The proposed footpath will run in front of the housing across the back of the tee.

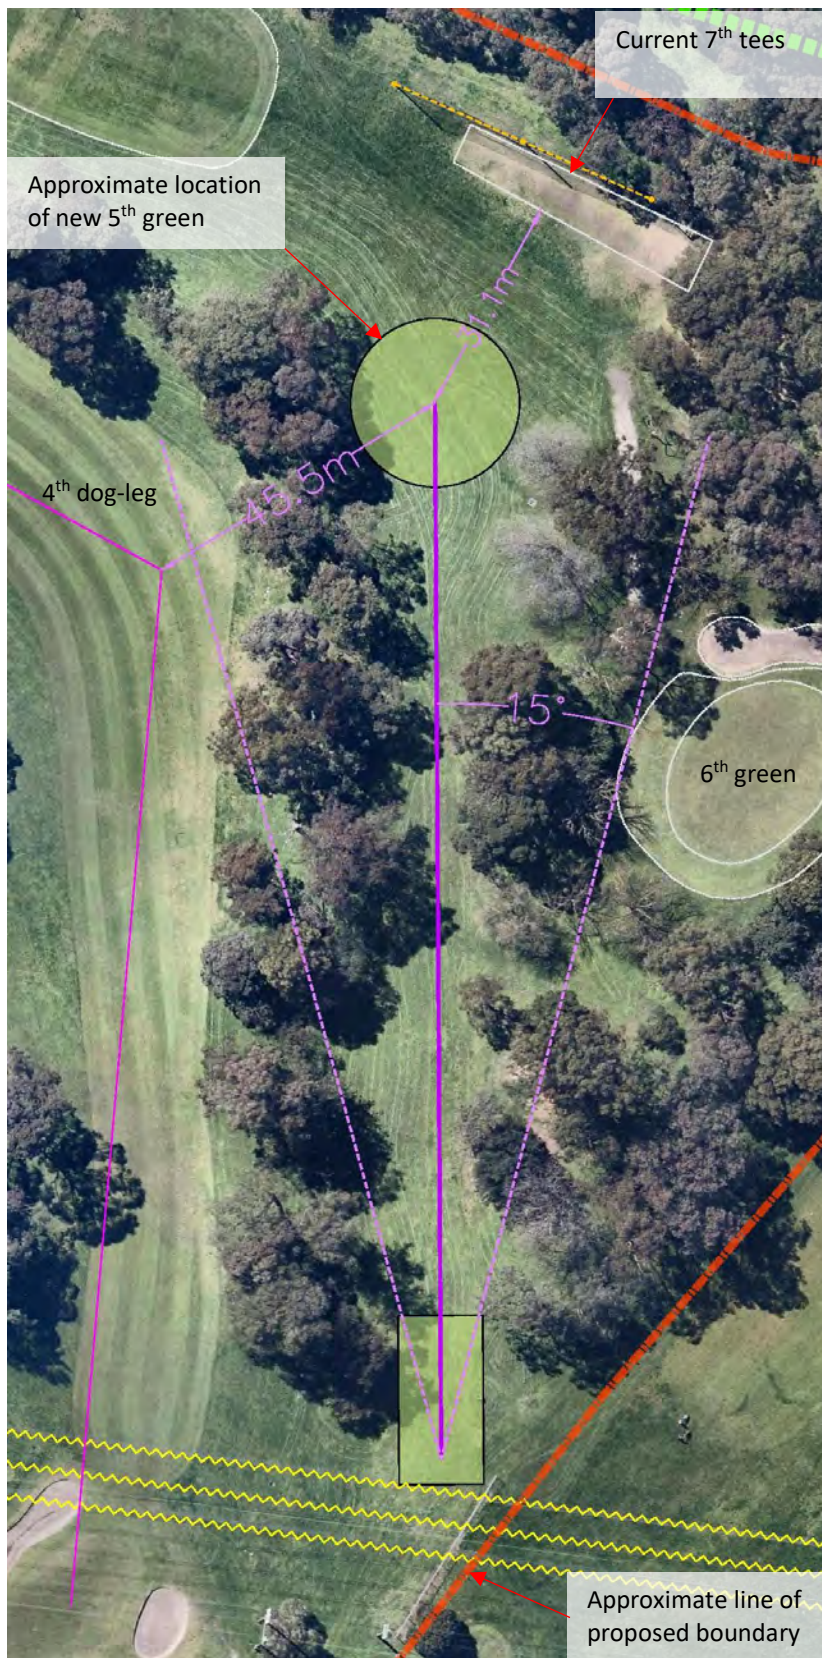
Figure 11 – aerial view of proposed 5th hole. Indicative layout shows ‘zone of play’, possible boundary with new public area (red dashed line) and existing overhead powerlines (yellow zig-zag lines)

The current 5th hole is to be decommissioned to allow the creation of the new public park area to the south of the golf course. So a replacement 5th hole is proposed between an avenue of trees between the current 4th and 6th holes (see Fig. 11 left). This avenue once formed the line of a much longer 7th hole but this was shortened a number of years ago for safety reasons. The new 5th hole will be a par 3 hole but its design has not yet been finalised so the figure to the left is merely indicative.

The designer should be conscious of the distance beyond the proposed green to the 7th tees to avoid creating a safety issue, particularly as most golfers are likely to wait to the left side of the tee. The EIGCA guidance (Fig. 4) suggests a 30-40m buffer between a green and the following tee, although this should be increased slightly when the holes are not in sequence. Care should also be taken when positioning hazards so that they do not pose a safety hazard to the tee, footpath users or properties beyond.

In this position too, the new 5th green is in close proximity to the landing area for the 4th hole (see Fig. 3) although, with the hole being a left to right dog-leg, most errant drives are likely to end up on the other side of the fairway. Whilst the intervening trees do provide a degree of protection, they also obscure the green from the tee so golfers will be unaware of the danger of a stray shot, struck in this direction.

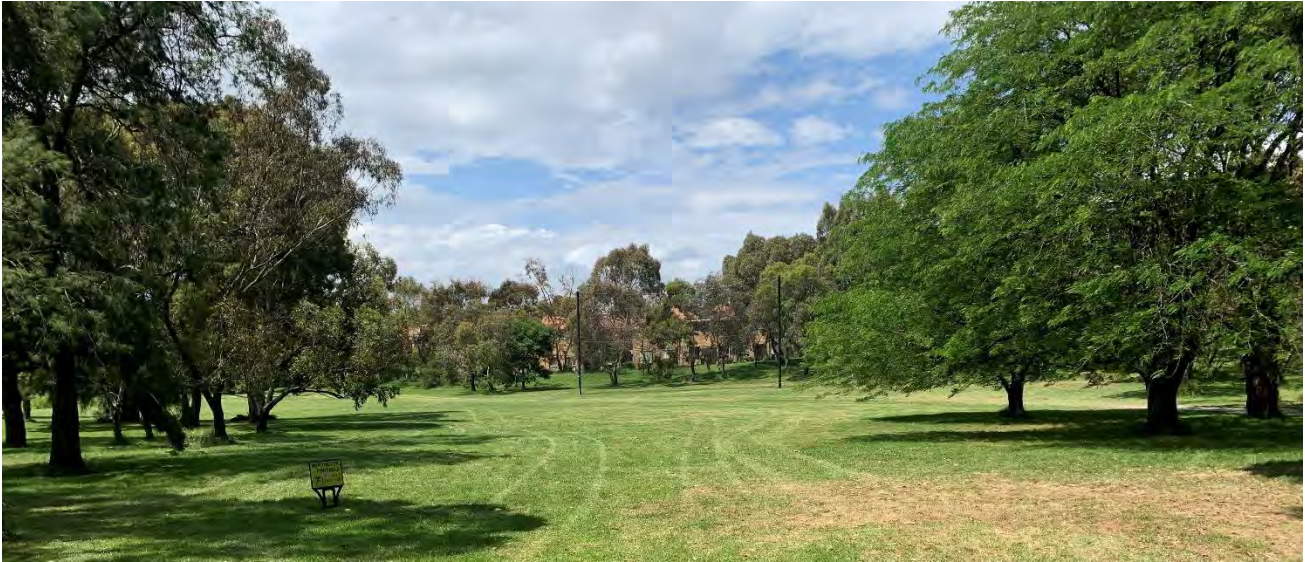
Figure 13 – View of potential 5th green location with existing 7th tees beyond
