Tree Assessment
for
Darebin City Council

Assessment of trees for VPO update in
Springthorpe Estate, Macleod.

Homewood Consulting Pty Ltd

16 May 2010

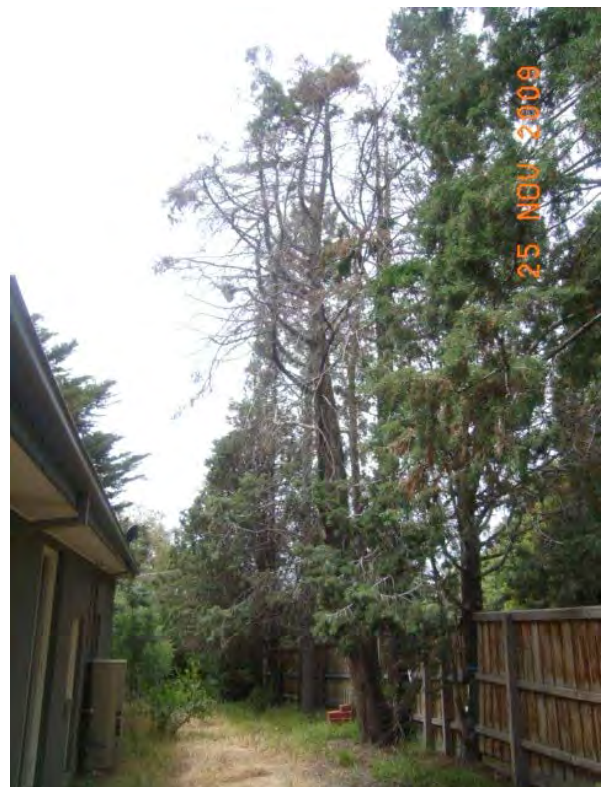
Tree Number 5 **Address:** 11 WOODLAWN CIRCUIT MACLEOD 3085
Map No: Sheet 1 **Location** Rear of Private Property

Botanical Name *Cupressus arizonica*
Common Name Arizona Cypress
Status: Exotic
Maturity: Mature
Dimensions (hwx) 13m x 5m
DBH (mm) 270
Health: Fair
Structure: Good
ULE: 10 to 20 years
Retention Value Moderate
TPZ Radius (m): 3.24

Risk of Harm: 1 in 590,400
Risk Category Low
Works: No works
Comments Canopy dieback

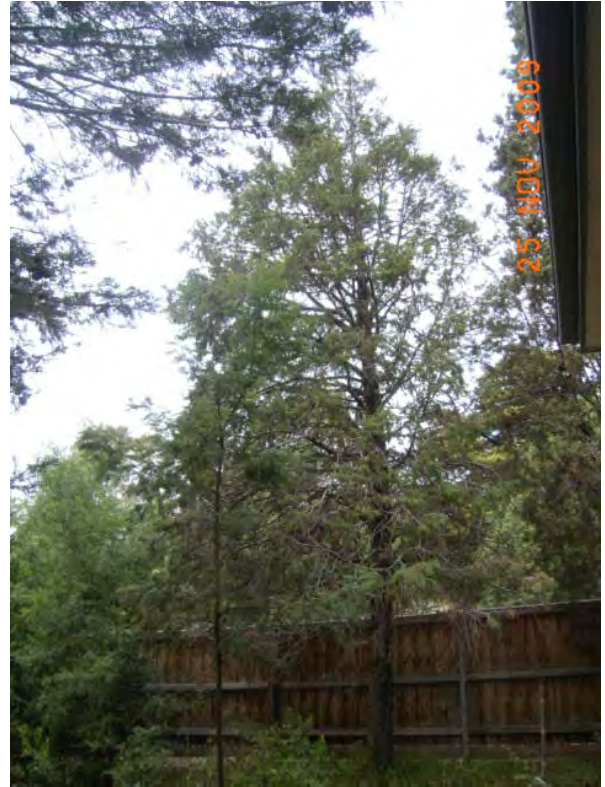
Tree Number 6 **Address:** 11 WOODLAWN CIRCUIT MACLEOD 3085
Map No: Sheet 1 **Location** Rear of Private Property

Botanical Name *Cupressus arizonica*
Common Name Arizona Cypress
Status: Exotic
Maturity: Mature
Dimensions (hwx) 16m x 4m
DBH (mm) 310
Health: Fair
Structure: Fair
ULE: 10 to 20 years
Retention Value Moderate
TPZ Radius (m): 3.72

Risk of Harm: 1 in 590,400
Risk Category Low
Works: No works
Comments

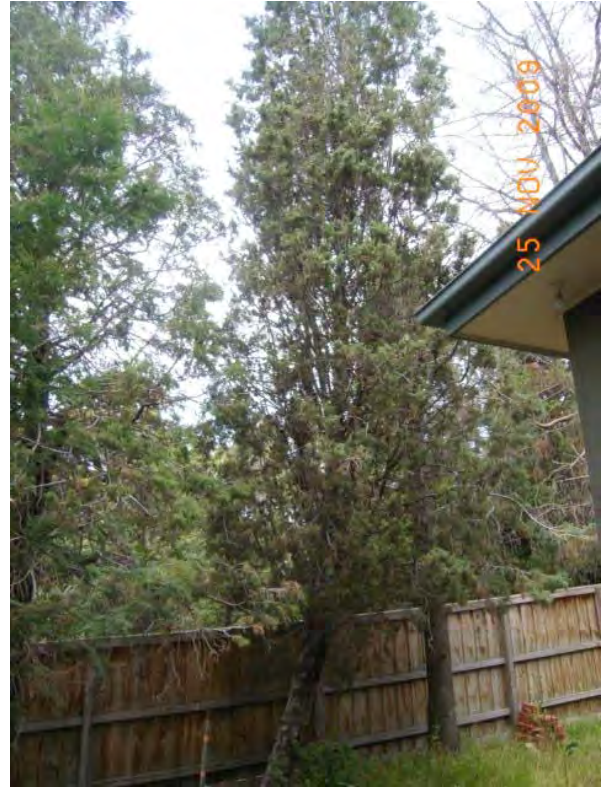
Tree Number 8 **Address:** 17 WOODLAWN CIRCUIT MACLEOD 3085

Comments Root barrier installed approximately 4m from trunk

Works: No works

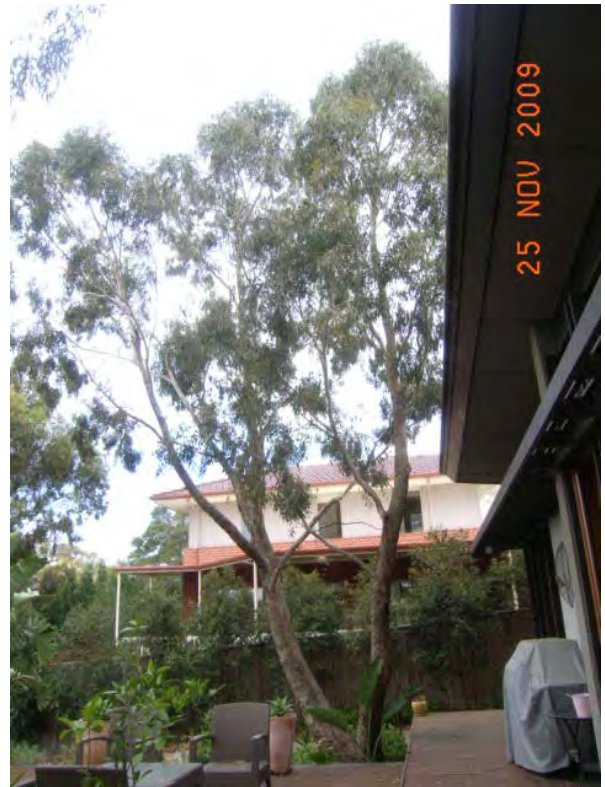
Tree Number 14 **Address:** 5 WOODLAWN CIRCUIT MACLEOD 3085
Map No: Sheet 1 **Location** Rear of Private Property

Botanical Name *Eucalyptus melliodora*
Common Name Yellow Box
Status: Indigenous
Maturity: Mature
Dimensions (hwx) 15m x 6m
DBH (mm) 330
Health: Fair
Structure: Good
ULE: 20 to 40 years
Retention Value High
TPZ Radius (m): 3.96

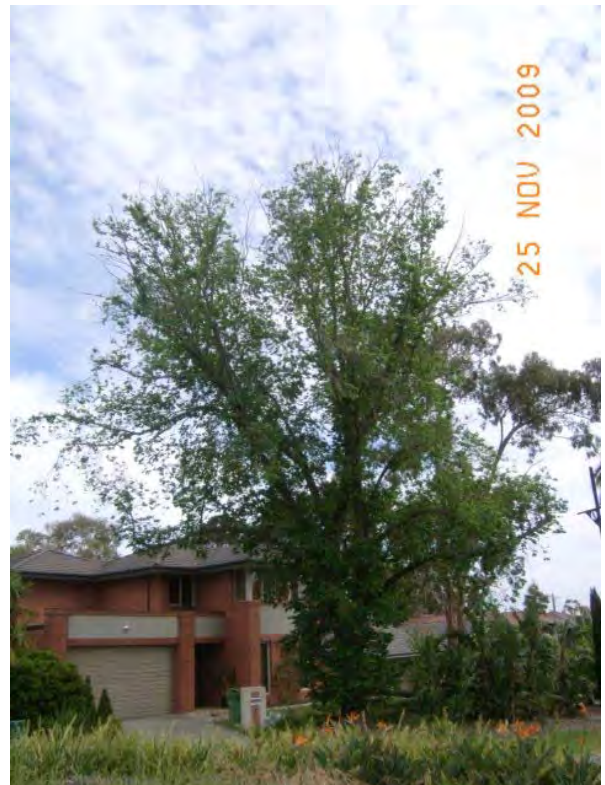
Tree Number 18 **Address:** 8 WOODLAWN CIRCUIT MACLEOD 3085
Map No: Sheet 1 **Location** Council Property

Botanical Name *Ulmus Xhollandica 'Vegeta'*
Common Name Dutch Elm
Status: Exotic
Maturity: Mature
Dimensions (hwx) 18m x 14m
DBH (mm) 740
Health: Fair
Structure: Fair
ULE: 20 to 40 years
Retention Value High
TPZ Radius (m): 8.88

Risk of Harm: 1 in 59,040
Risk Category Moderate
Works: Mulch required,Irrigation

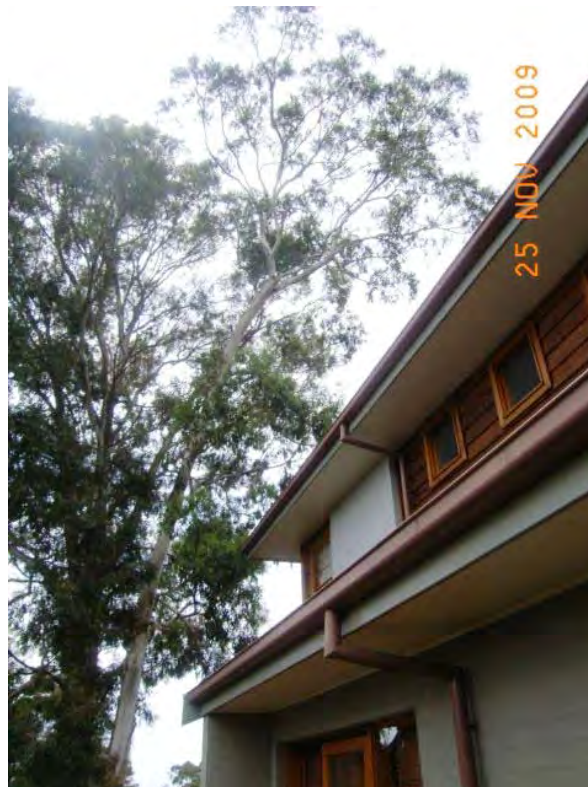
Tree Number 19 **Address:** 3 WOODLAWN CIRCUIT MACLEOD 3085
Map No: Sheet 1 **Location** Rear of Private Property

Botanical Name *Eucalyptus melliodora*
Common Name Yellow Box
Status: Indigenous
Maturity: Mature
Dimensions (hwx) 21m x 10m
DBH (mm) 450
Health: Good
Structure: Fair
ULE: 20 to 40 years
Retention Value High
TPZ Radius (m): 5.4

Risk of Harm: 1 in 16,400
Risk Category Moderate
Works: Weight reduction

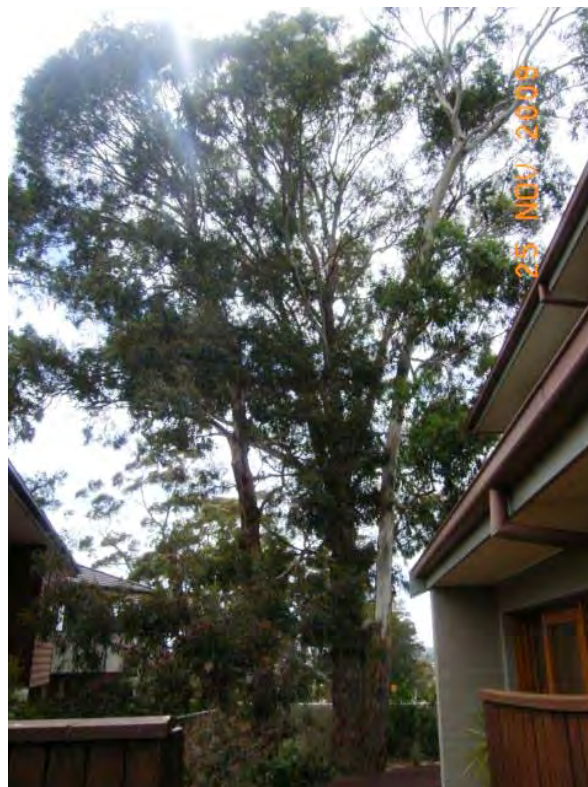
Tree Number 20 **Address:** 3 WOODLAWN CIRCUIT MACLEOD 3085
Map No: Sheet 1 **Location** Rear of Private Property

Botanical Name *Eucalyptus melliodora*
Common Name Yellow Box
Status: Indigenous
Maturity: Mature
Dimensions (hwx) 23m x 15m
DBH (mm) 950
Health: Good
Structure: Good
ULE: 20 to 40 years
Retention Value High
TPZ Radius (m): 11.4

Risk of Harm: 1 in 6,192
Risk Category High
Works: Weight reduction

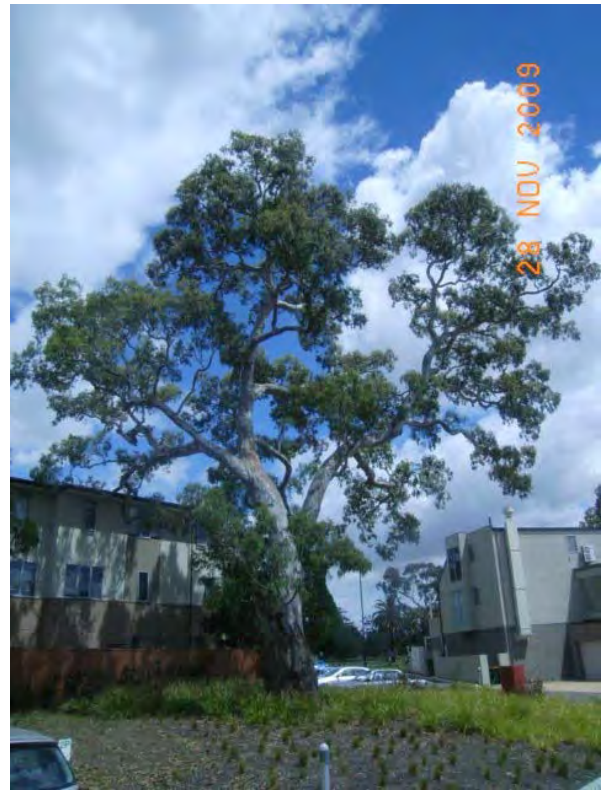
Tree Number 53 **Address:** SPRINGTHORPE BOULEVARD MACLEOD 3085

Works: Reinspection every 2yrs

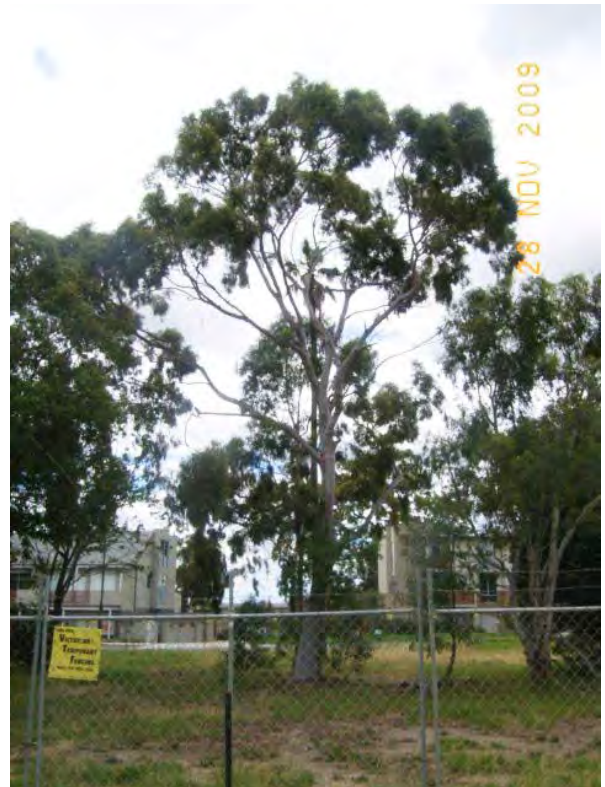
Tree Number 55 **Address:** 43 SPRINGTHORPE BOULEVARD MACLEOD 30
Map No: Sheet 1 **Location** Front of Private Property

Botanical Name *Corymbia citriodora*
Common Name Lemon-scented Gum
Status: Native
Maturity: Mature
Dimensions (hwx) 18m x 14m
DBH (mm) 590
Health: Good
Structure: Fair
ULE: 20 to 40 years
Retention Value High
TPZ Radius (m): 7.08

Risk of Harm: 1 in 14,169,600
Risk Category Very low
Works: Weight reduction
Comments Could not gain site access, DBH estimated

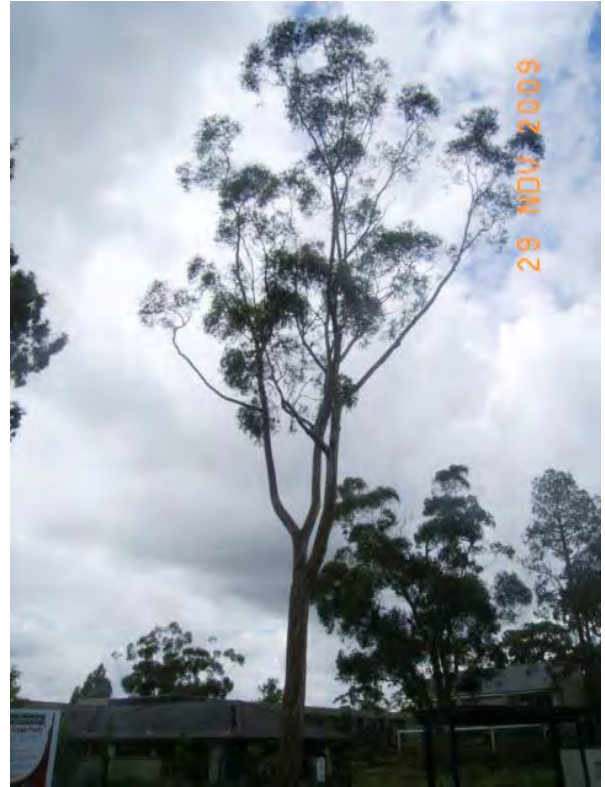
Botanical Name *Eucalyptus cladocalyx*
Common Name Sugar Gum
Status: Native
Maturity: Mature
Dimensions (hwx) 21m x 15m
DBH (mm) 760
Health: Good
Structure: Poor
ULE: 10 to 20 years
Retention Value Moderate
TPZ Radius (m): 9.12

Risk of Harm: 1 in 1,440
Risk Category Very high
Works: Aerial Inspection, Reinspection every 2yrs
Comments Parrot damage, bus shelter beneath canopy, possible to convert to habitat

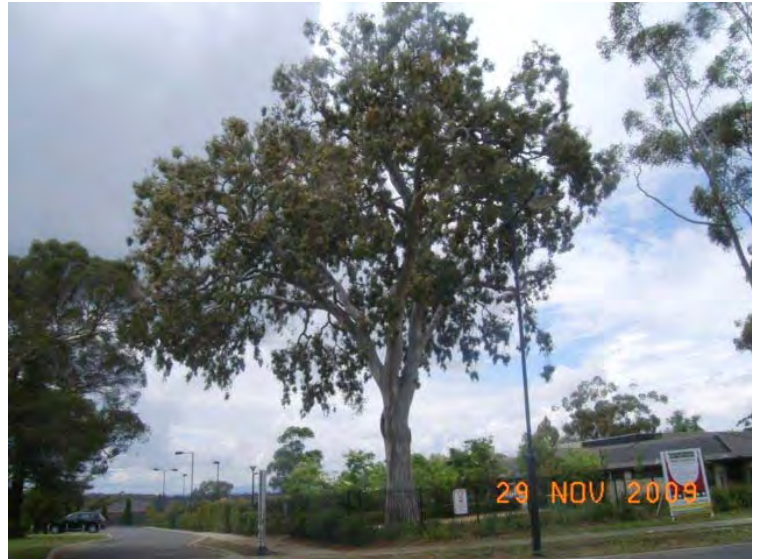
Tree Number 65 **Address:** 64 SPRINGTHORPE BOULEVARD MACLEOD 30

Comments Parrot damage

Works: Aerial Inspection, Reinspection every 2yrs

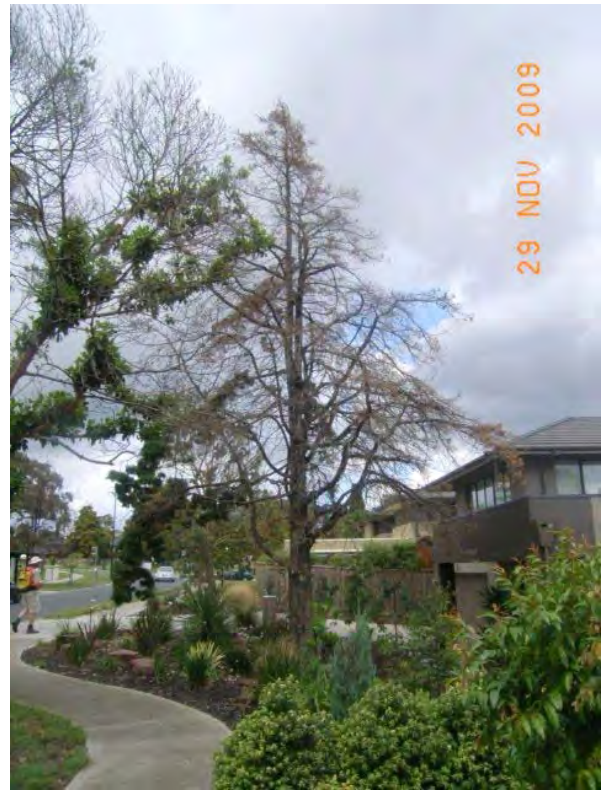
Tree Number 67 **Address:** 59 SPRINGTHORPE BOULEVARD MACLEOD 30
Map No: **Location** Front of Private Property

Botanical Name *Cupressus lusitanica*
Common Name Mexican Cypress
Status: Exotic
Maturity: Mature
Dimensions (hwx) 14m x 8m
DBH (mm) 420
Health: Very poor
Structure: Poor
ULE: Unsafe
Retention Value Low
TPZ Radius (m): 5.04

Risk of Harm: 1 in 16,400
Risk Category Moderate
Works: Removal

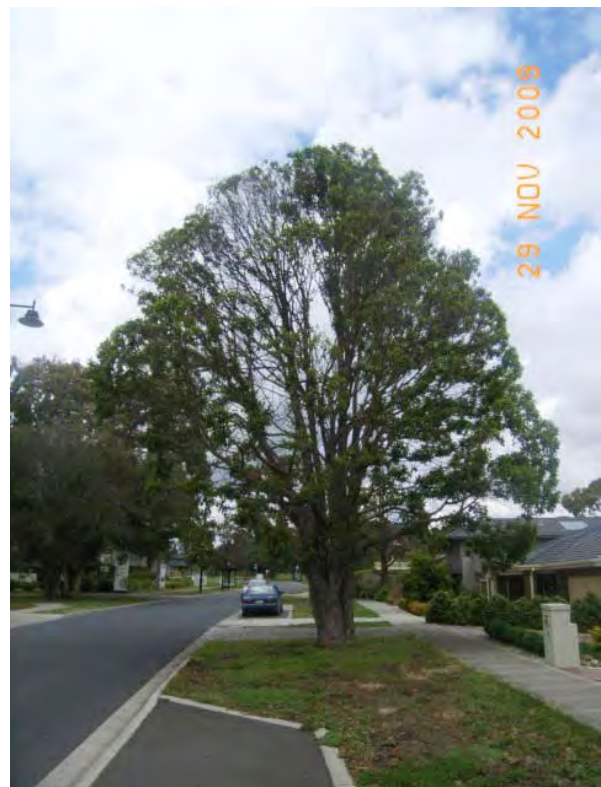
Tree Number 68 **Address:** 63 SPRINGTHORPE BOULEVARD MACLEOD 30
Map No: **Location** Council Property

Risk of Harm: 1 in 590,400
Risk Category Low
Works: No works
Comments Crossover constructed approximately 1m from trunk

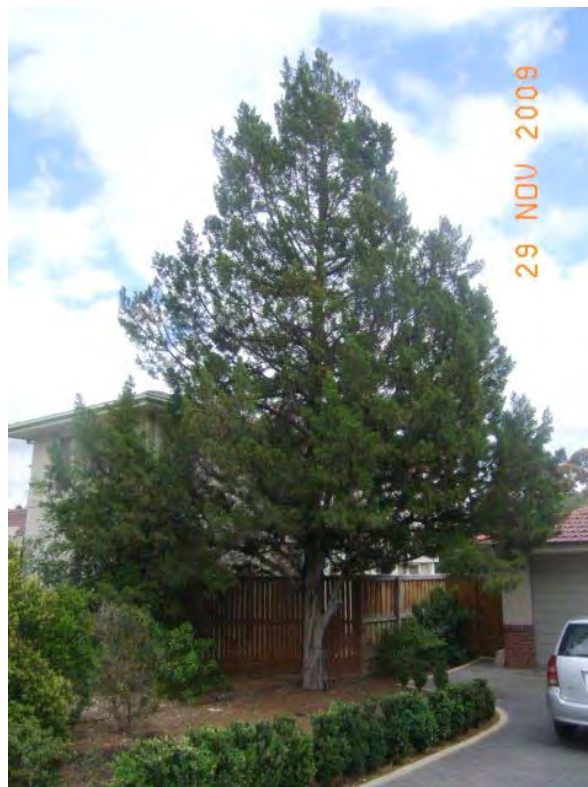
Tree Number 70 **Address:** 65 SPRINGTHORPE BOULEVARD MACLEOD 30
Map No: Sheet 3 **Location** Front of Private Property

Comments Canopy foliage thinning

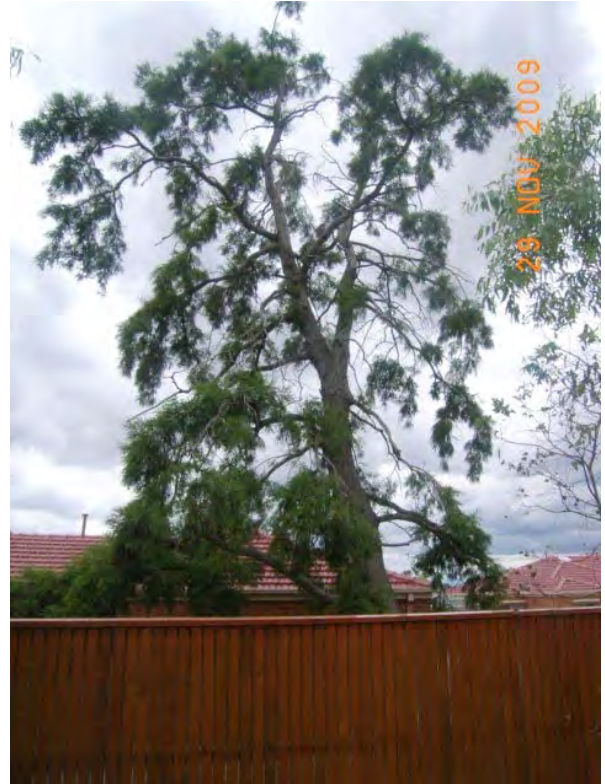
Tree Number 75 **Address:** POTTAGE CIRCUIT MACLEOD 3085

Comments Canopy dieback

Works: Mulch

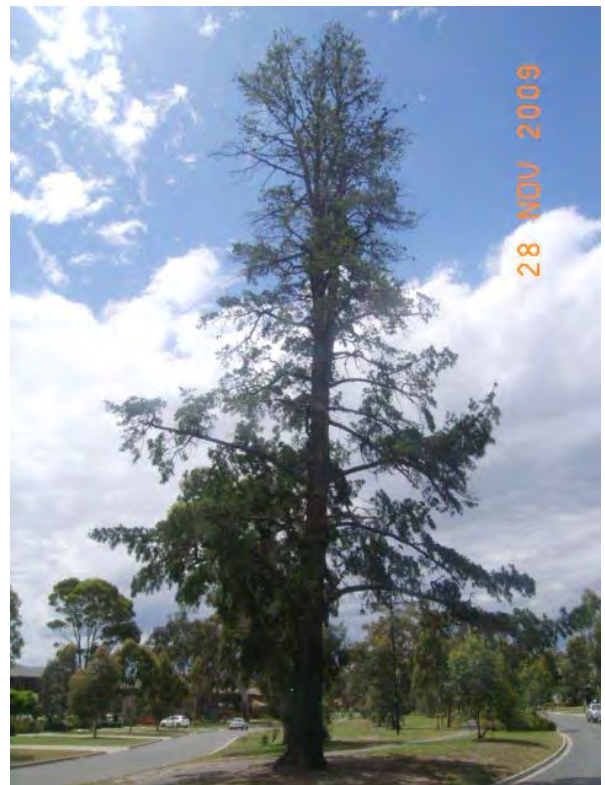
Tree Number 76 **Address:** 7 THE COMMON MACLEOD 3085

Comments Canopy dieback

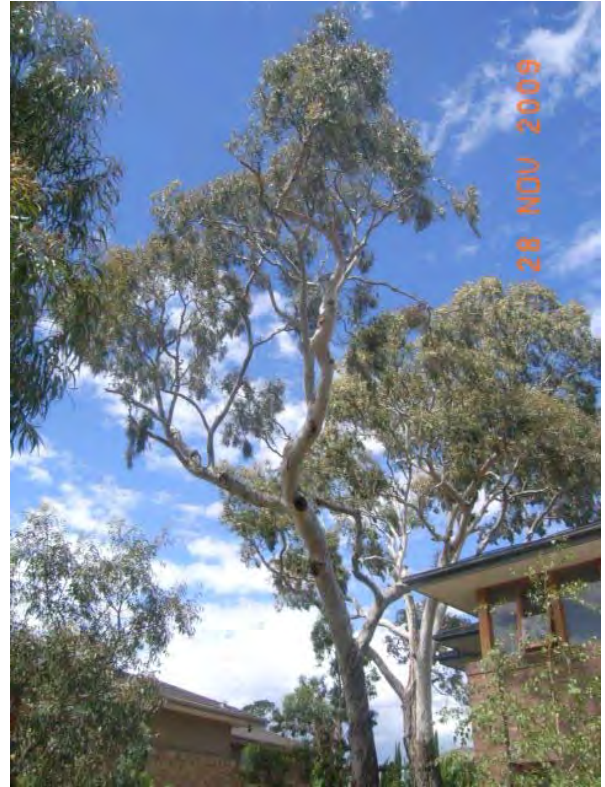
Tree Number 81 **Address:** 16 THE COMMON MACLEOD 3085

Comments Inspect cavity in limb over house

Works: Aerial Inspection, Reinspection every 2yrs

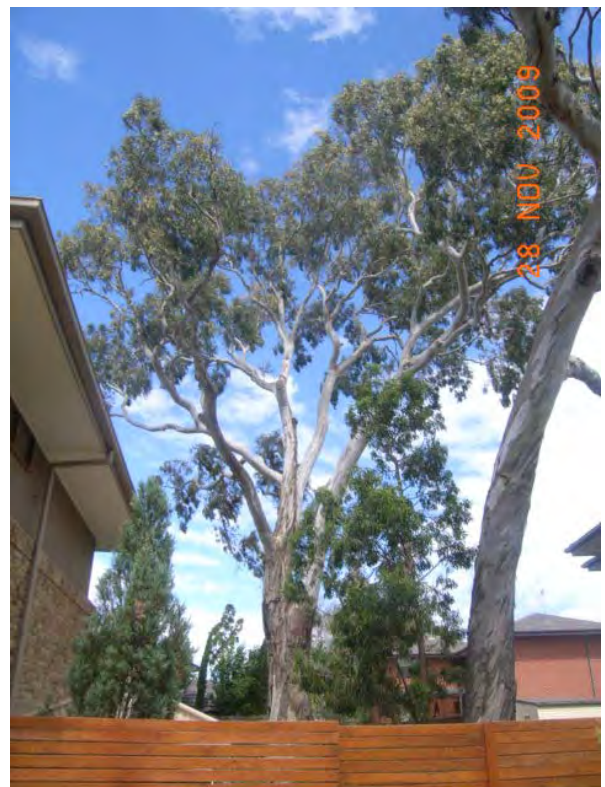
Tree Number 82 **Address:** 16 THE COMMON MACLEOD 3085

Comments Couldnt get site access DBH estimated, parrot damage

Works: Aerial Inspection, Reinspection every 2yrs

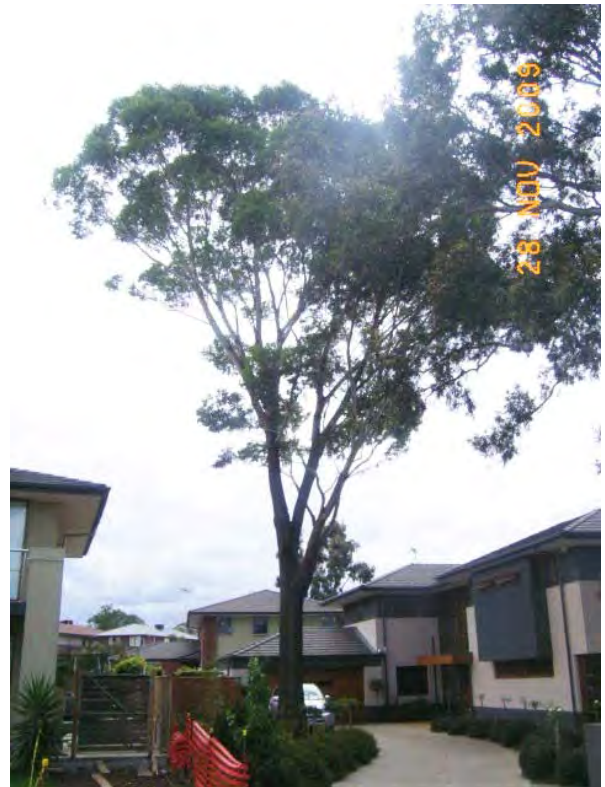
Tree Number 91 **Address:** 19 THE COMMON MACLEOD 3085

Comments Parrot damage

Works: Aerial Inspection

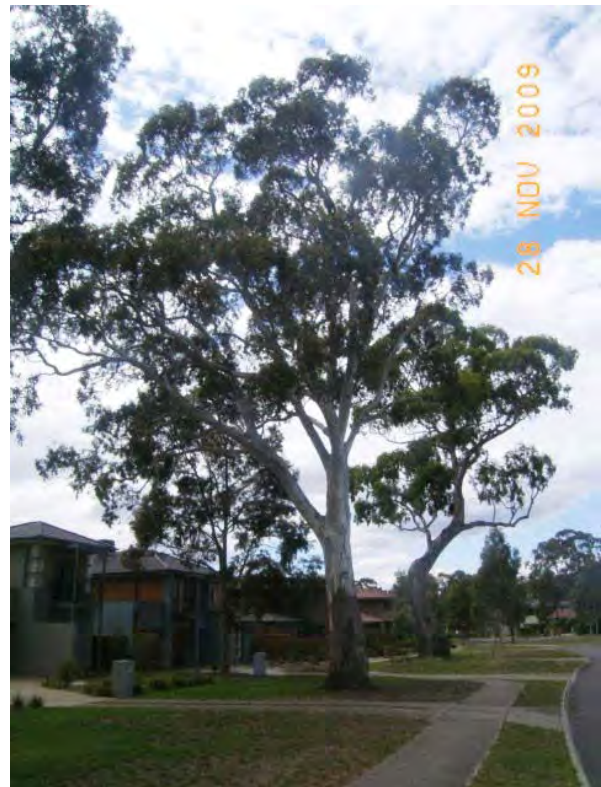
Tree Number 94 **Address:** 21 THE COMMON MACLEOD 3085
Map No: Sheet 2 **Location** Council Property

Risk of Harm: 1 in 619,200
Risk Category Low
Works: Weight reduction, Reinspection every 2yrs
Comments Reduce western branches over property/driveway

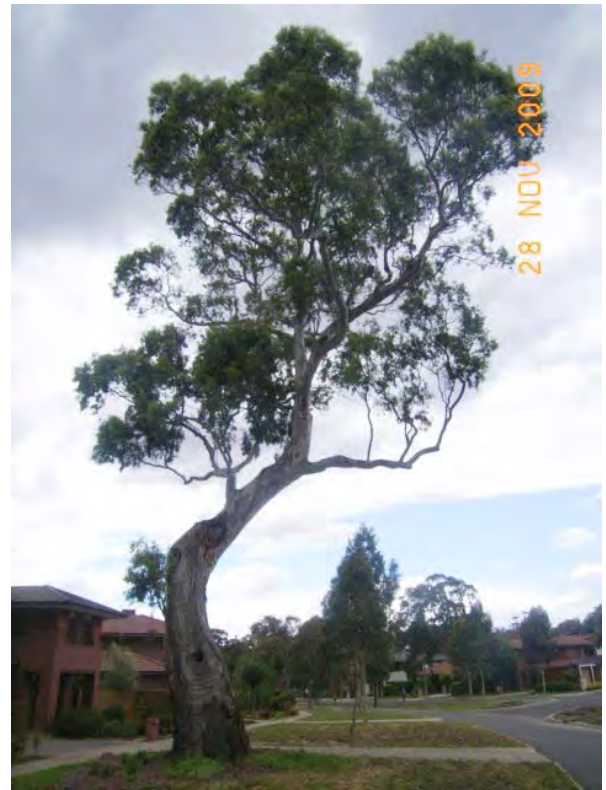
Tree Number 99 **Address:** 23 THE COMMON MACLEOD 3085

Comments Parrot damage, Weight reduce limbs with 60-80mm pruning cuts where possible

Works: Aerial Inspection, Weight reduction, Mulch required, Annual inspection

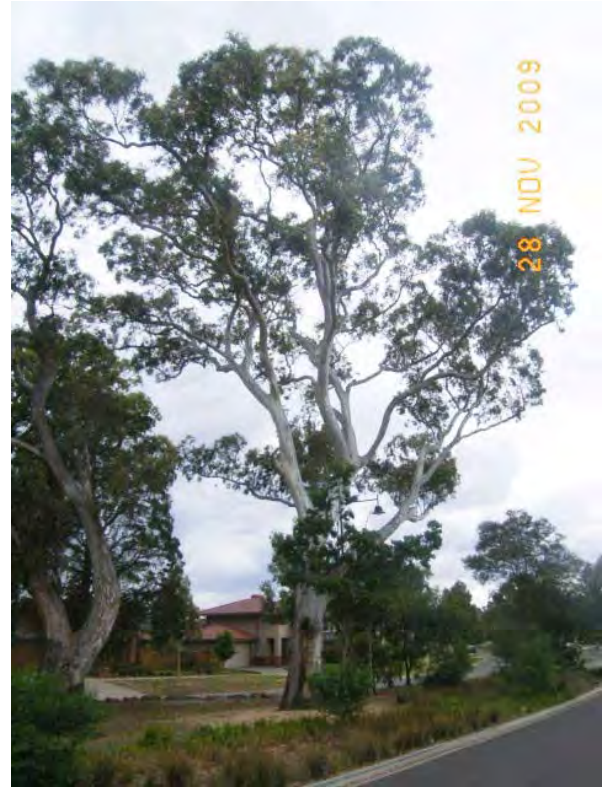
Tree Number 100 **Address:** 26 THE COMMON MACLEOD 3085

Comments Aerial inspect tree whilst performing works, Annual inspection to see if tree health improves

Works: Aerial Inspection, Property/Asset clearance, Mulch required, Annual inspection

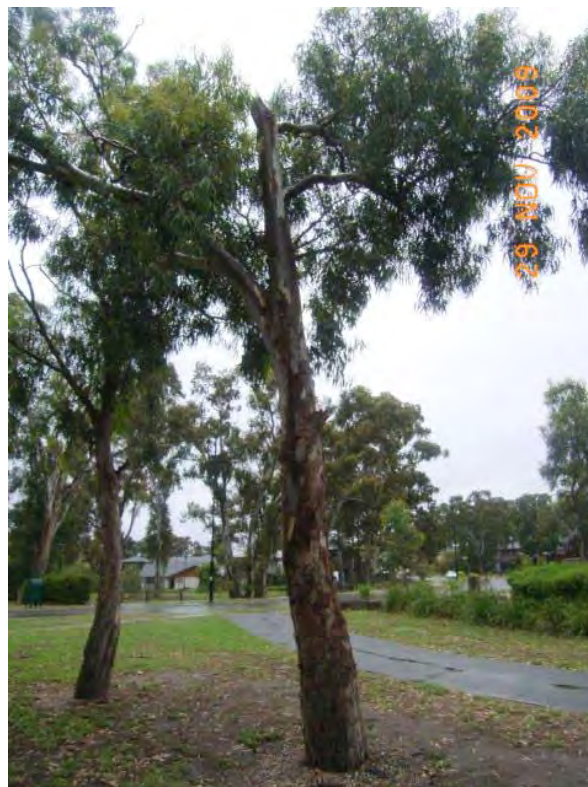
Tree Number 110 **Address:** 80 SPRINGTHORPE BOULEVARD MACLEOD 30

Comments Head of tree has failed

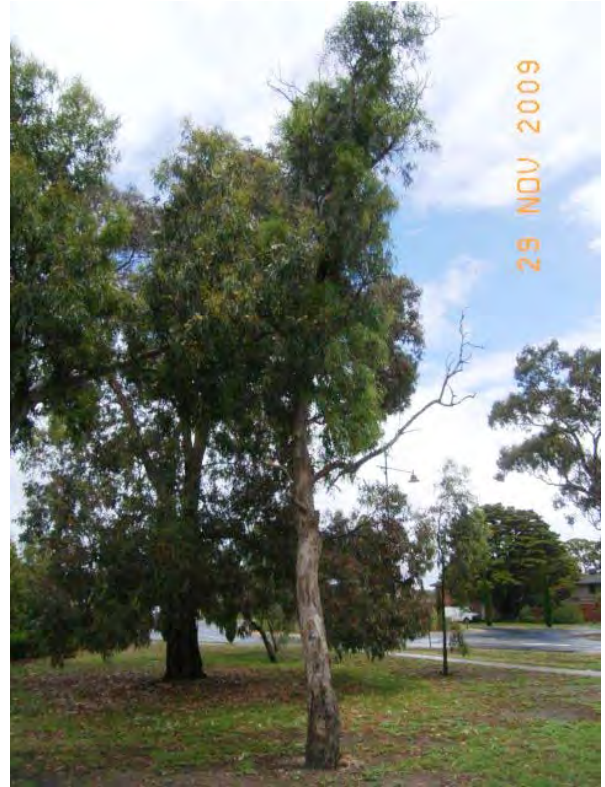
Tree Number 111 **Address:** 82 SPRINGTHORPE BOULEVARD MACLEOD 30

Comments Canopy dieback

Works: Mulch required

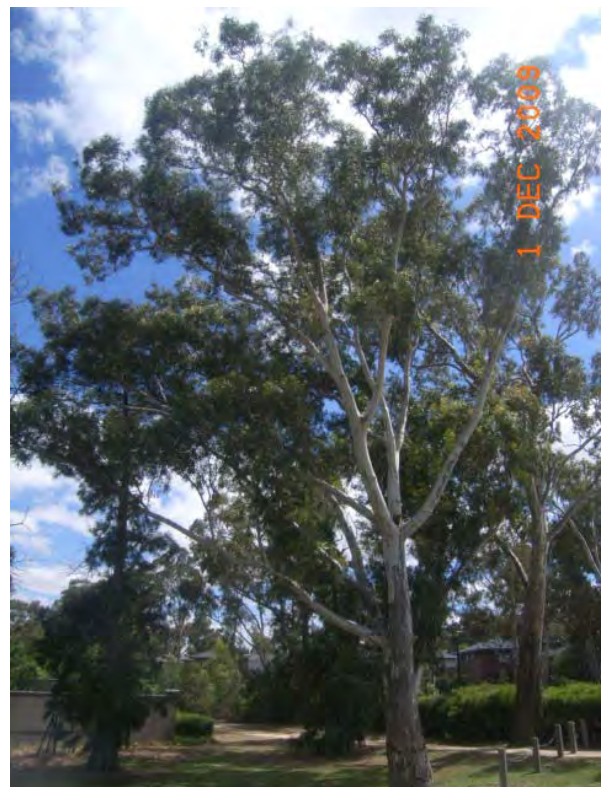
Tree Number 114 **Address:** 2 LINAKER DRIVE MACLEOD 3085

Comments Parrot damage

Works: Aerial Inspection, Reinspection every 2yrs

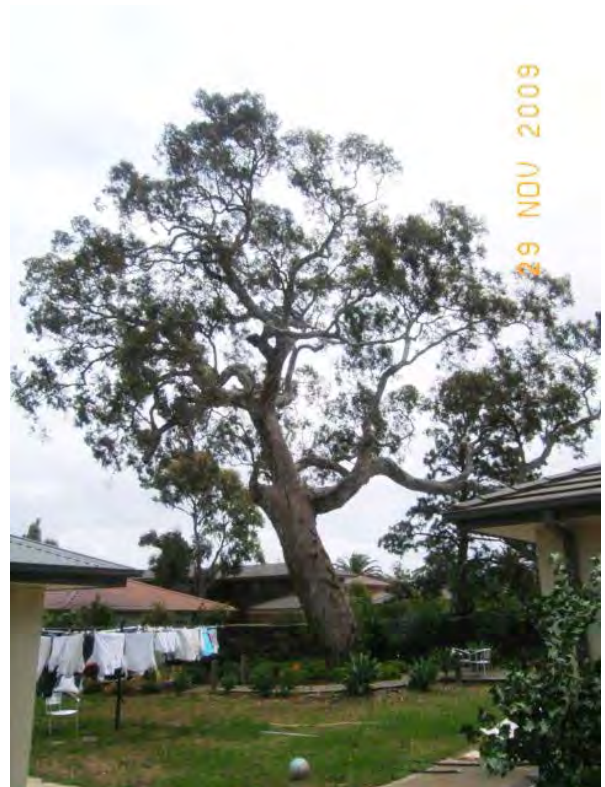
Tree Number 128 **Address:** 11 LINAKER DRIVE MACLEOD 3085

Comments Multiple bee hives, multiple hollows

Risk of Harm: 1 in 1,440
Risk Category Very high
Works: Aerial Inspection, Deadwood removal, Weight reduction, Annual inspection

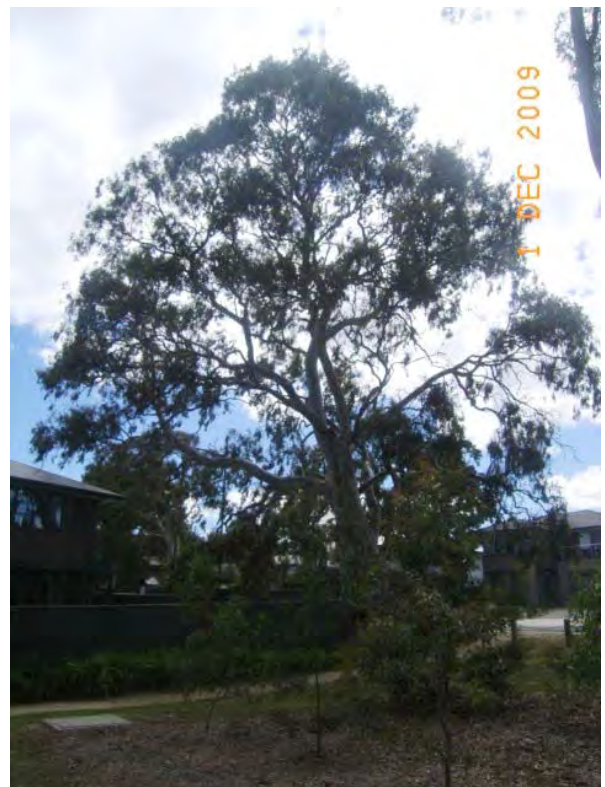
Tree Number 130 **Address:** 89 SPRINGTHORPE BOULEVARD MACLEOD 30

Comments Mistletoe present

Works: Deadwood removal, Reinspection every 2yrs

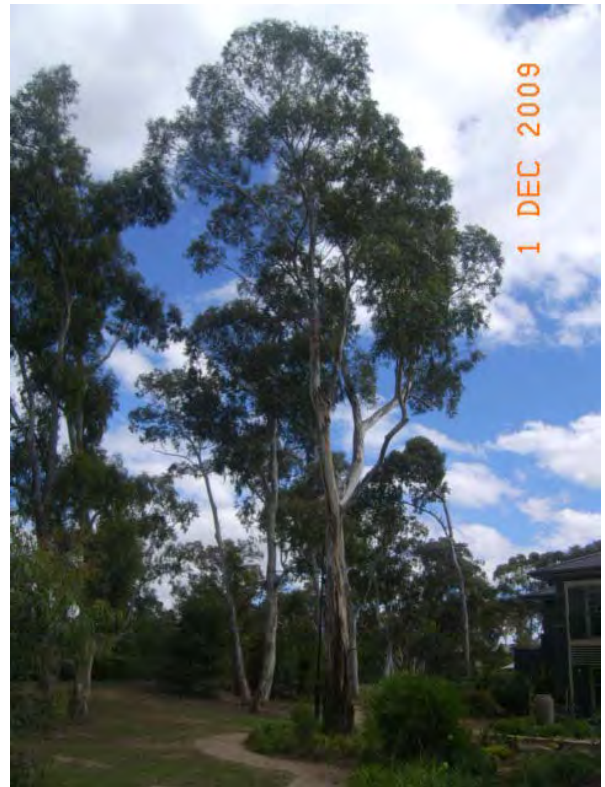
Tree Number 137 **Address:** 4 EVERETT COURT MACLEOD 3085

Comments Parrot damage

Works: Aerial Inspection

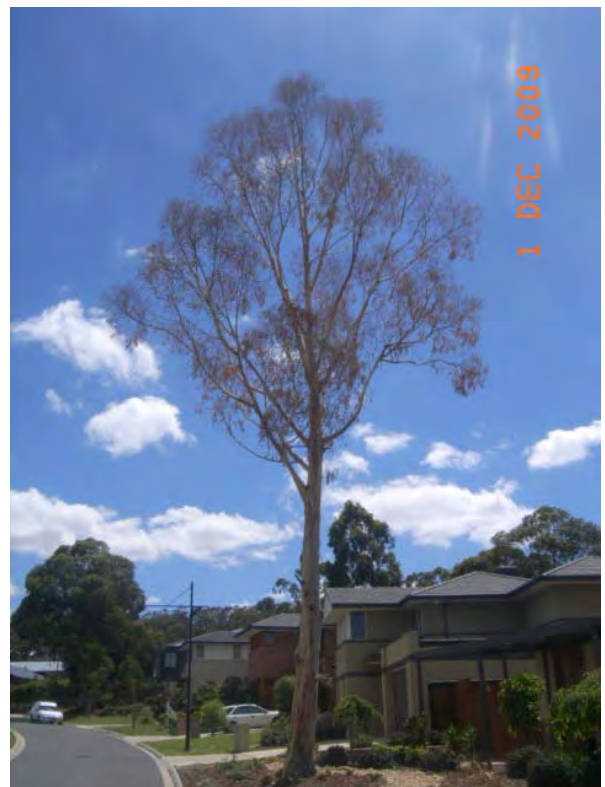
Tree Number 154 **Address:** 12 BRITTINGHAM COURT MACLEOD 3085

ULE: Unsafe

Comments Tree appears to be poisoned

Works: Removal

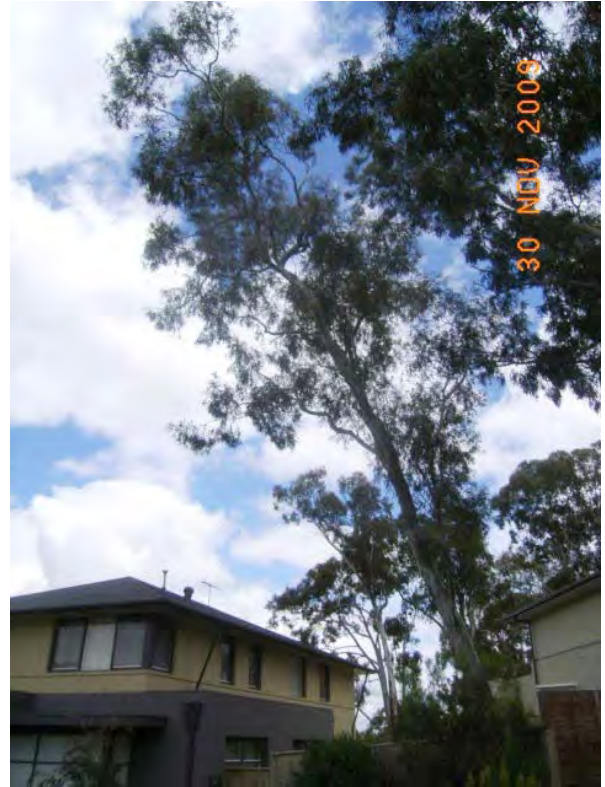
Tree Number 182 **Address:** 107 SPRINGTHORPE BOULEVARD MACLEOD 3

Comments Canopy dieback

Works: No works

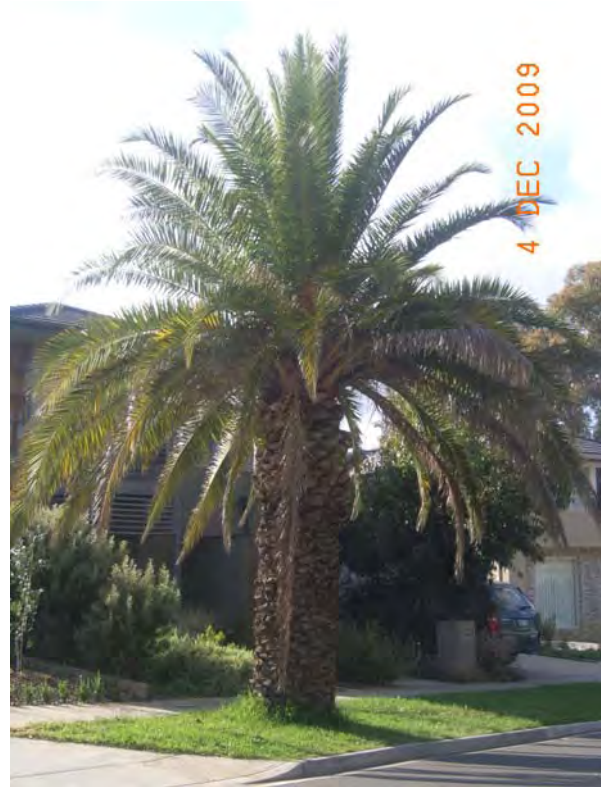
Tree Number 184 **Address:** 119 ERNEST JONES DRIVE MACLEOD 3085

Risk of Harm: 1 in 59,040
Risk Category Moderate
Works: No works

Comments Mistletoe present

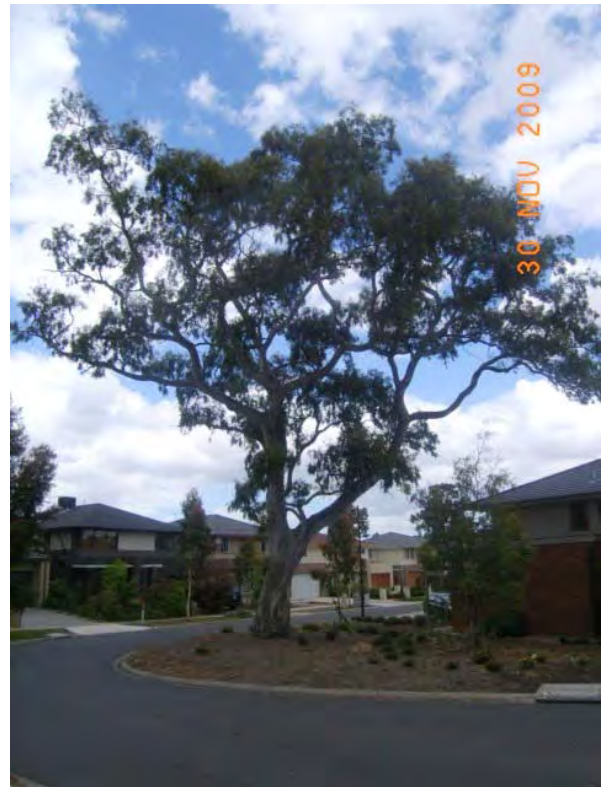
Tree Number 186 **Address:** 9 EVAN SMITH CLOSE MACLEOD 3085
Map No: Sheet 4 **Location** Rear of Private Property

Botanical Name *Eucalyptus melliodora*
Common Name Yellow Box
Status: Indigenous
Maturity: Mature
Dimensions (hwx) 18m x 14m
DBH (mm) 500
Health: Good
Structure: Fair
ULE: 20 to 40 years
Retention Value High
TPZ Radius (m): 6

Risk of Harm: 1 in 590,400
Risk Category Low
Works: Property/Asset clearance

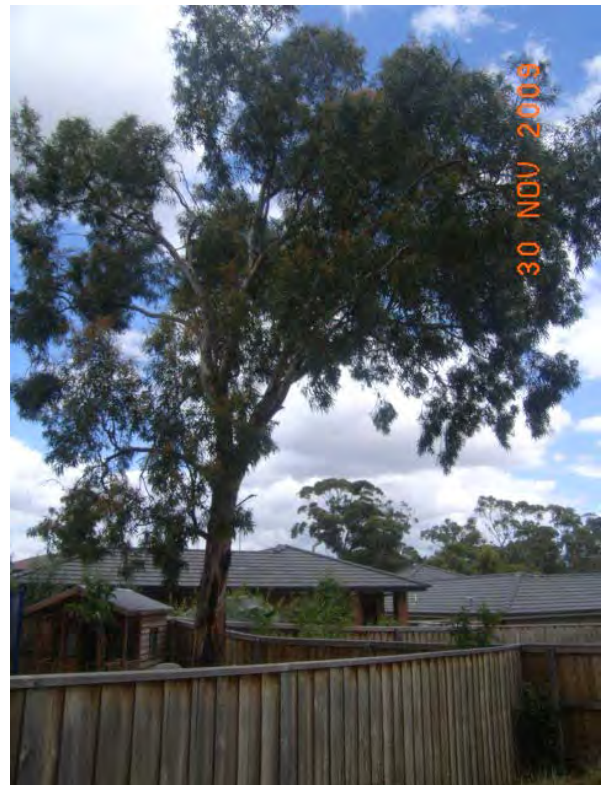
Tree Number 191 **Address:** 137 ERNEST JONES DRIVE MACLEOD 3085

Comments Canopy foliage thinning, extend mulched area

Works: Mulch required

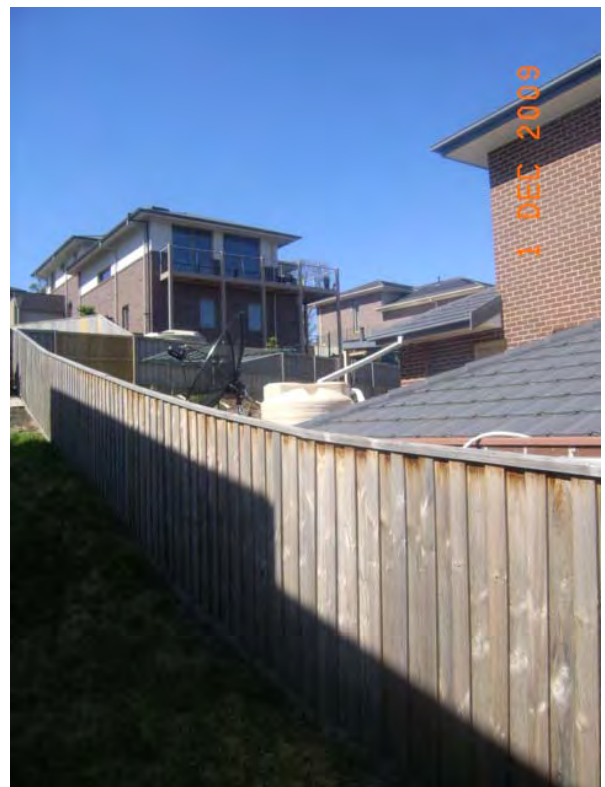
Tree Number 199 **Address:** 4 EVAN SMITH CLOSE MACLEOD 3085
Map No: Sheet 4 **Location** Rear of Private Property

Botanical Name *Eucalyptus viminalis*
Common Name Manna Gum
Status: Indigenous
Maturity: Mature
Dimensions (hwx) 19m x 19m
DBH (mm) 1250
Health: Good
Structure: Fair
ULE: 20 to 40 years
Retention Value High
TPZ Radius (m): 15

Risk of Harm: 1 in 61,920
Risk Category Moderate
Works: Reinspection every 2yrs

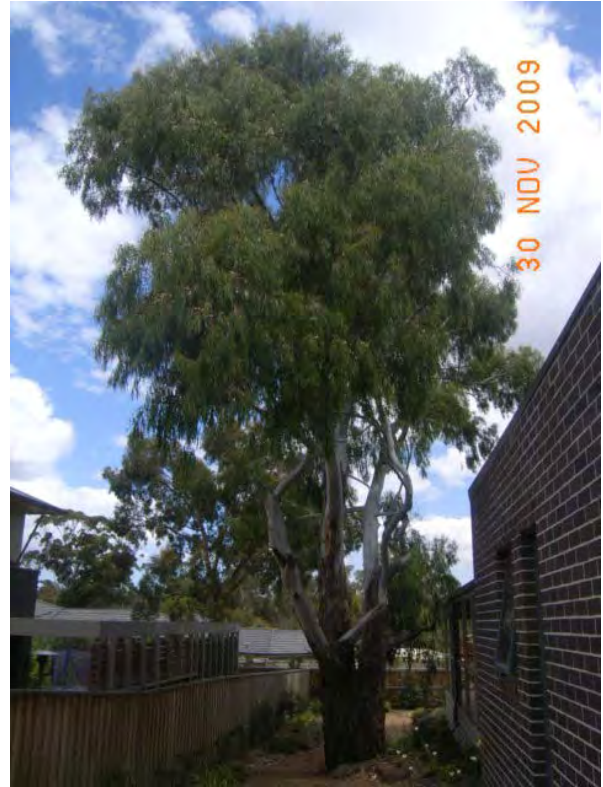
Tree Number 200 **Address:** 3 EVAN SMITH CLOSE MACLEOD 3085
Map No: Sheet 4 **Location** Council Property

Botanical Name *Eucalyptus melliodora*
Common Name Yellow Box
Status: Indigenous
Maturity: Mature
Dimensions (hwx) 21m x 12m
DBH (mm) 790
Health: Good
Structure: Poor
ULE: 20 to 40 years
Retention Value High
TPZ Radius (m): 9.48

Risk of Harm: 1 in 7,200
Risk Category High
Works: Codominant reduction, Reinspection every 2yrs

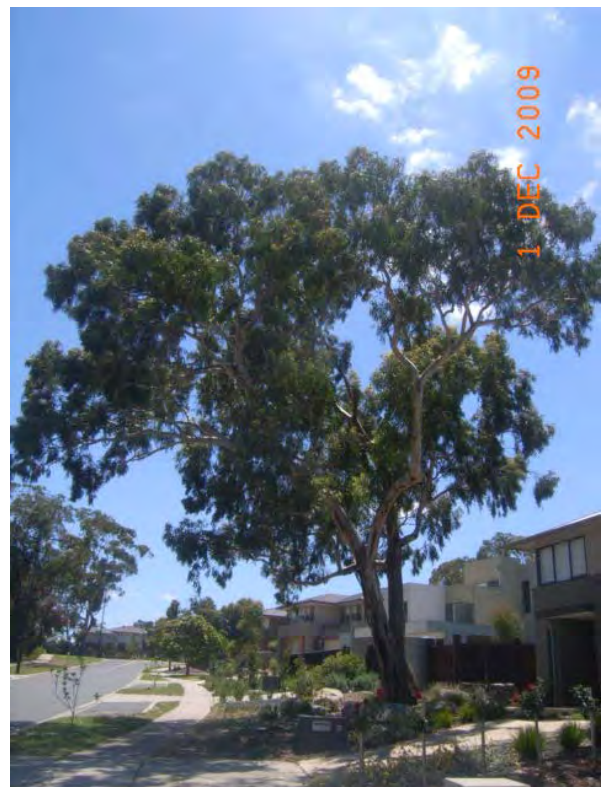
Tree Number 203 **Address:** 137 ERNEST JONES DRIVE MACLEOD 3085

Comments Lots of epicormics

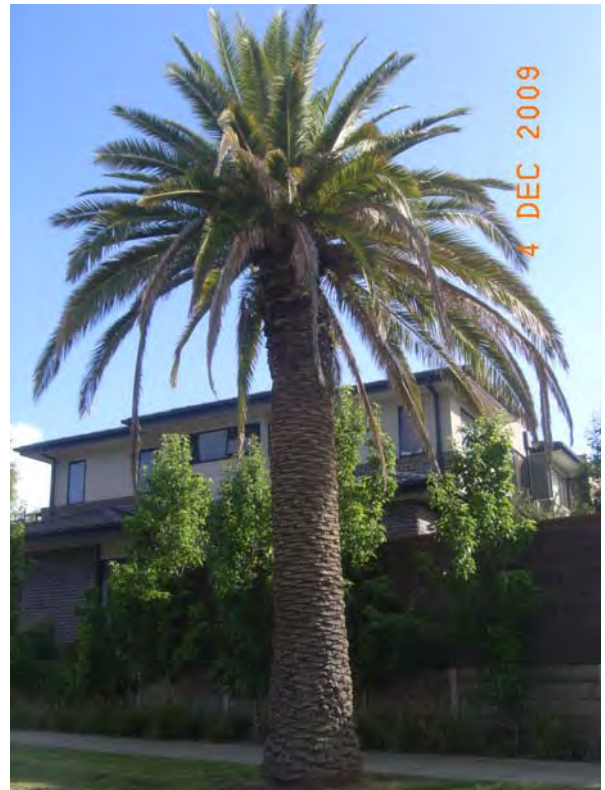
Tree Number 208 **Address:** 15 SUGARLOAF DRIVE MACLEOD 3085

Comments Building in close proximity to tree

Risk of Harm: 1 in 1,800,000,000
Risk Category Very low
Works: Formative pruning

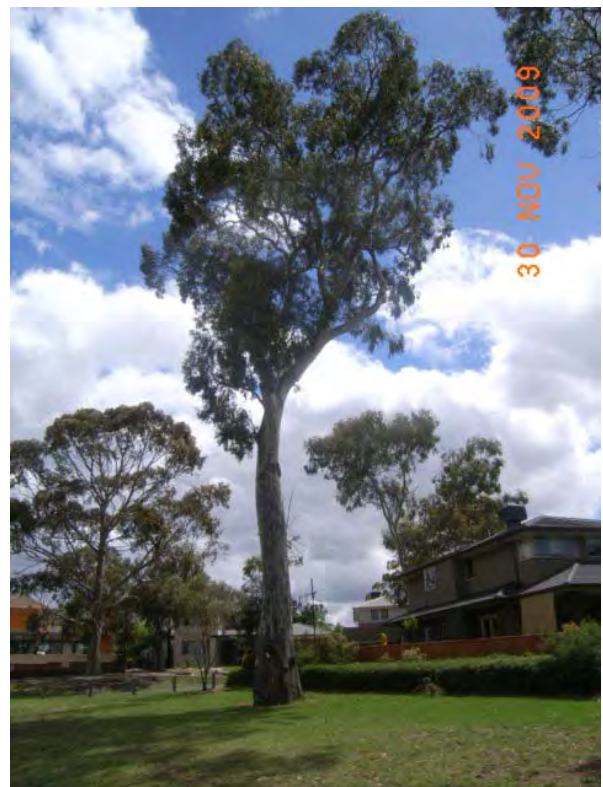
Tree Number 217 **Address:** 147 ERNEST JONES DRIVE MACLEOD 3085

Comments Crossover constructed approximately 0.5m from trunk, Reduce possible insect damage limbs as required from inspection

Works: Aerial inspection, Weight reduction

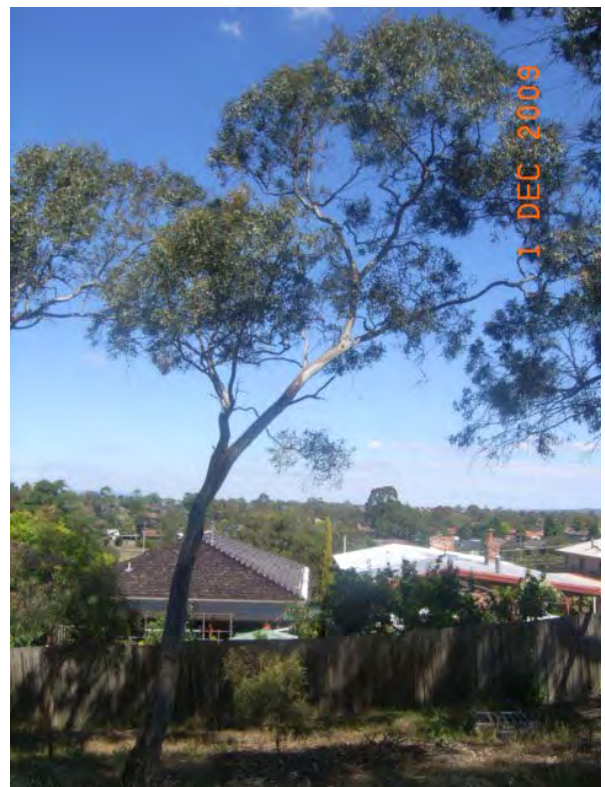
Tree Number 226 **Address:** 64 SUGARLOAF DRIVE MACLEOD 3085

Comments Reduce epicormics on previous failure point, inspect upper canopy

Works: Aerial inspection, Weight reduction, Reinspection every 2yrs

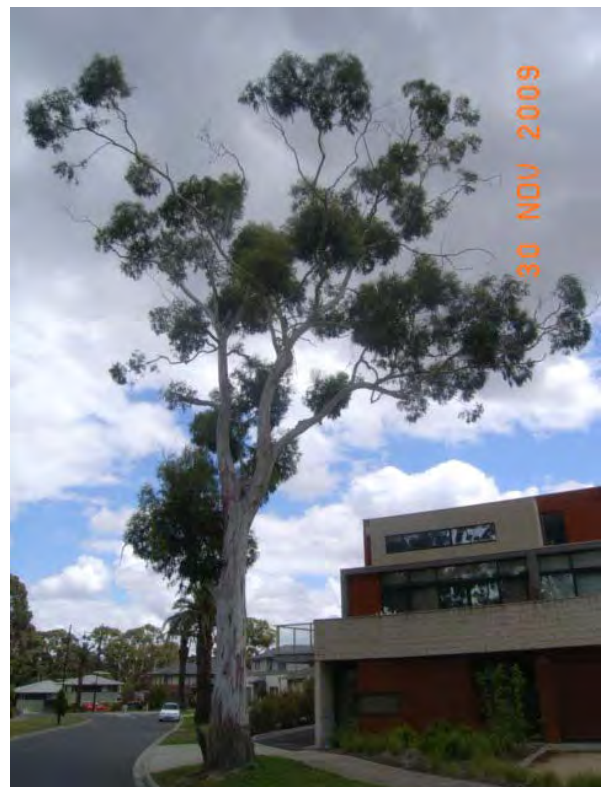
Tree Number 229 **Address:** 31 LOOKOUT RISE MACLEOD 3085

Comments Tree has been poisoned but health currently good

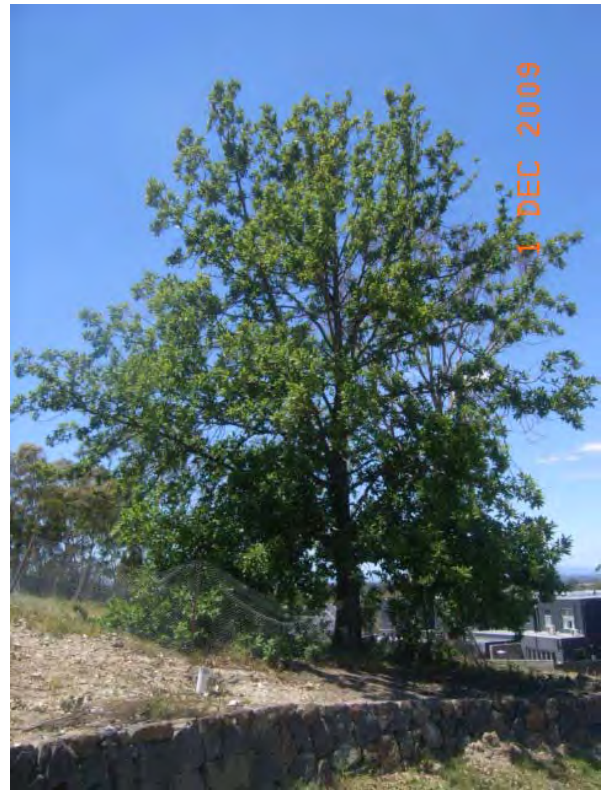
Tree Number 230 **Address:** 33 LOOKOUT RISE MACLEOD 3085

ULE: Unsafe

Comments Tree has been poisoned

Works: Removal

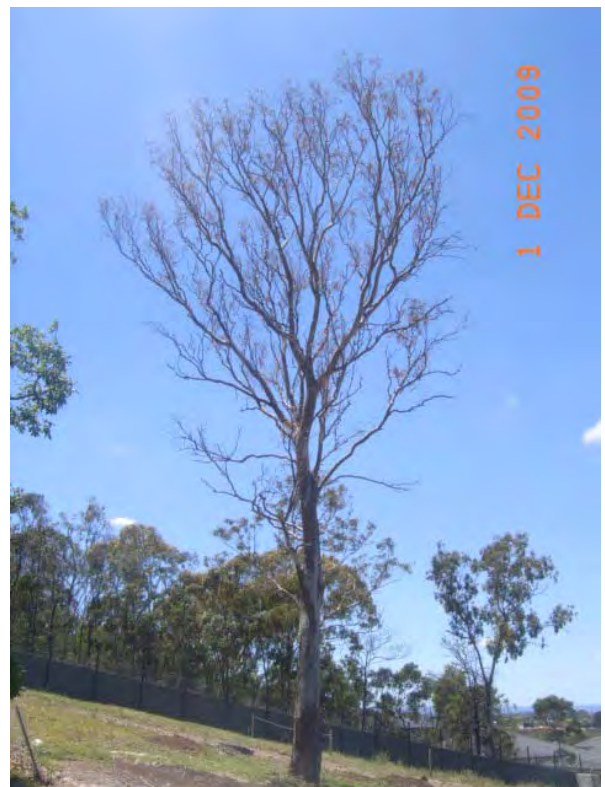
Tree Number 231 **Address:** ERNEST JONES DRIVE MACLEOD 3085

Comments Crossover constructed approximately 1m from trunk

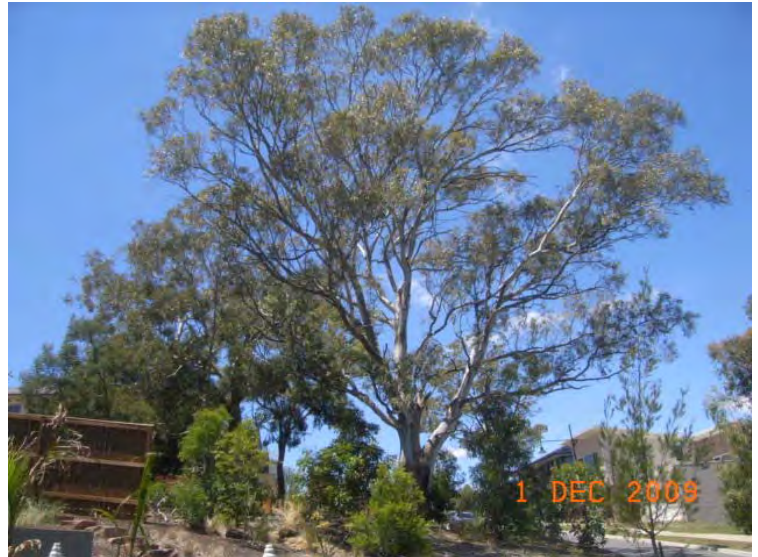
Tree Number 234 **Address:** 23 LOOKOUT RISE MACLEOD 3085

Comments Crossover constructed approximately 0.5m from trunk
