Tree Assessment
for
Darebin City Council

Assessment of trees for VPO update in
Springthorpe Estate, Macleod.

Homewood Consulting Pty Ltd

16 May 2010

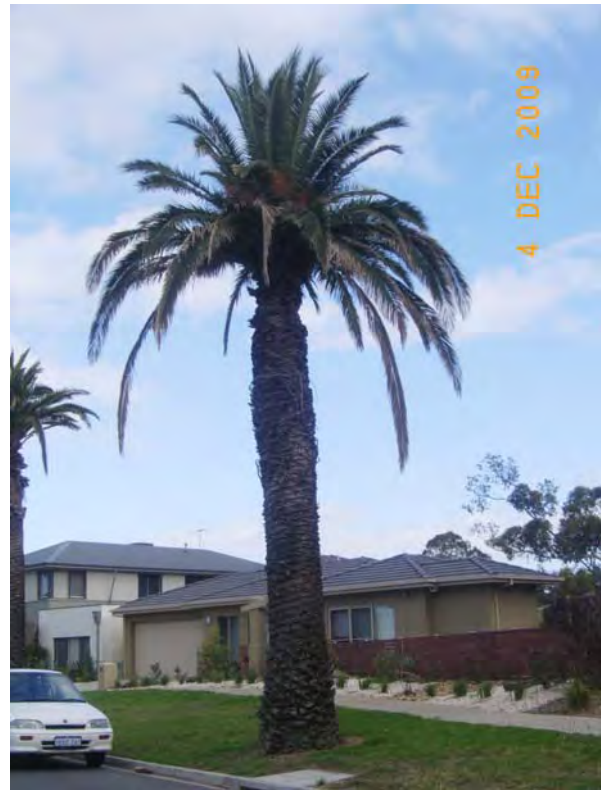
Tree Number 238 **Address:** 16 LOOKOUT RISE MACLEOD 3085

Comments Bee hive present

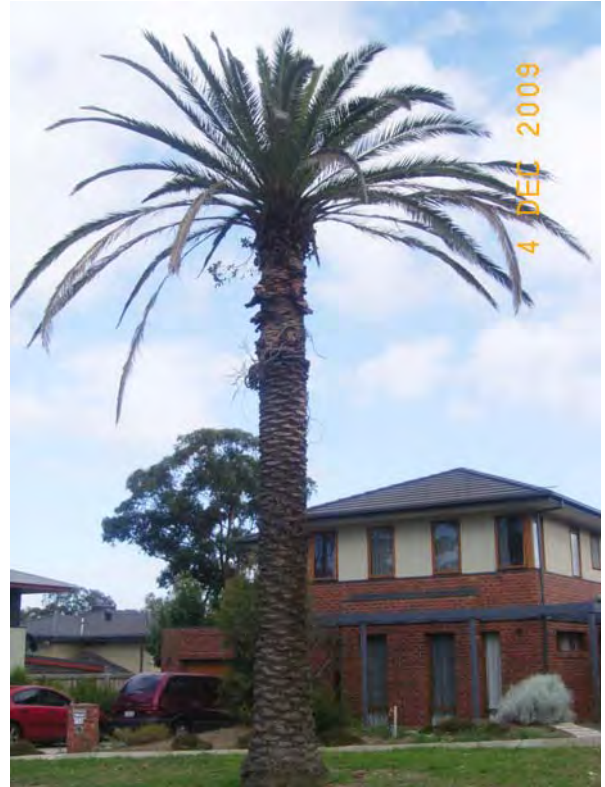
Tree Number 242 **Address:** 161 ERNEST JONES DRIVE MACLEOD 3085

Risk of Harm: 1 in 61,920
Risk Category Moderate
Works: Weight reduction, Reinspection every 2yrs
Comments Reduce stem over property/building

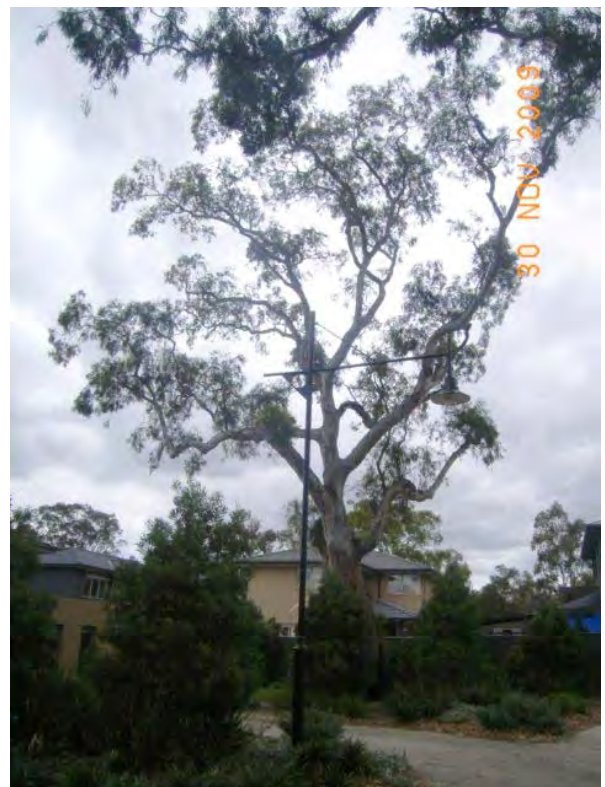
Tree Number 261 **Address:** 167 ERNEST JONES DRIVE MACLEOD 3085

Comments Could not gain site access, DBH estimated

Works: Reinspection every 2yrs

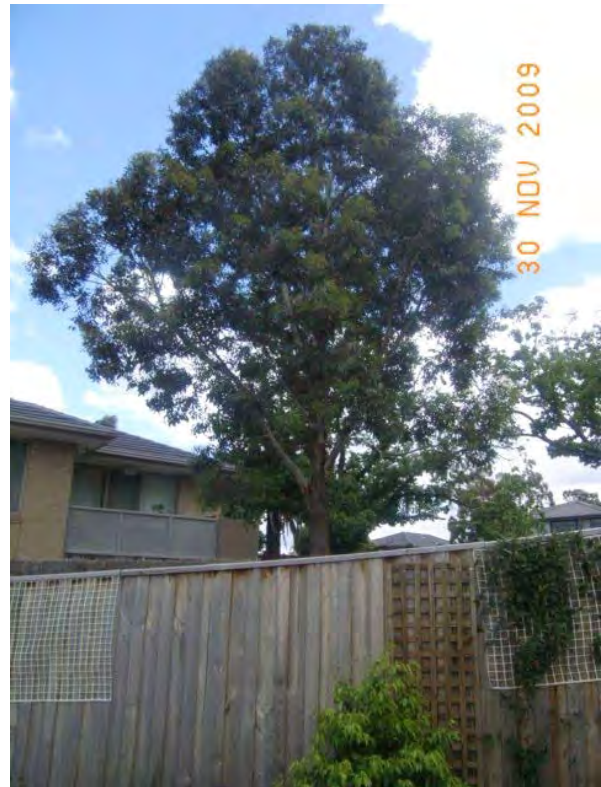
Tree Number 266 **Address:** 107 MAIN DRIVE MACLEOD 3085
Map No: Sheet 4 **Location** Rear of Private Property

Botanical Name *Eucalyptus botryoides*
Common Name Southern Mahogany
Status: Native
Maturity: Mature
Dimensions (hwx) 20m x 17m
DBH (mm) 820
Health: Good
Structure: Good
ULE: 20 to 40 years
Retention Value High
TPZ Radius (m): 9.84

Risk of Harm: 1 in 59,040
Risk Category Moderate
Works: Weight reduction
Comments

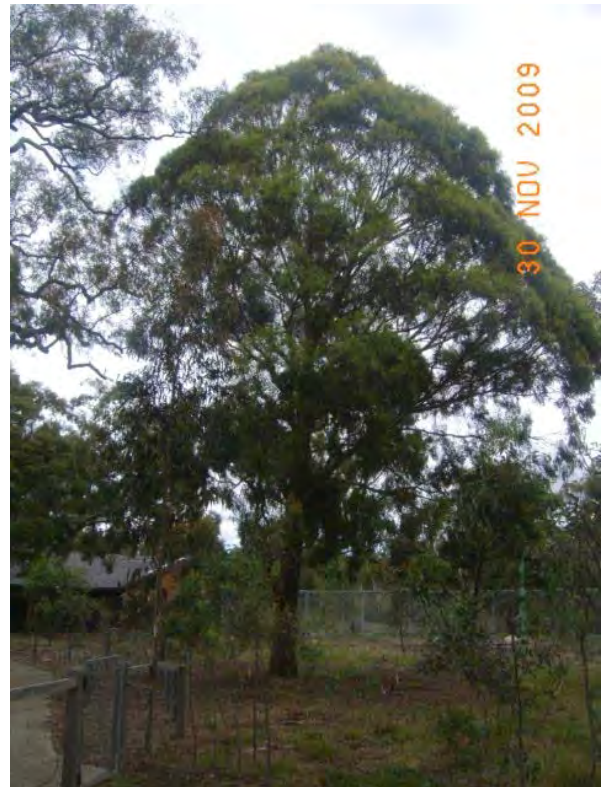
Tree Number 276 **Address:** 9 LOOKOUT RISE MACLEOD 3085

Comments Could not gain site access, DBH estimated, tree requires TPZ from construction, mistletoe present

Works: Mulch required

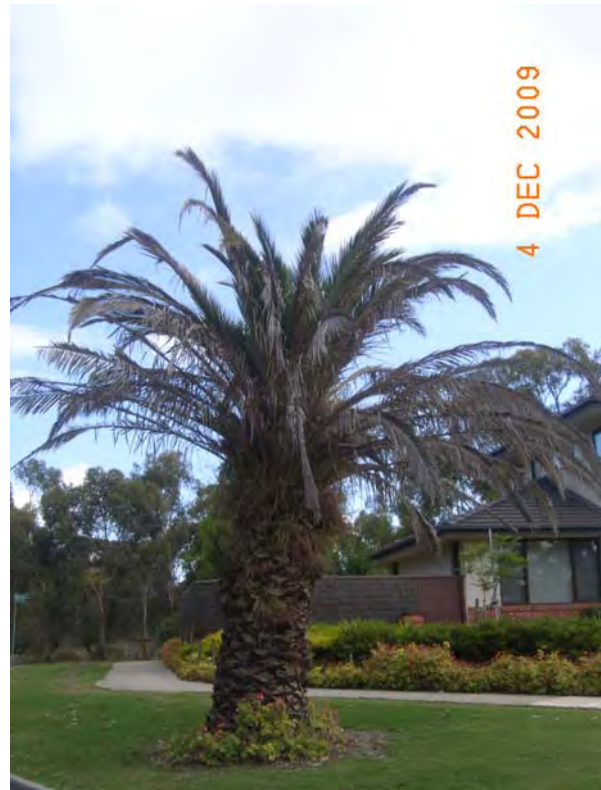
Tree Number 278 **Address:** 167 ERNEST JONES DRIVE MACLEOD 3085

Comments Could not gain site access, DBH estimated

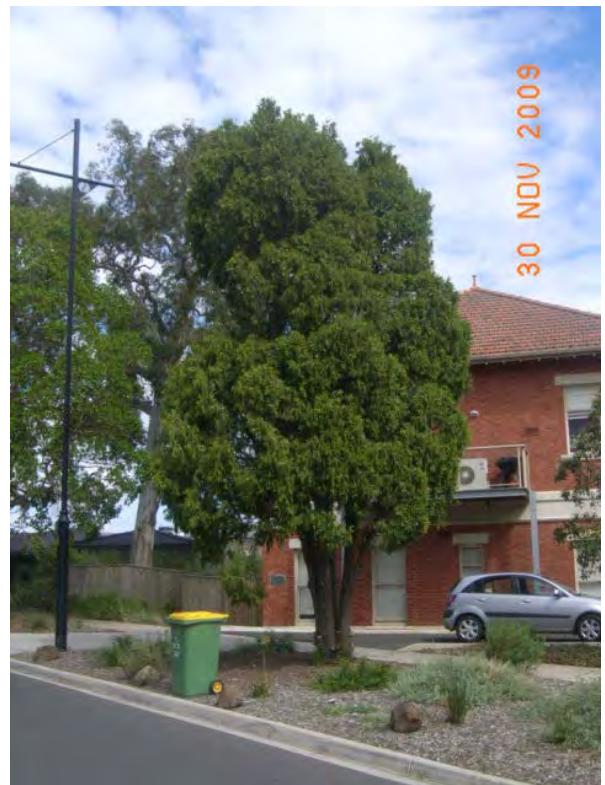
Tree Number 283 **Address:** 167 ERNEST JONES DRIVE MACLEOD 3085

Comments Could not gain site access, DBH estimated

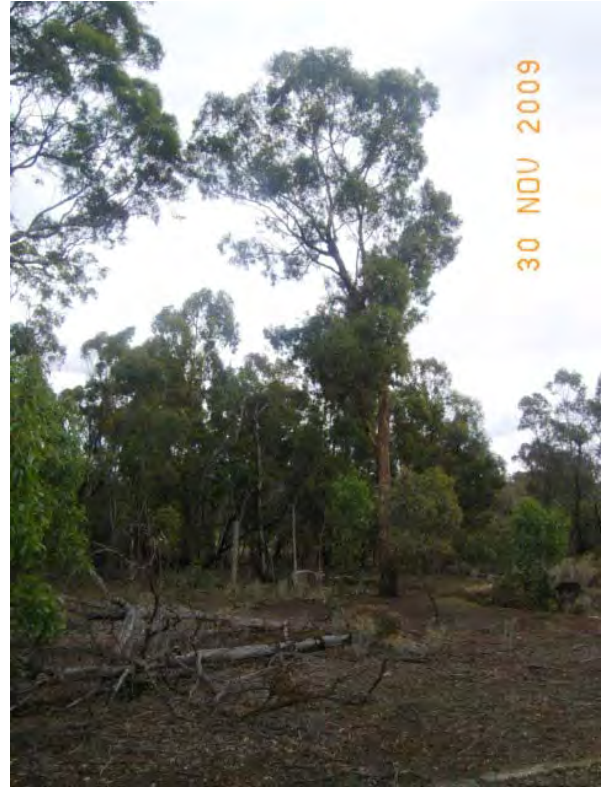
Tree Number 284 **Address:** ERNEST JONES DRIVE MACLEOD 3085

Comments Convert tree to habitat, birds are currently nesting in hollows

Works: Heavy reduction

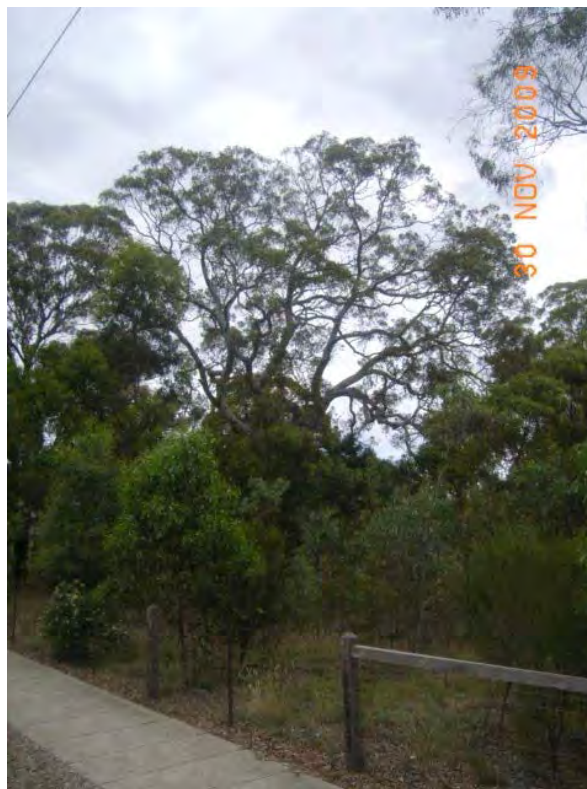
Tree Number 287 **Address:** 1 GRESSWELL ROAD MACLEOD 3085

Comments Parrot damage

Works: Weight reduction, Reinspection every 2yrs

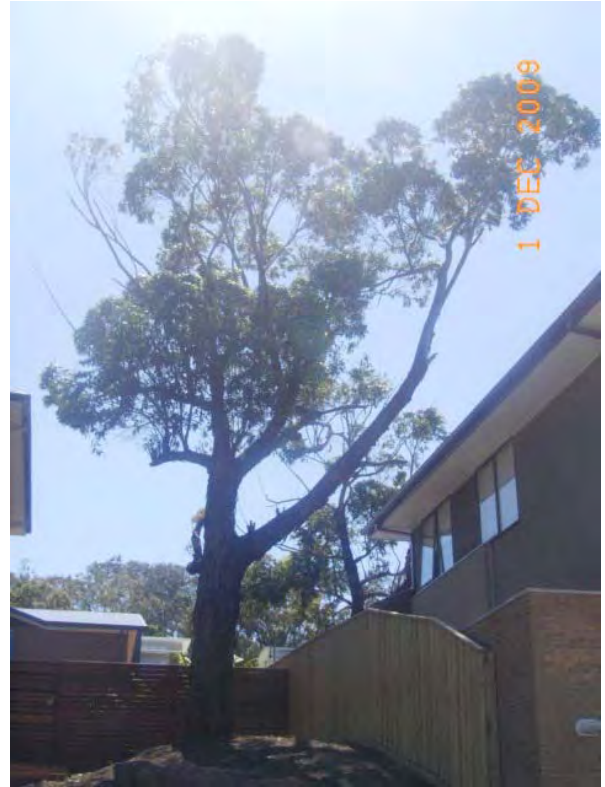
Tree Number 294 **Address:** 6 GRESSWELL ROAD MACLEOD 3085

Comments Excavation approximately 3m
from trunk

Works: Reinspection every 2yrs

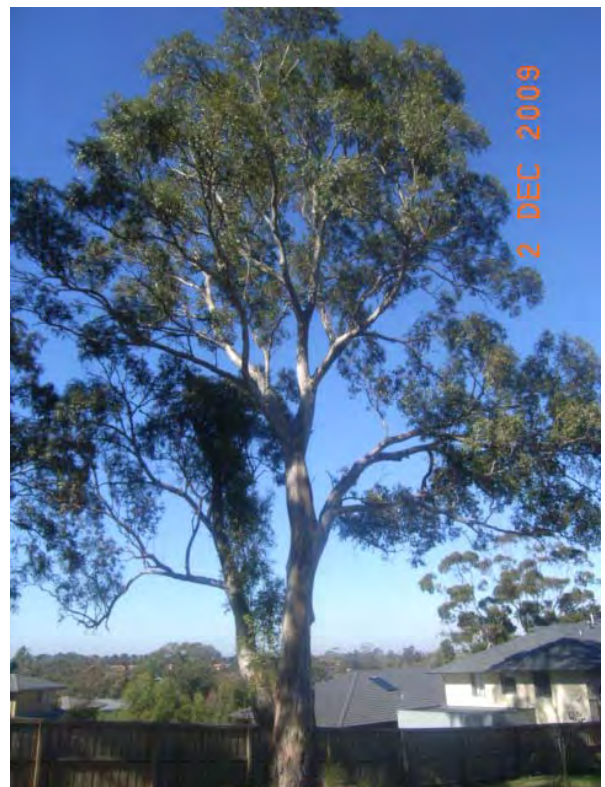
Tree Number 295 **Address:** 4 GARNER COURT MACLEOD 3085

Comments Evidence of previous branch failure

Works: Weight reduction, Reinspection every 2yrs

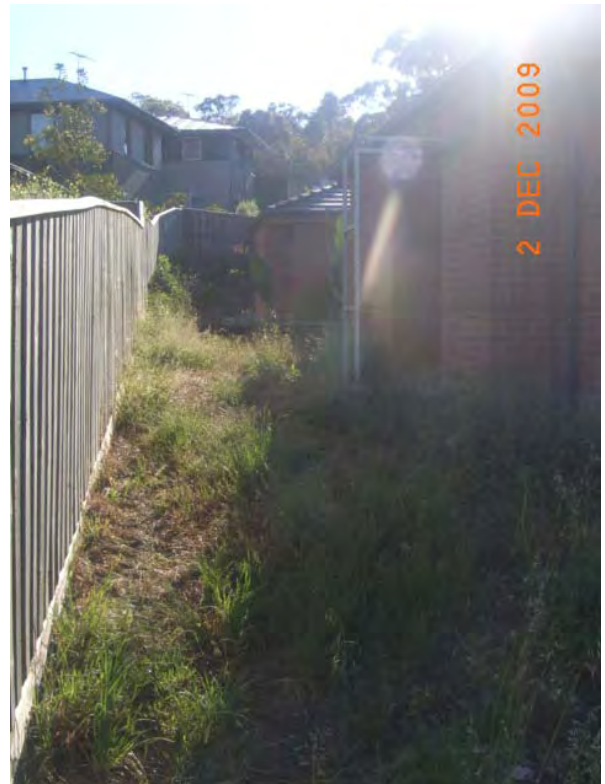
Tree Number 297 **Address:** 80 SUGARLOAF DRIVE MACLEOD 3085

Botanical Name *Cupressus lusitanica*
Common Name Mexican Cypress
Status: Exotic
Maturity: Mature
Dimensions (hwx) 19m x 16m
DBH (mm) 1100
Health: Fair
Structure: Fair
ULE: 20 to 40 years
Retention Value High
TPZ Radius (m): 13.2

Risk of Harm: 1 in 590,400
Risk Category Low
Works: Mulch required
Comments Tree requires TPZ from construction

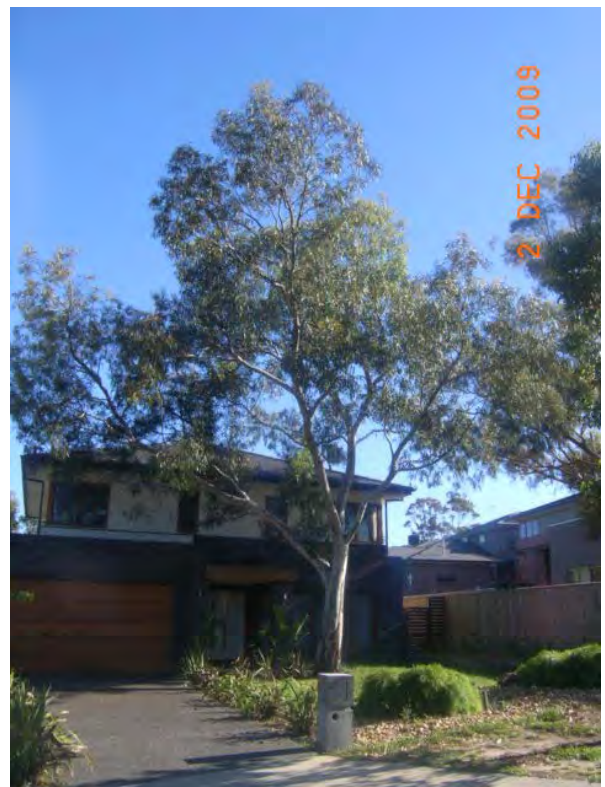
Tree Number 305 **Address:** 15 GRESSWELL ROAD MACLEOD 3085

Comments Could not gain site access, DBH estimated

Works: Mulch required

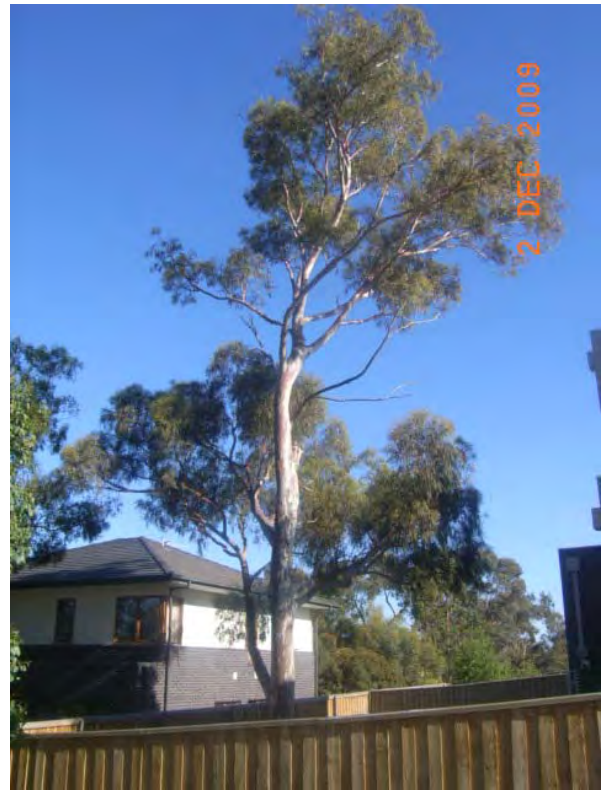
Tree Number 306 **Address:** 16 GRESSWELL ROAD MACLEOD 3085

Comments Retaining wall less than 1m from trunk

Works: Broken branch

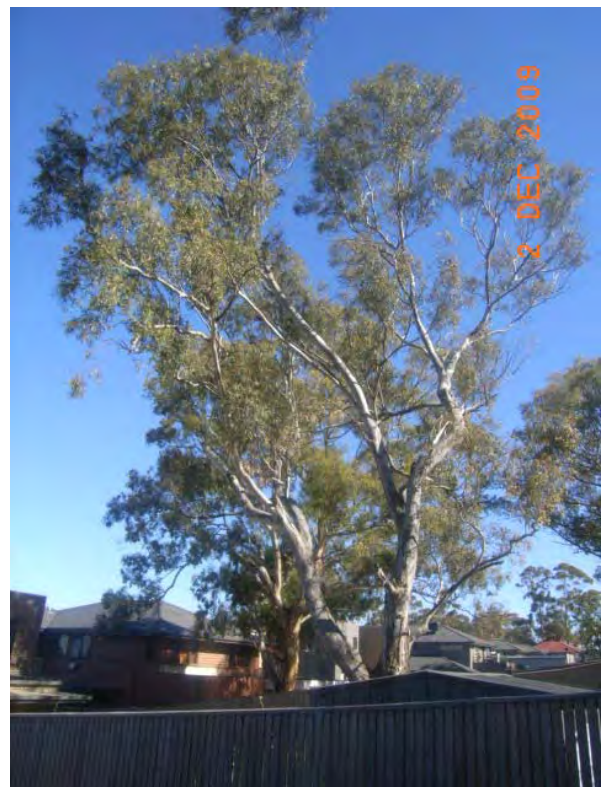
Tree Number 307 **Address:** 86 SUGARLOAF DRIVE MACLEOD 3085

Comments Could not gain site access, DBH estimated, tree requires TPZ from construction

Works: Mulch required

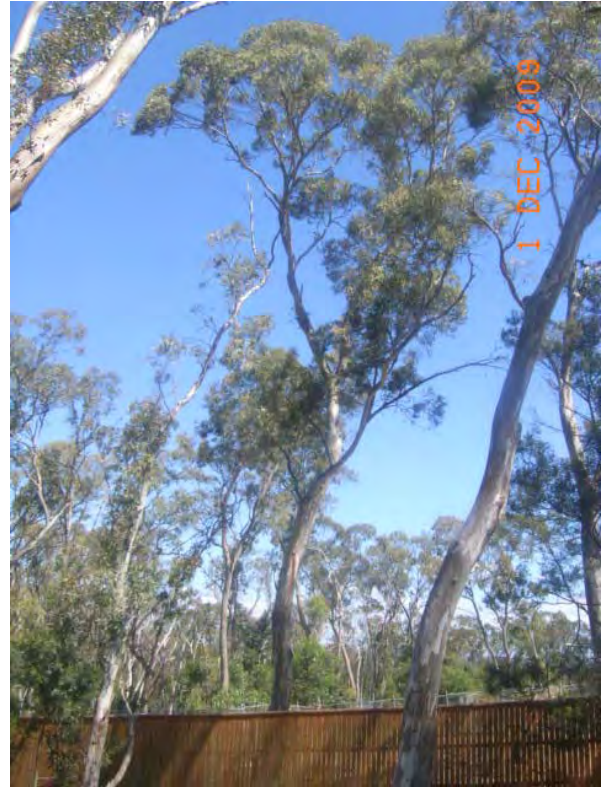
Tree Number 308 **Address:** 86 SUGARLOAF DRIVE MACLEOD 3085

Comments Could not gain site access, DBH estimated, excavation approximately 300mm from trunk

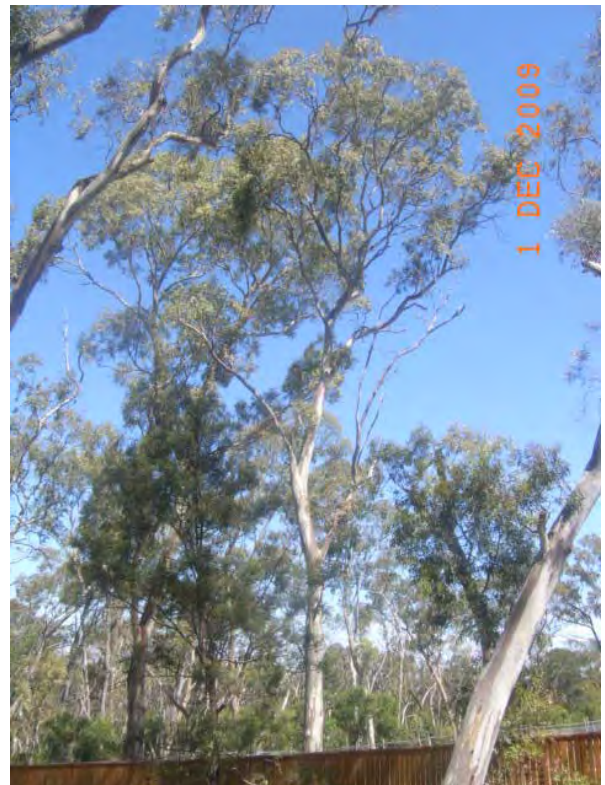
Tree Number 309 **Address:** 44 CRESTWOOD AVENUE MACLEOD 3085

Comments Tree requires TPZ from construction

Works: Mulch required

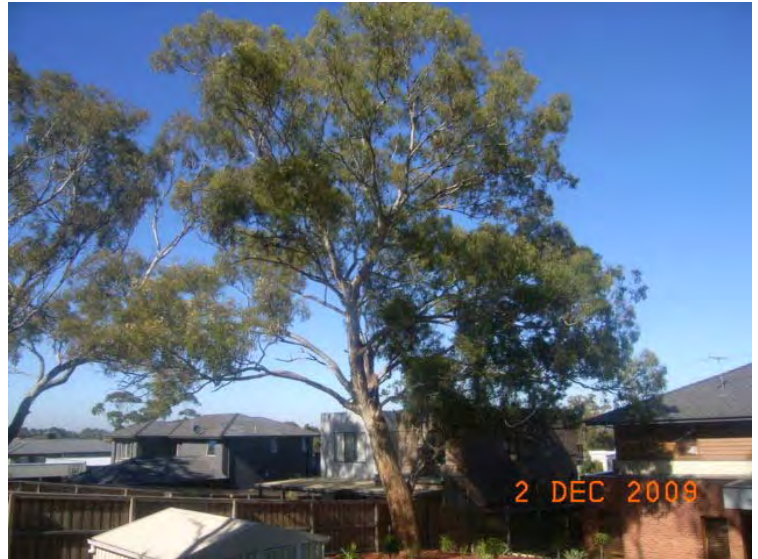
Tree Number 312 **Address:** 44 CRESTWOOD AVENUE MACLEOD 3085

Comments Canopy dieback

Works: Mulch
required,Irrigation,Reinspection
every 2yrs

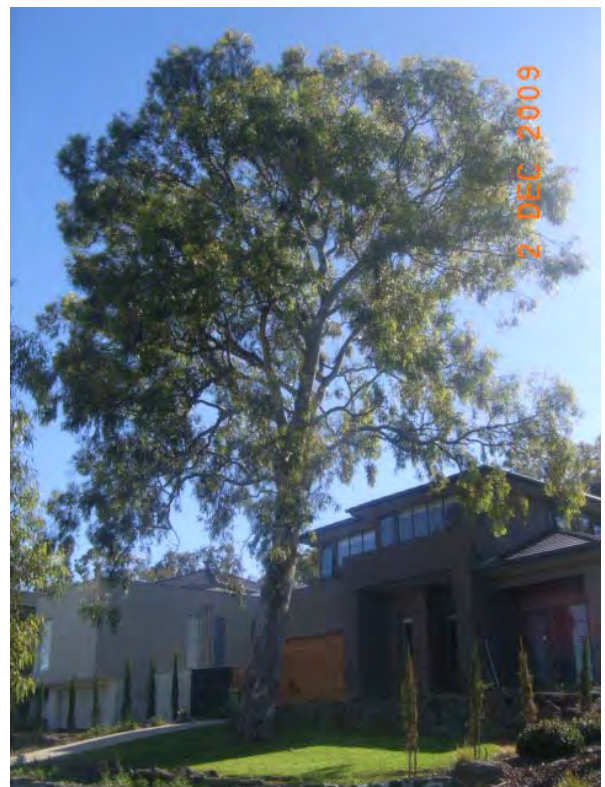
Tree Number 325 **Address:** 2 CAHIR CLOSE MACLEOD 3085

Comments Excavation approximately 1m
from trunk

Works: Mulch required

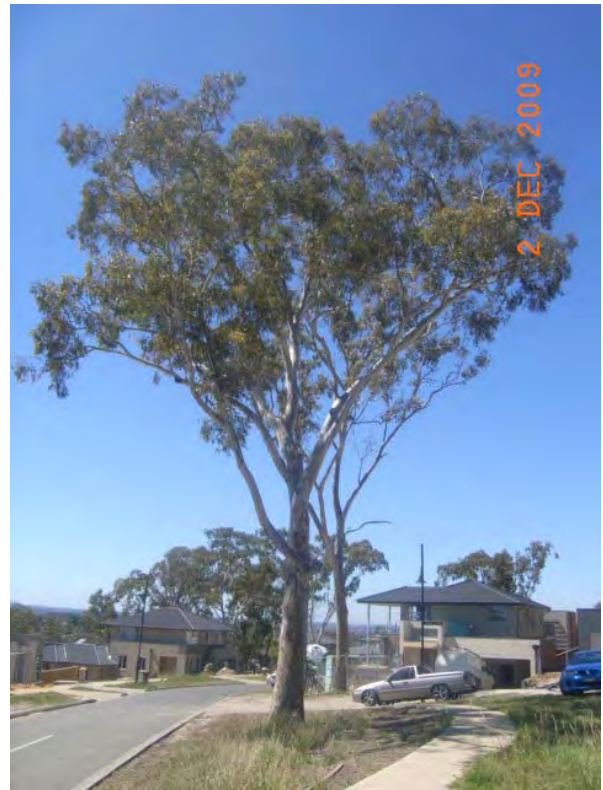
Tree Number 328 **Address:** 49 CRESTWOOD AVENUE MACLEOD 3085

Comments Tree requires TPZ from construction

Works: Mulch required

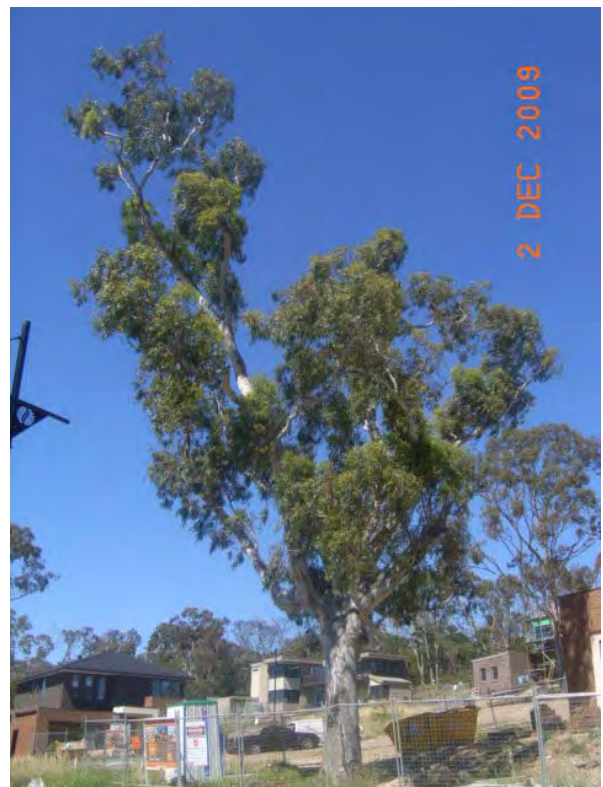
Tree Number 329 **Address:** 23 CRESTWOOD AVENUE MACLEOD 3085

Comments Tree requires TPZ from construction

Works: Mulch required

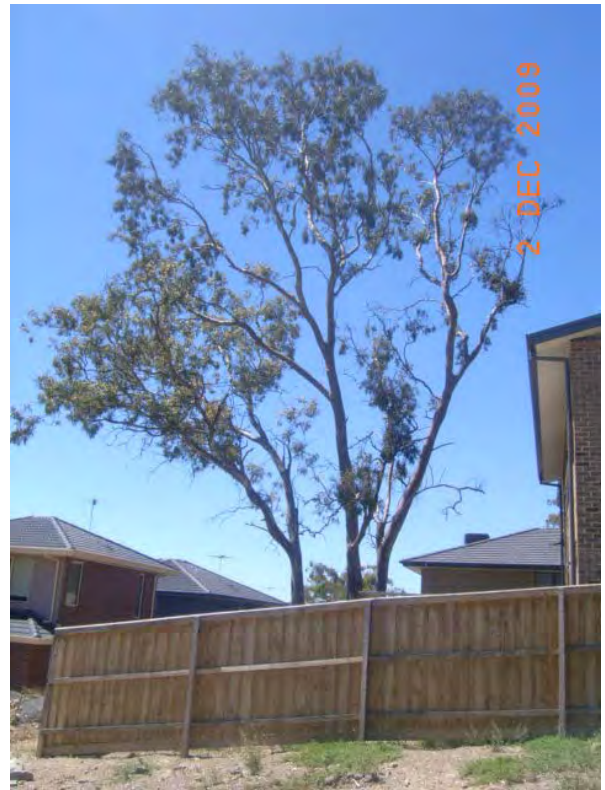
Tree Number 332 **Address:** 86 GRESSWELL ROAD MACLEOD 3085

Comments Exclude cars parking beneath canopy

Works: Exclude/Move target, Mulch required, Reinspection every 2yrs

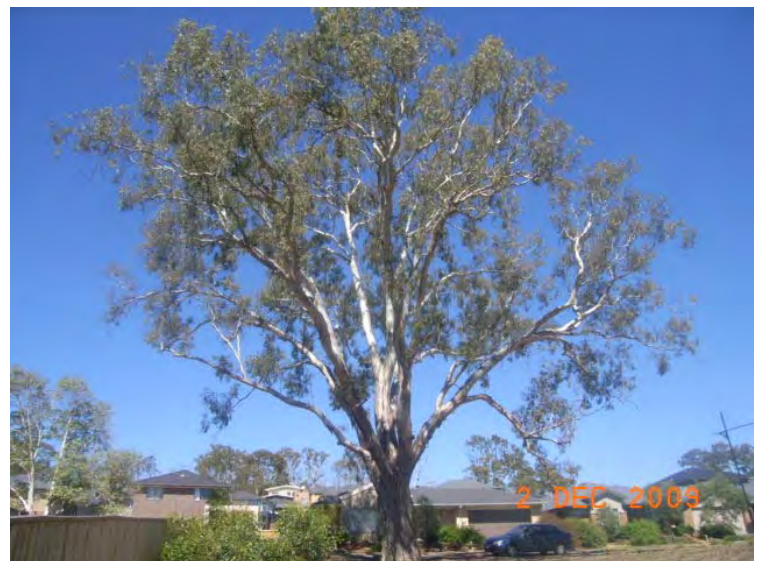
Tree Number 333 **Address:** 42 GRESSWELL ROAD MACLEOD 3085

Comments Multiple hollows

Works: Mulch required, Reinspection every 2yrs

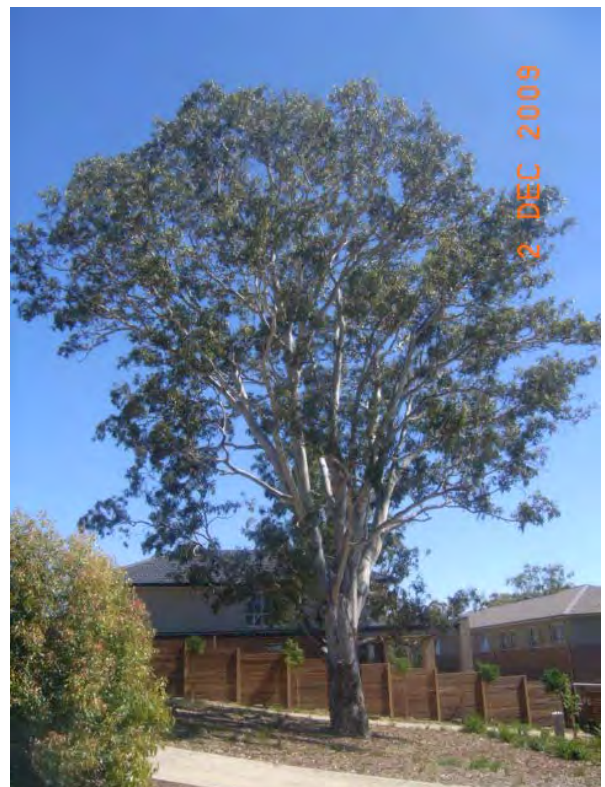
Tree Number 335 **Address:** OMEARA PLACE MACLEOD 3085

Comments Parrot damage

Works: Aerial Inspection, Reinspection every 2yrs

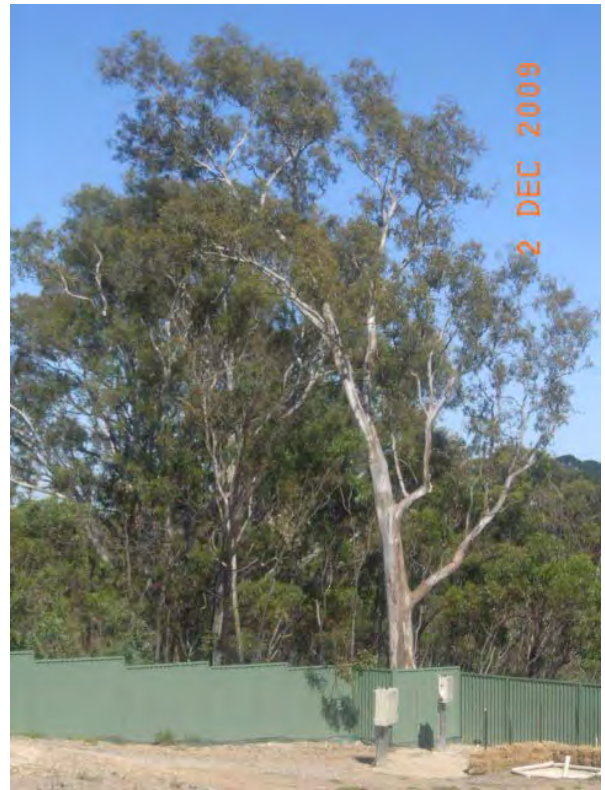
Tree Number 341 **Address:** 47-49 GRESSWELL ROAD MACLEOD 3085

Comments Excavation approximately 1m from trunk
