Cheddar Road Pedestrian Crossing Facilities

Background and Strategic Need

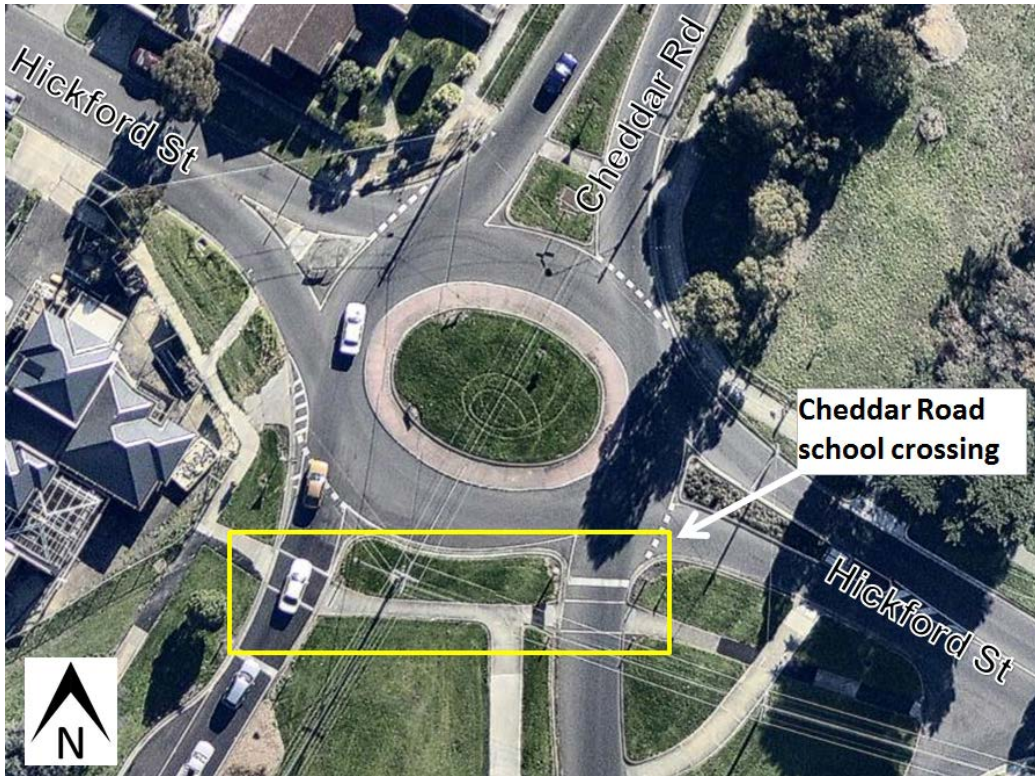
Figure 2: Cheddar Road school crossing

There is an existing two leg supervised school crossing on Cheddar Road near Hickford Street to assist students and parents of Maharishi School and Reservoir Views Primary School to cross Cheddar Road. The crossing in this location is also used by other pedestrians and cyclists to access the Cheddar Road Shared Path from both sides of Cheddar Road. The central median of Cheddar Road allows pedestrians to cross one lane of traffic at a time, which is safer and more convenient than crossing two lanes.

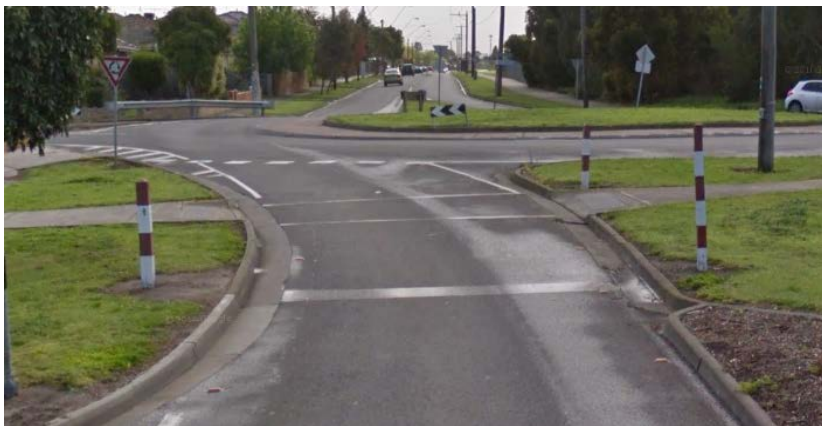
Figure 3: Cheddar Road school crossing (northbound)

- Upgrade existing warning signage on each approach to the crossing by replacing the orange signs with fluoro yellow signs.
- Replace the short flag-holding red and white school crossing post at the northbound crossing with a 1.8 metre post as per VicRoads standards.
- Reinstate a missing red and white school crossing post at the northbound crossing.
- Repaint all existing red and white school crossing posts.
- Repaint the school crossing linemarking.

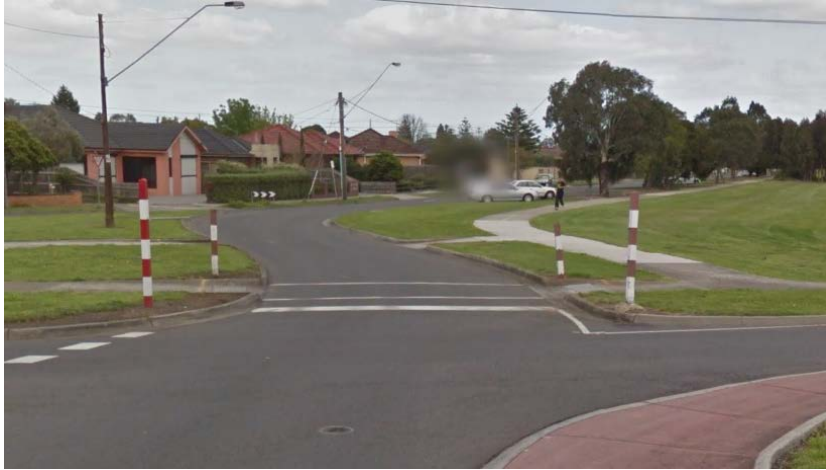
Figure 4: Cheddar Road school crossing (southbound)

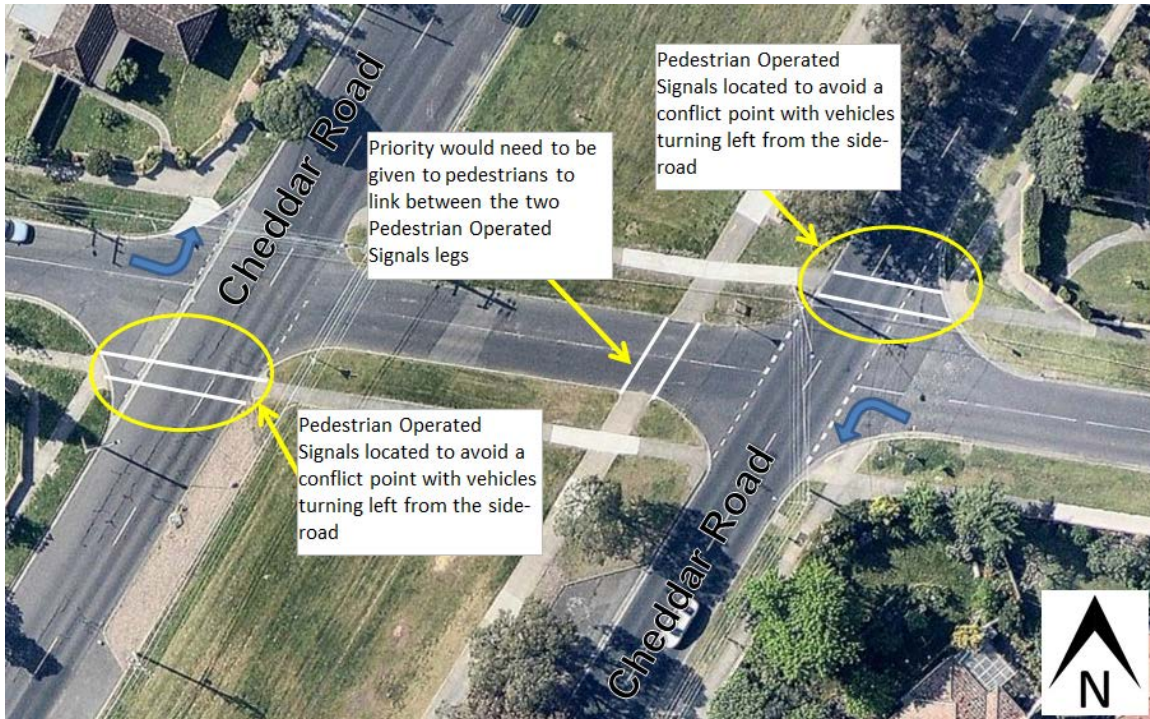
To minimise conflict points with vehicles and maximise safety, Pedestrian Operated Signals would have to be arranged in a 'dog leg' manner (refer to Figure 7 below). This is not considered an acceptable outcome for pedestrians, and therefore the entire intersection would need to be signalised, resulting in significant financial requirements for Council.

Figure 7: Required 'dog leg' arrangement of Pedestrian Operated Signals at Cheddar Road and a side road
