**Geotechnical Investigation:
Northcote Golf Course
143 Normanby Avenue, THORNBURY**

Report Prepared by A.S. James Pty Ltd

14 April 2023

Report No: 122226

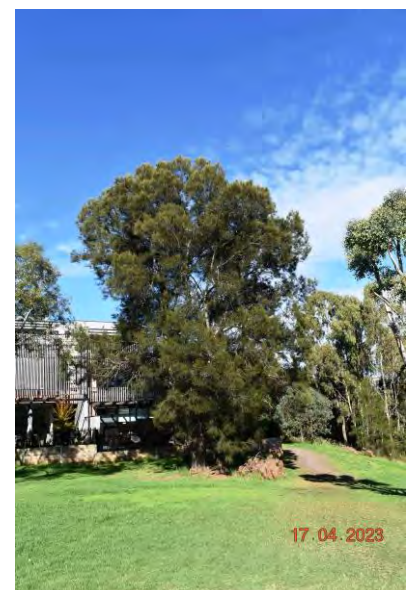
Tree ID 4

Encroachment Level: Major **Outcome:** Lost

Comments: Tree has been ring barked with large saw cut in trunk

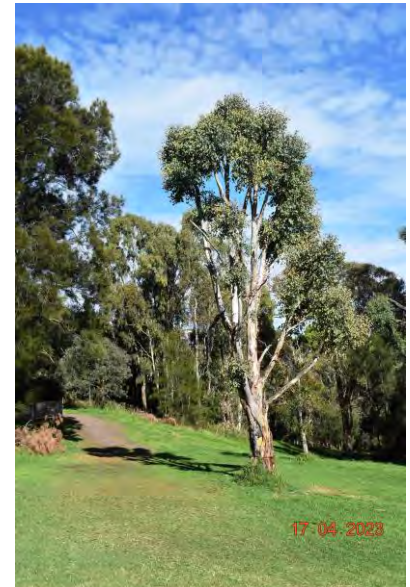
Tree ID 5

Encroachment Level: Major **Outcome:** Retained

Comments: Extended low limbs over existing foot pad. Casuarina growing from base on southern side

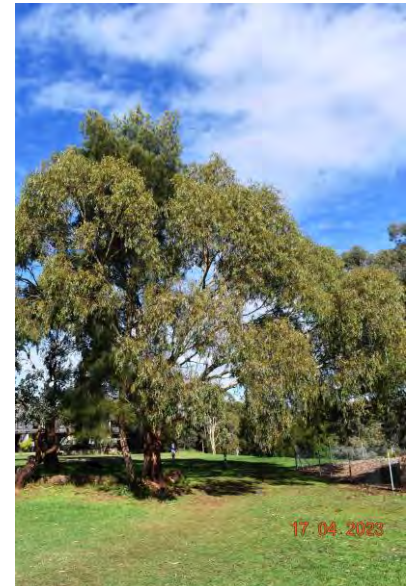
Tree ID 6

Encroachment Level: None **Outcome:** Retained

Comments: Growing from base of adjacent tree

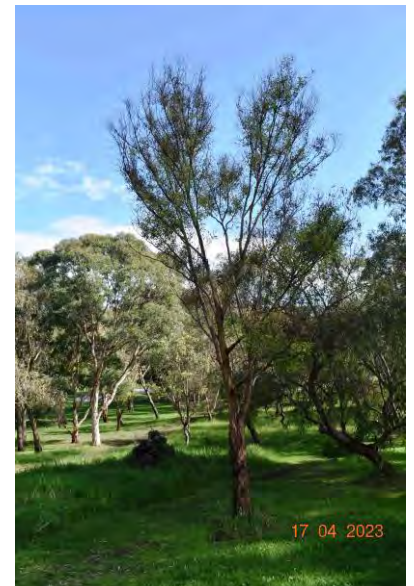
Tree ID 9

Encroachment Level: Major **Outcome:** Lost

Comments: Located inbetween 2 foot pads

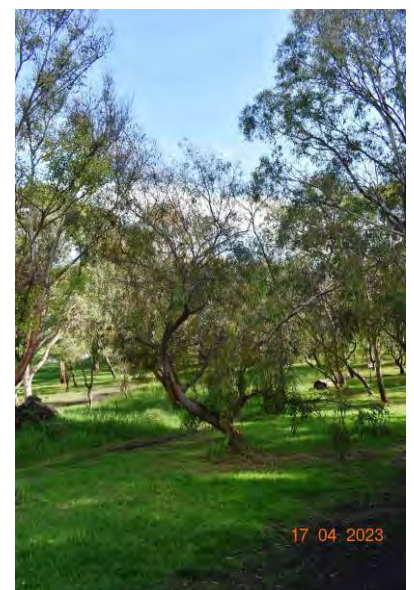
Tree ID 10

Encroachment Level: None **Outcome:** Retained

Comments: Reduction in health. Located 1m from southern path

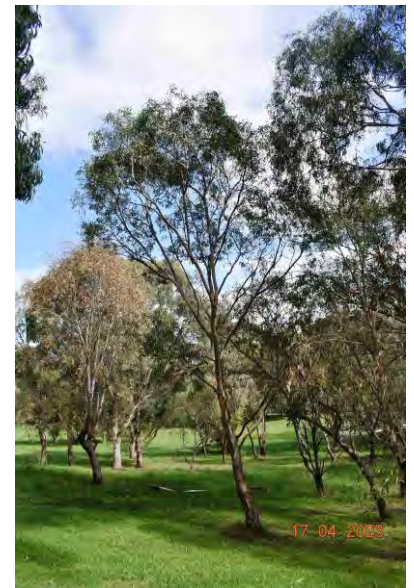
Tree ID 15

Common Name River Red Gum **Origin:** Indigenous
Height (m): 6 **Health:** Fair
Width (m): 3 **Structure:** Poor
DBH (cm): 10 **ULE:** 20+
Dia. @ base (cm): 17
Tree Significance: Low
Retention Value: Low
TPZ Radius (m): 2 **TPZ encroachment %:**0
SRZ Radius (m): 1.6 **SRZ intrusion:** No
Encroachment Level: None **Outcome:** Retained
Comments: Juvenile specimen with kinked trunk

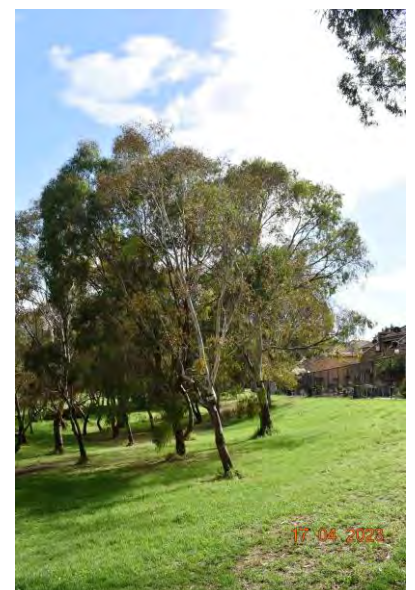
Tree ID 19

Encroachment Level: Major **Outcome:** Retained

Comments: Co-dominant near base and canopy

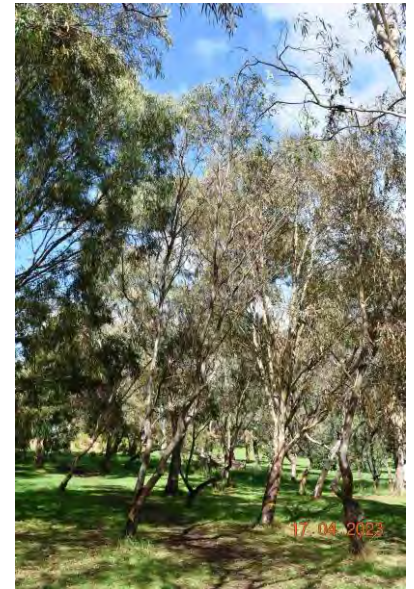
Tree ID 23

Encroachment Level: None **Outcome:** Retained

Comments: Minor health decline. Located 50cm from existing foot pad

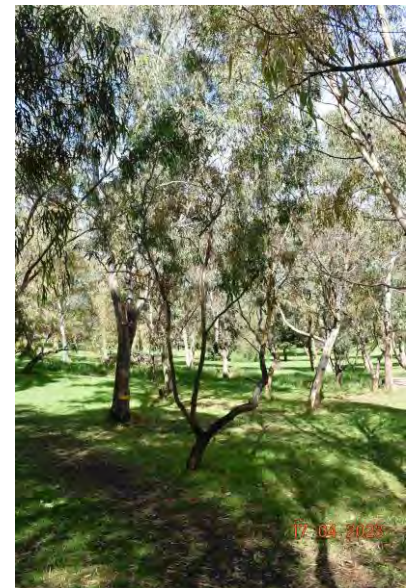
Tree ID 24

Encroachment Level: None **Outcome:** Retained

Comments: Minor health decline. Located 70cm from existing foot pad

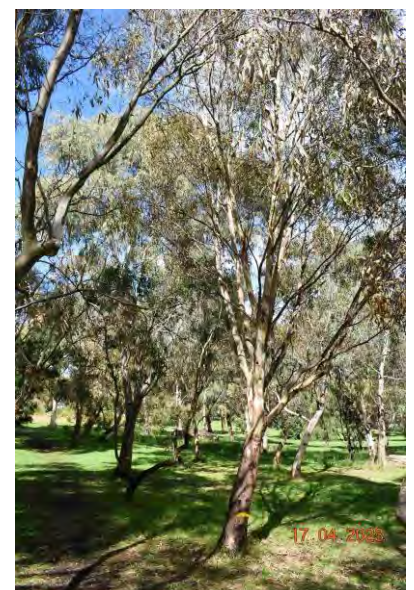
Tree ID 25

Encroachment Level: None **Outcome:** Retained

Comments: Minor health decline. Located 50cm from existing foot pad

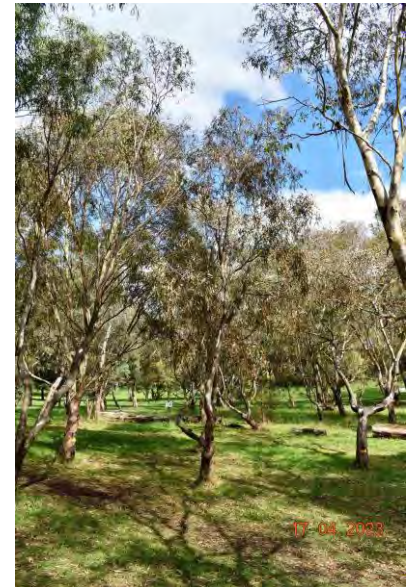
Tree ID 26

Encroachment Level: None **Outcome:** Retained

Comments: Minor health decline

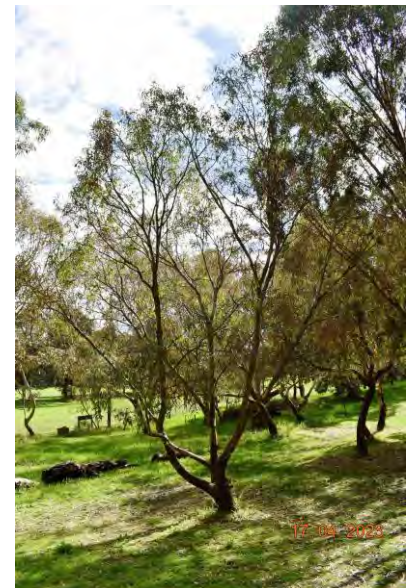
Tree ID 30

Comments: Declining health and average structure

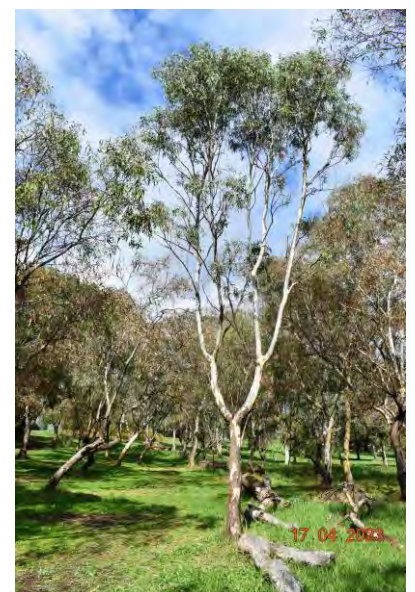
Tree ID 31

Comments: Edge of unkempt area

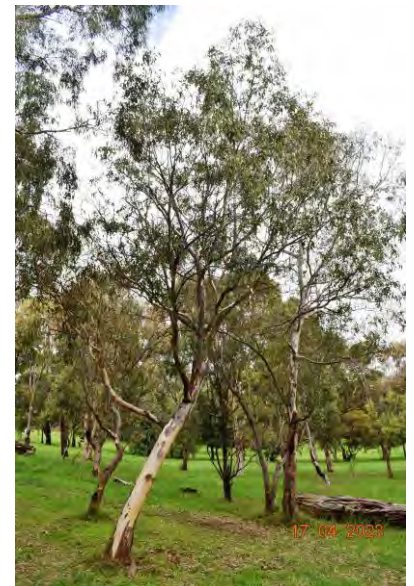
Tree ID 36

Comments: Moderate trunk lean over path

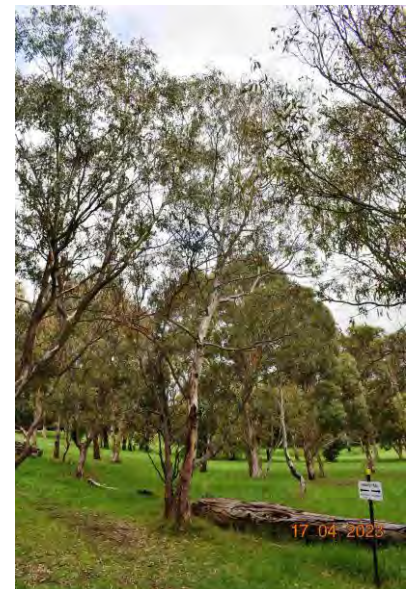
Tree ID 38

Comments: Located 40cm from path

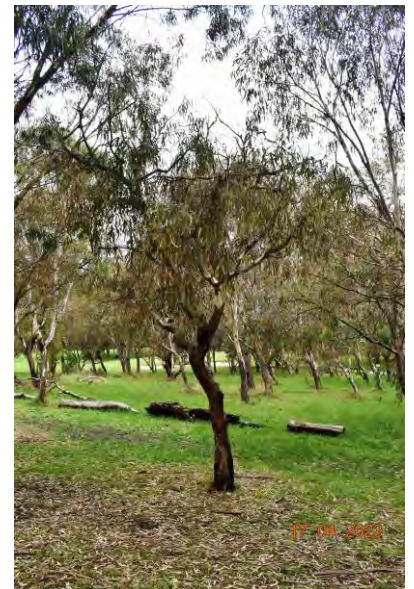
Tree ID 41

Comments: Stunted growth and poor form

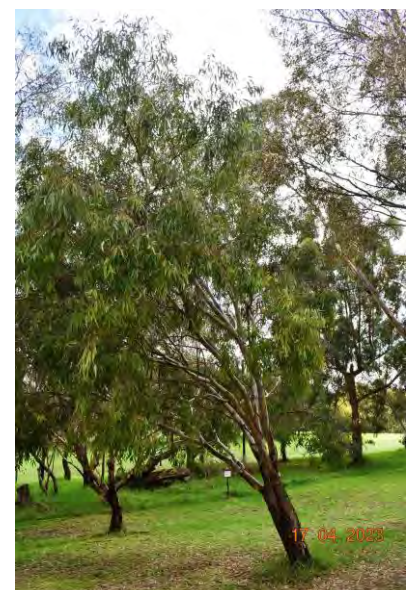
Tree ID 46

Comments: ~30cm from foot pad

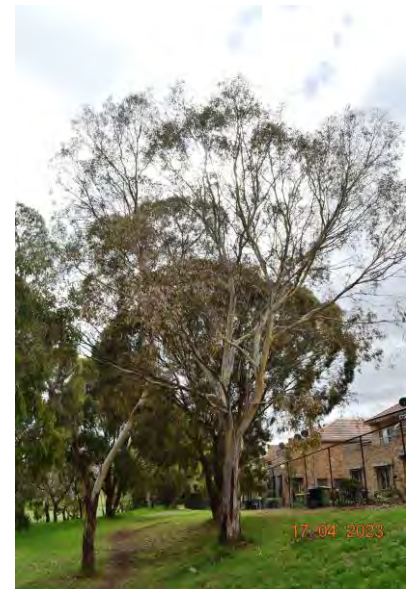
Tree ID 47

Comments: Declining health

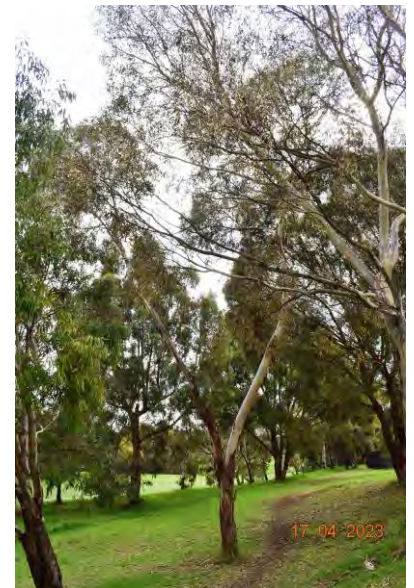
Tree ID 48

Comments: Co-dominant at 2m with extended limbs

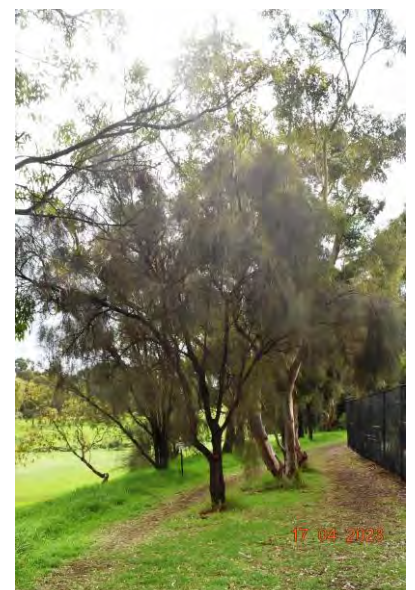
Tree ID 55

Comments: Trunk co-dominant

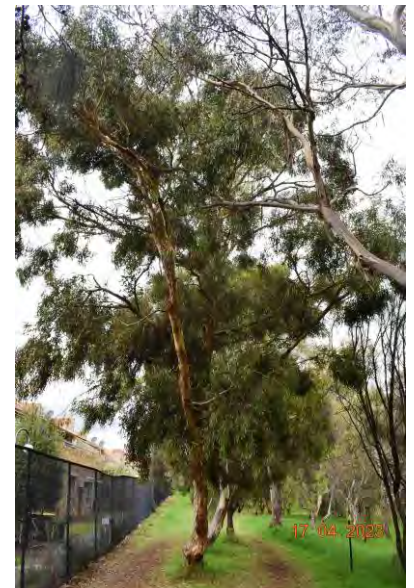
Tree ID 57

Comments: Co-dominant near base

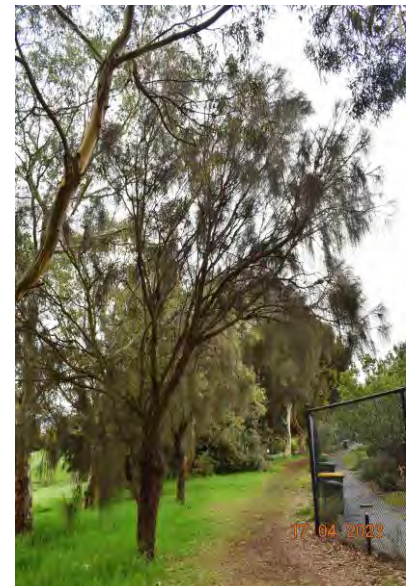
Tree ID 60

Comments: Edge of path

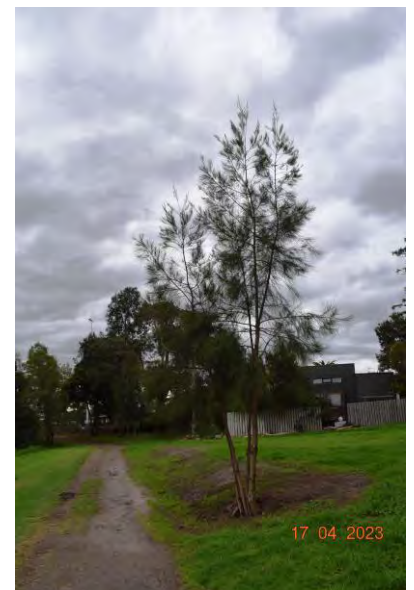
Tree ID 70

Comments: Regrowth from stump

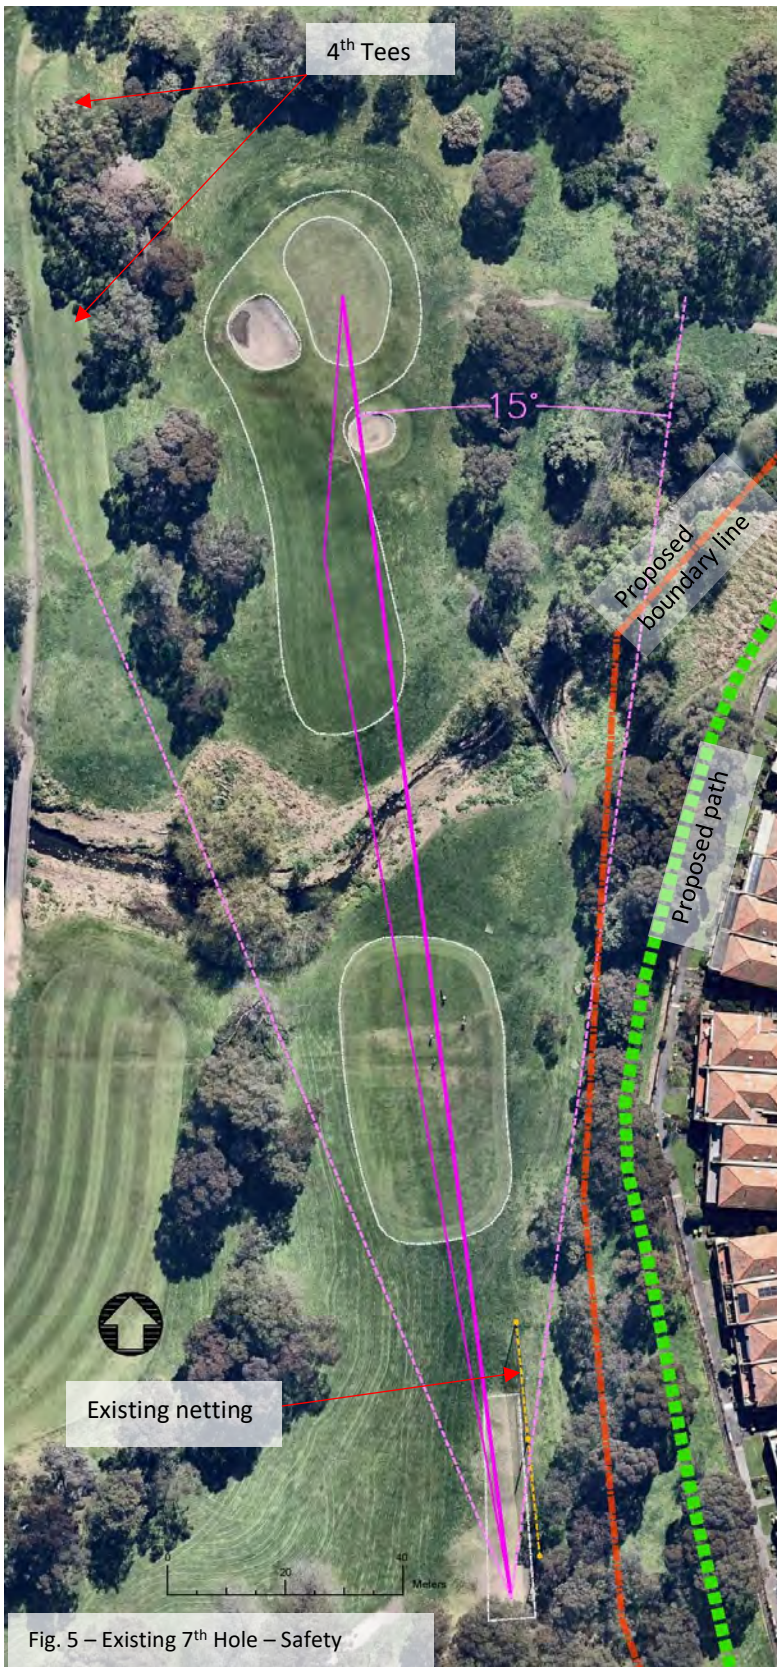
Fig. 5 – Existing 7th Hole – Safety

There is some existing netting to the right of the tees. This extends for 40m and is 10m high. The netting is positioned very close to the right side of the tee and appears to be in good condition.

As can be seen from the illustration to the right (Fig. 5), the eastern boundary line and residential properties sit outside the 15 degree 'zone of play' and could be regarded as being 'as safe as reasonably practical'. The addition of the netting supplements this and affords an extra 'layer' of protection. The probability of a golf ball impacting on a neighbouring property is felt to be negligible.

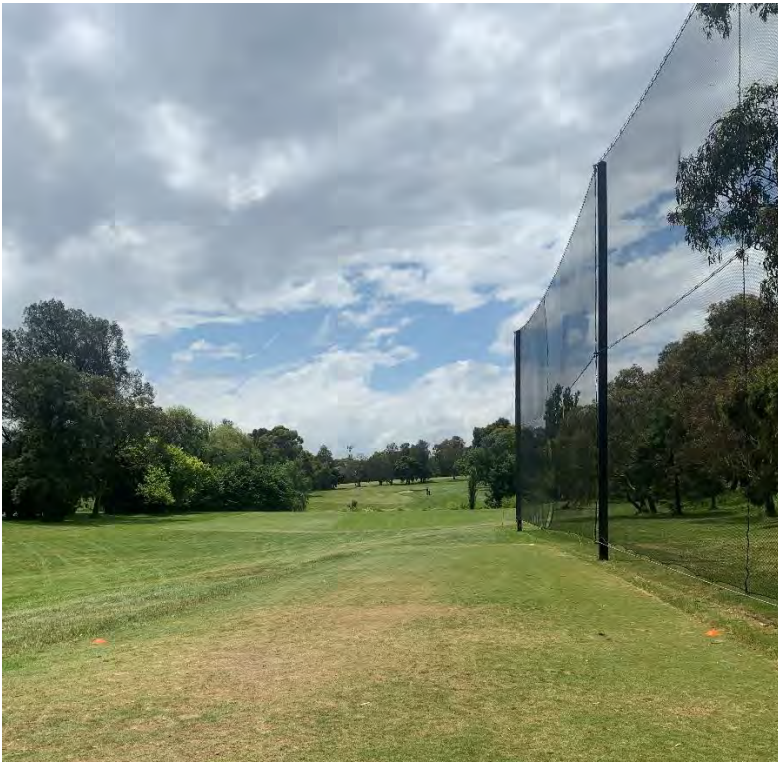
Figure 6 (below) – 7th tee with ‘ball-stop’ netting to right

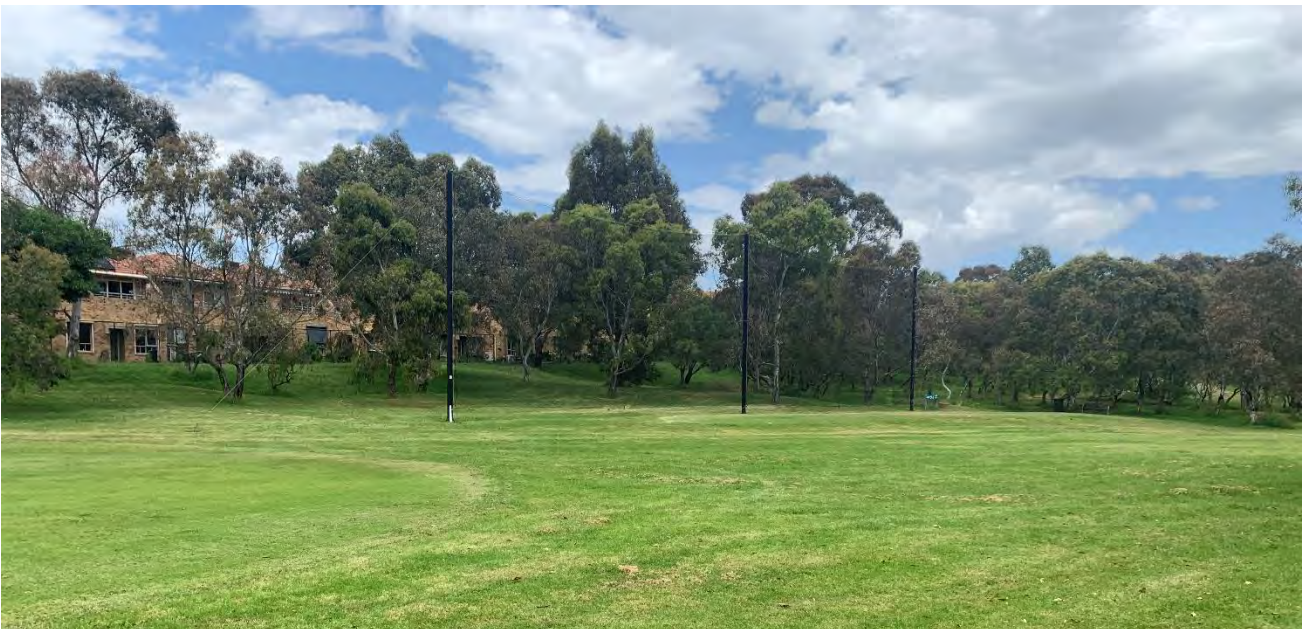
Figure 7 (below) – looking back towards 7th tee illustrating height of ‘ball-stop’ netting
