Tree Assessment
for
Darebin City Council

Assessment of Trees for VPO Update in Mount Cooper
Estate, Bundoora.

3 December 2009

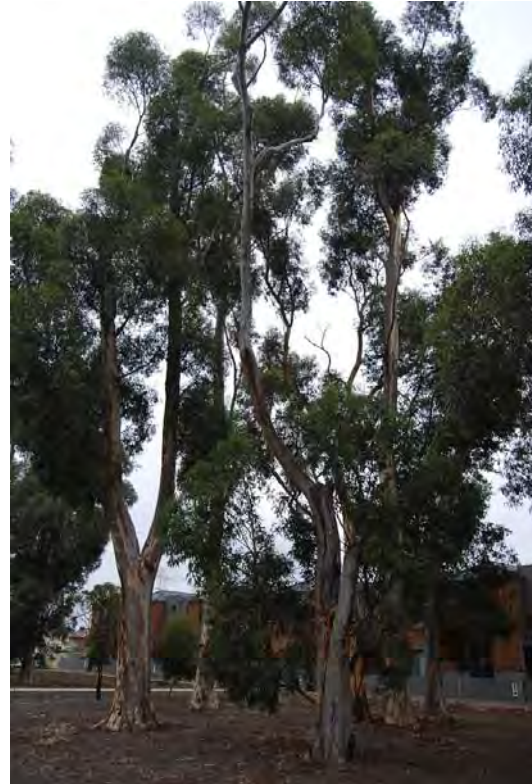
Figure 10. Sugars Gums along Mt Cooper Drive

In the case of the Council owned trees at Mt Cooper Estate, those of highest concern are the River Red Gums (*Eucalyptus camaldulensis*, See Figure 9) near the south end of Snake Gully Drive and the original homestead and the Sugar Gums (*Eucalyptus cladocalyx*, See Figure 10) located along Mt Cooper Drive. If left unattended, these trees will fail in the future, with potentially catastrophic circumstances.

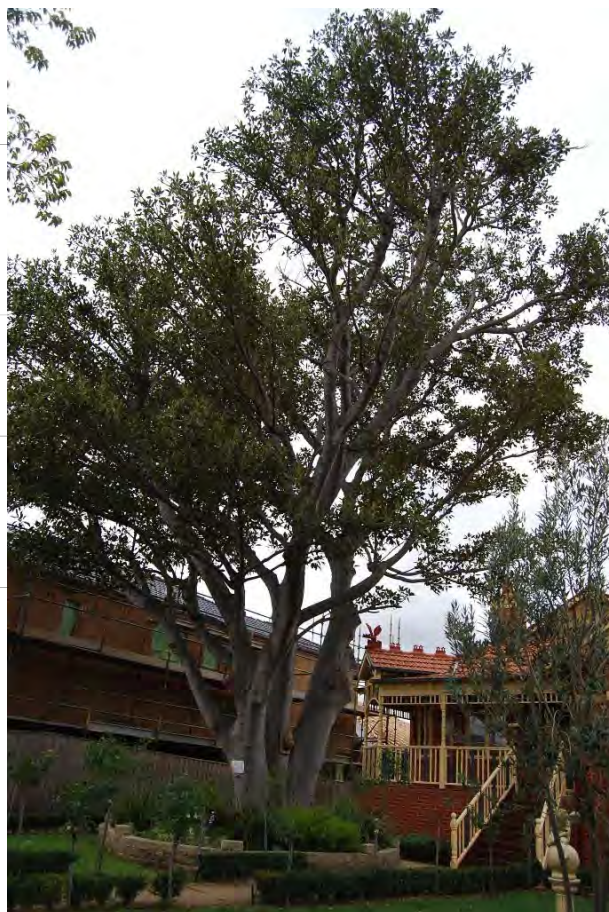
Tree Number: 14

Location: Rear of property
Address 5 LURLINE STREET

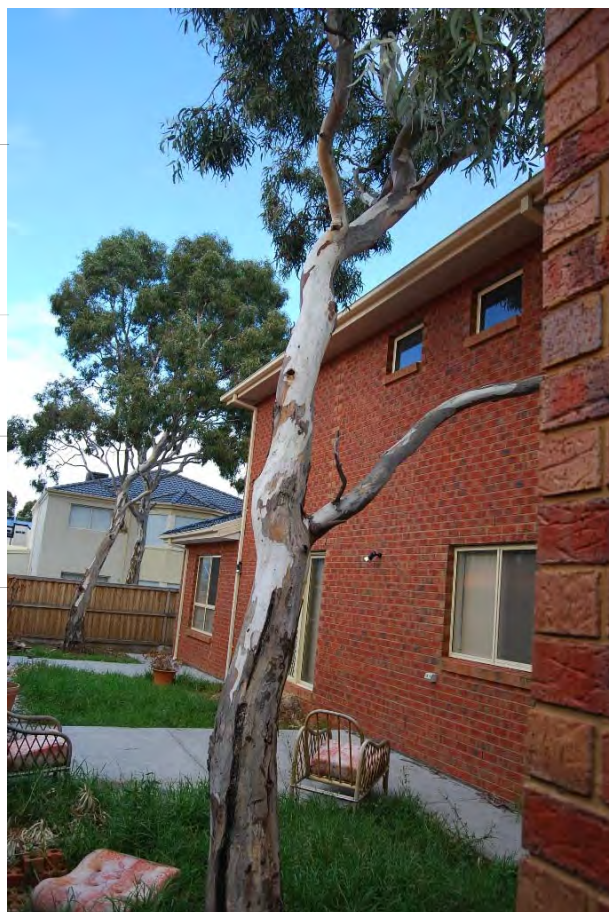
Tree Number: 17

Location: Front yard of property
Address: 6 LURLINE STREET

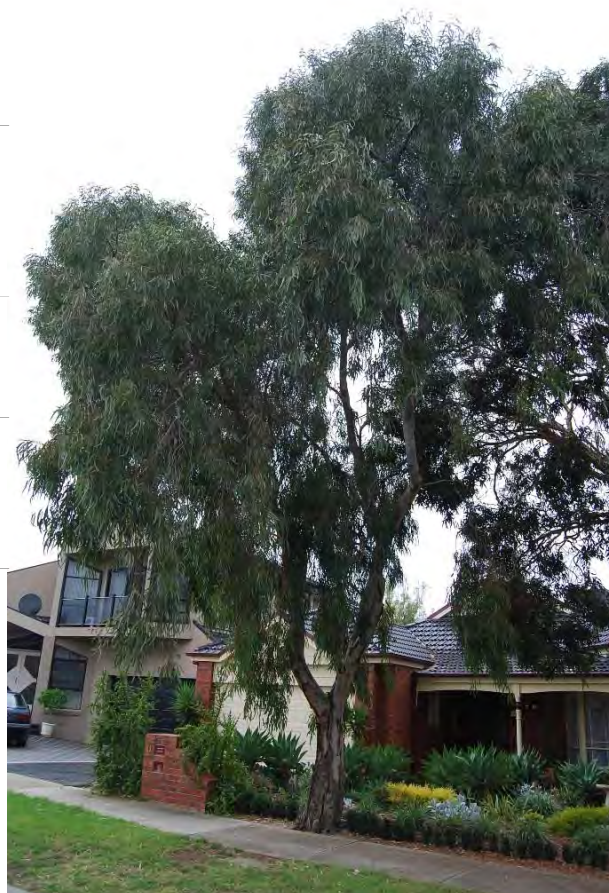
Tree Number: 18

Location: Rear of property
Address: 13 BOADLE ROAD

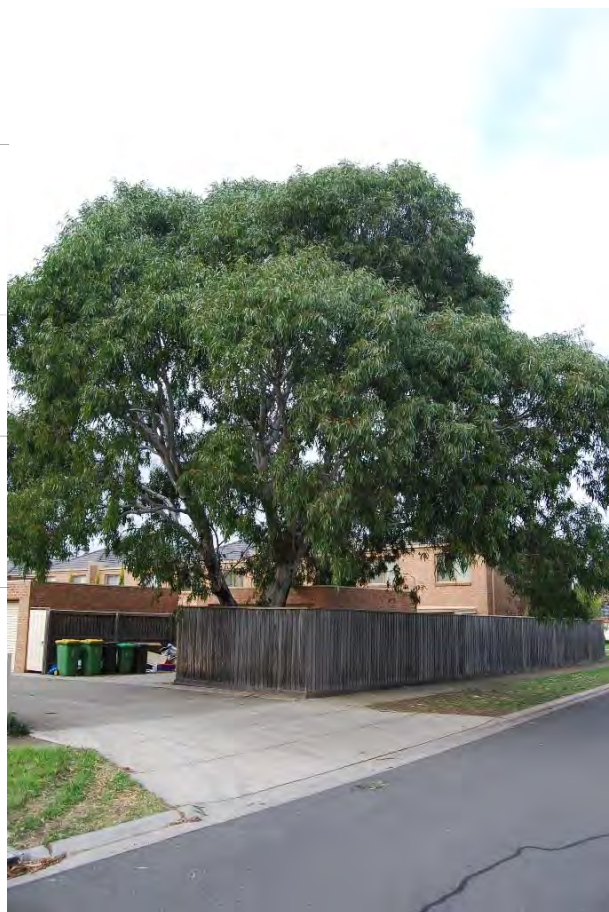
Tree Number: 19

Location: Council land
Address: 1 LURLINE STREET

Risk Category: Moderate

Comments: Remove fill at base

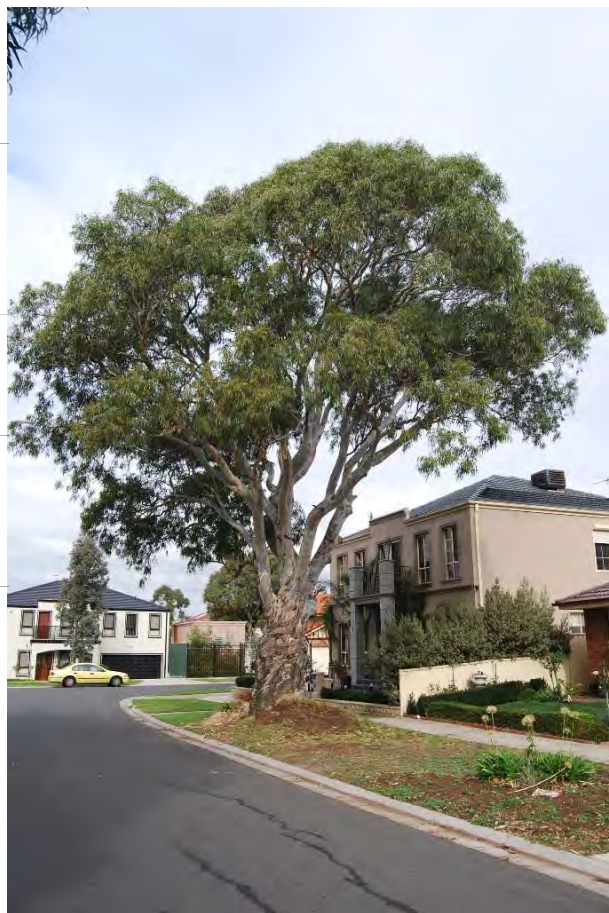
Tree Number: 20

Location: Front yard of property
Address BOADLE ROAD

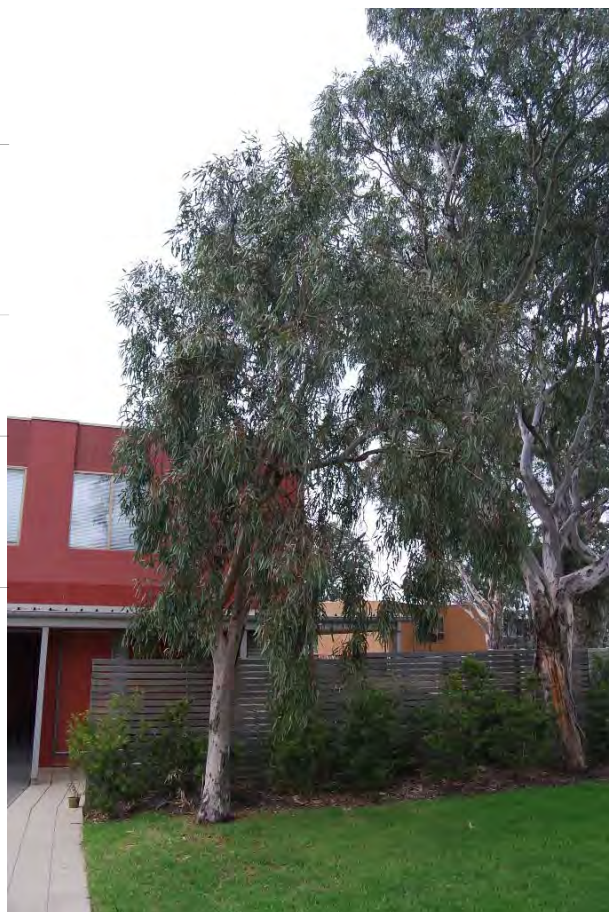
Tree Number: 21

Location: Front yard of property
Address BOADLE ROAD

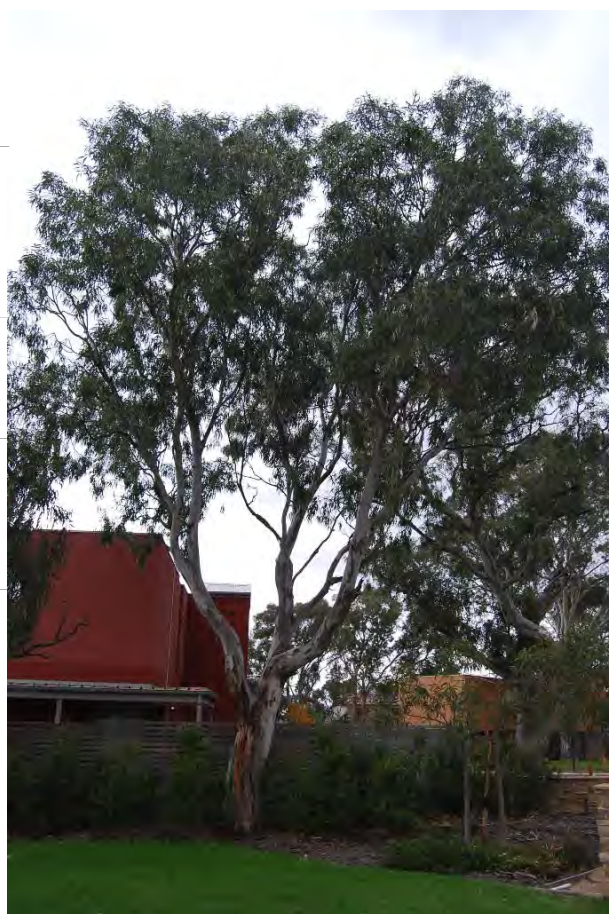
Tree Number: 23

Location: Front yard of property
Address BOADLE ROAD

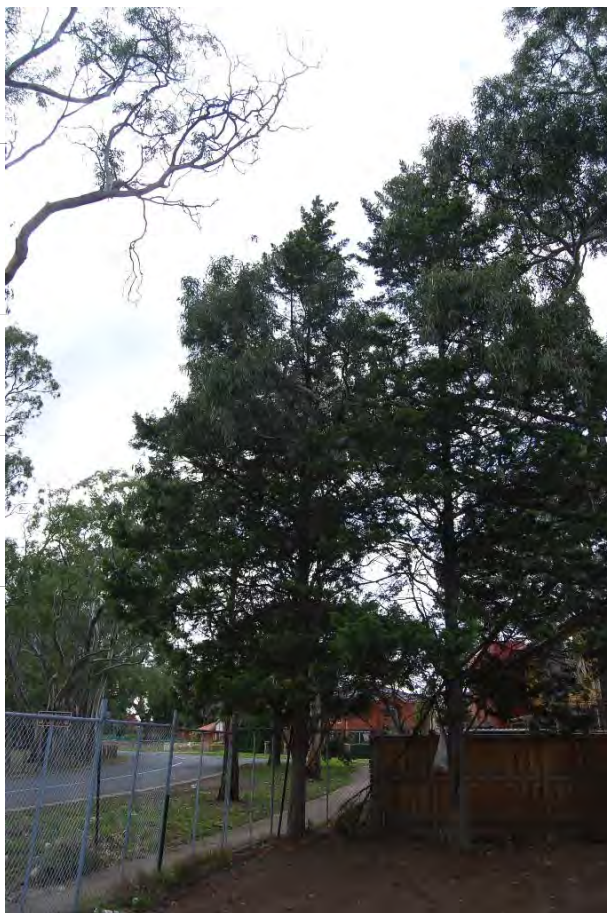
Tree Number: 29

Risk Category: Moderate

Comments Mulch

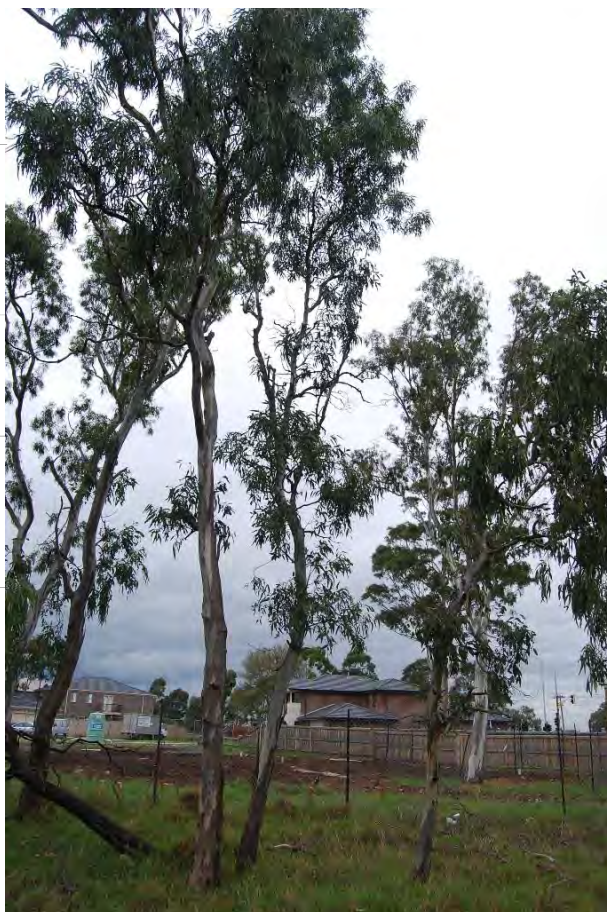
Tree Number: 35

Risk Category: High

Comments Heavy phototropic lean

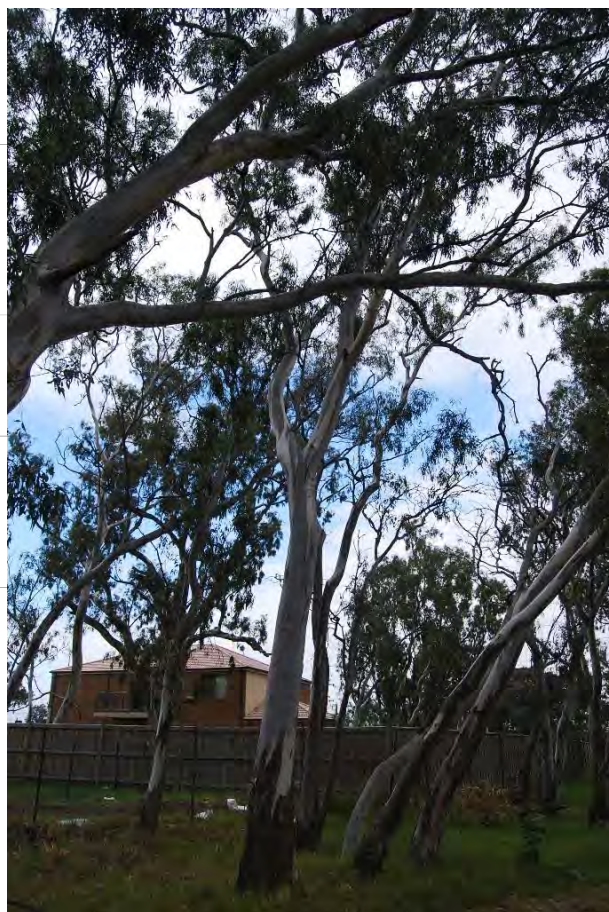
Tree Number: 41

Risk Category: Moderate

Comments Exclude

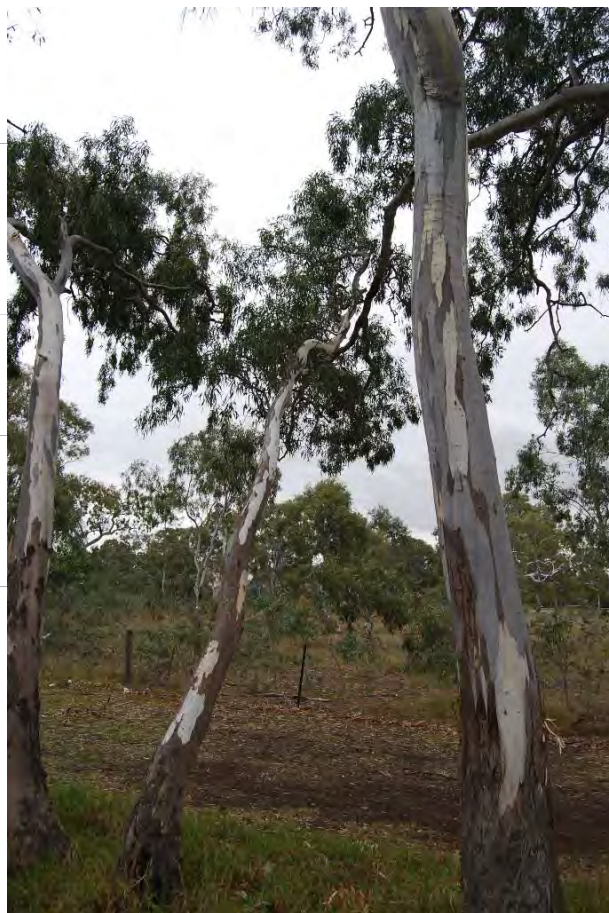
Tree Number: 42

Risk Category: Moderate

Comments: Exclude

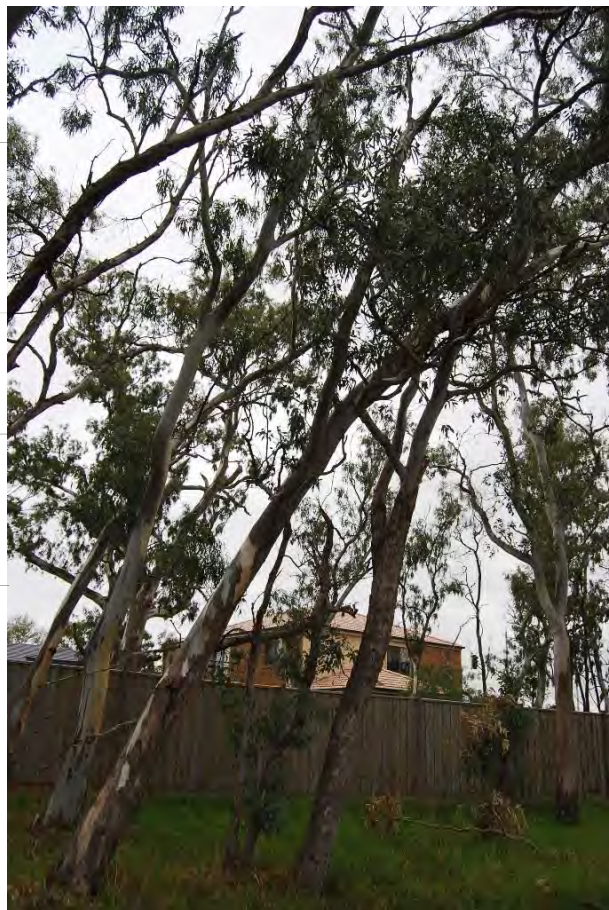
Tree Number: 58

Risk Category: Moderate

Comments Mulch

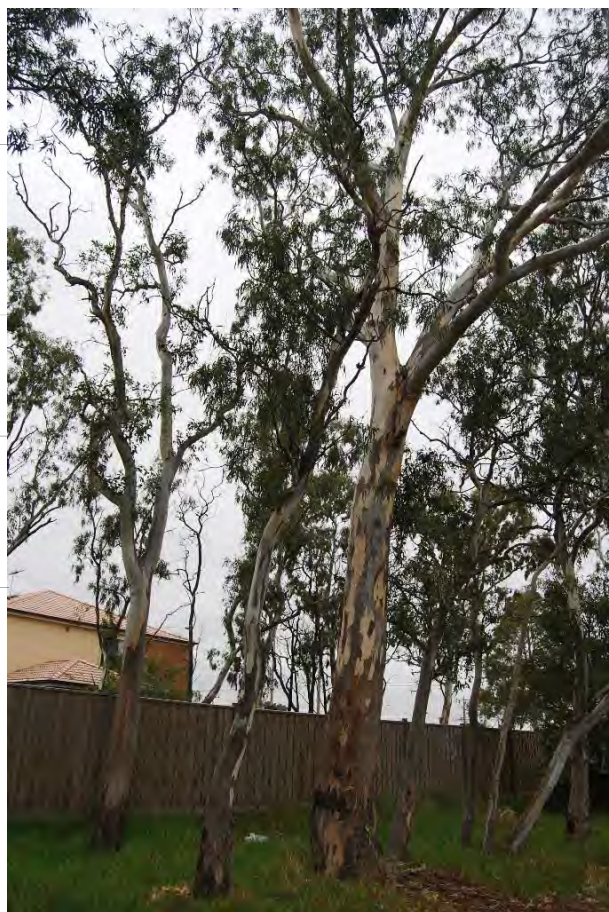
Tree Number: 60

Risk Category: Moderate

Comments Weight reduce southern and eastern stem

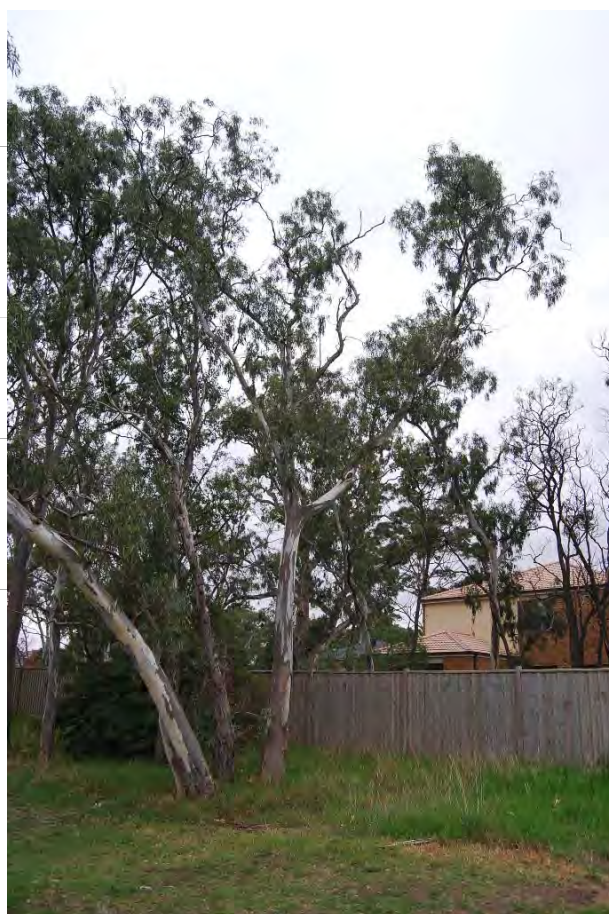
Tree Number: 67

Risk Category: Very high

Comments Exclude

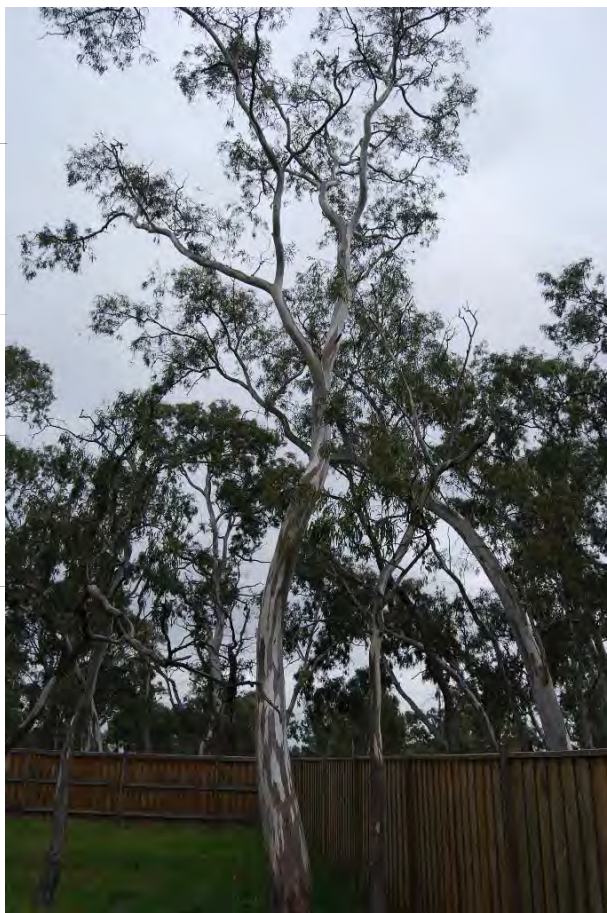
Tree Number: 71

Risk Category: Moderate

Comments Heavy lean

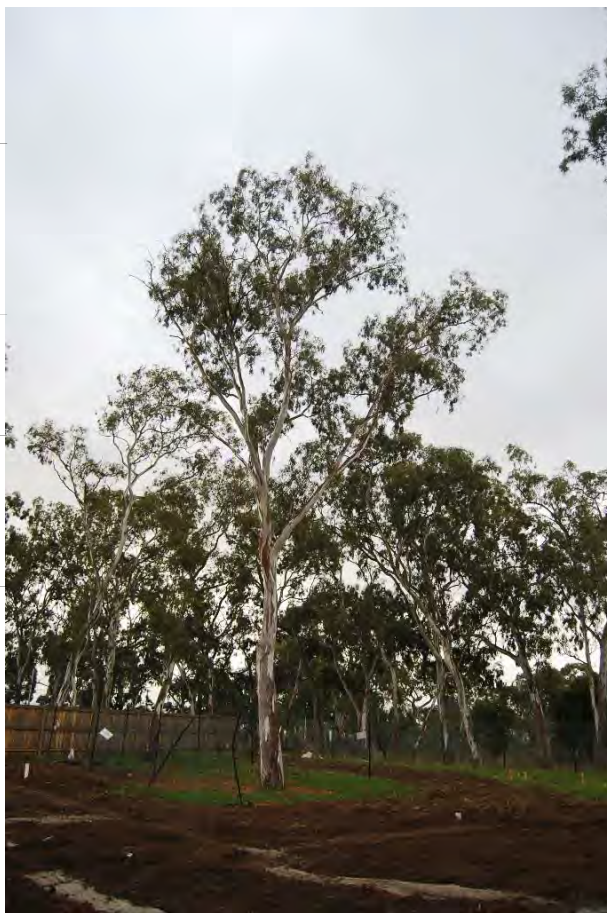
Tree Number: 78

Risk Category: Moderate

Comments Inspect wound in upper canopy.

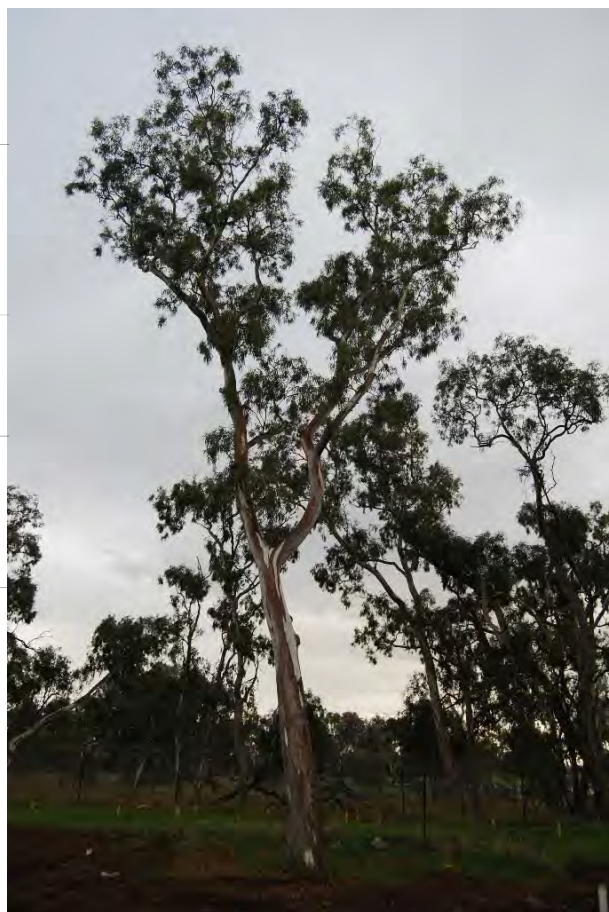
Tree Number: 79

Risk Category: Low

Comments Mulch

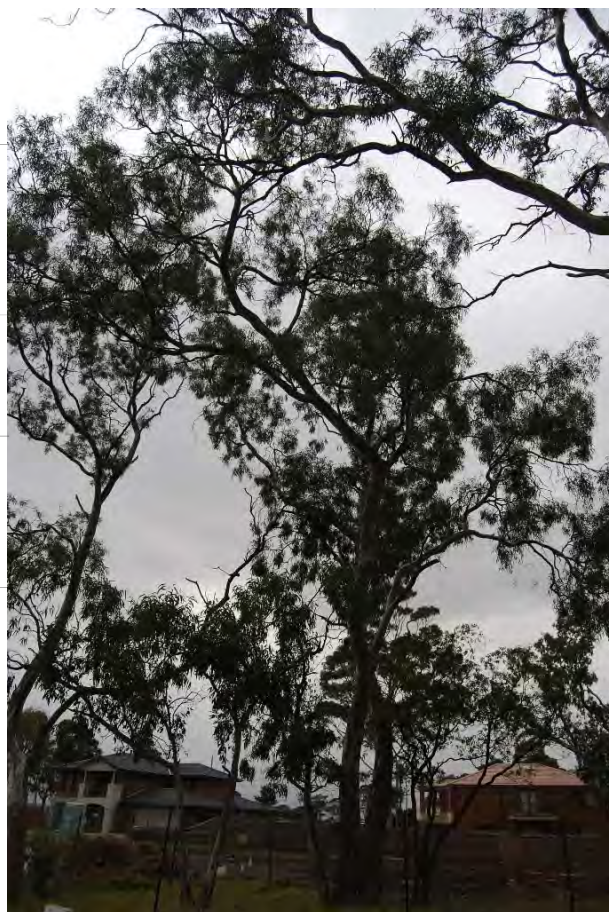
Tree Number: 81

Risk Category: Moderate

Comments Mulch

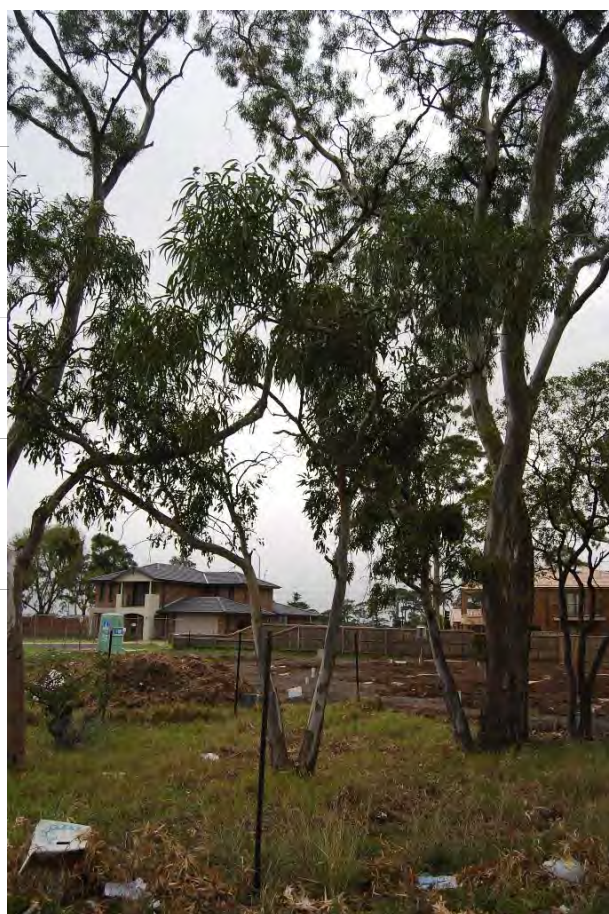
Tree Number: 82

Risk Category: High

Comments Mulch

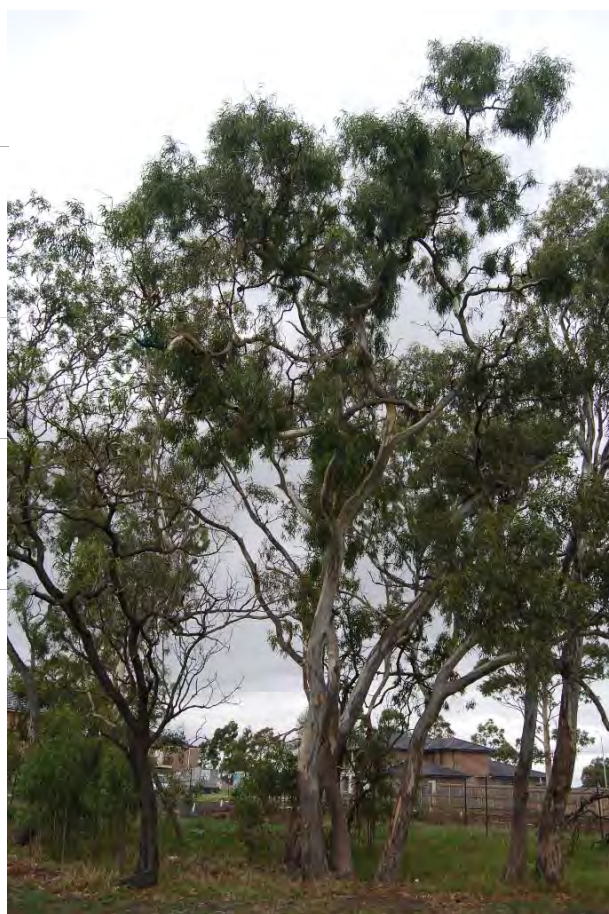
Tree Number: 90

Works: Deadwood removal
Risk of Harm: 1 in 860,000
Risk Category: Low
Comments Large hanging branch

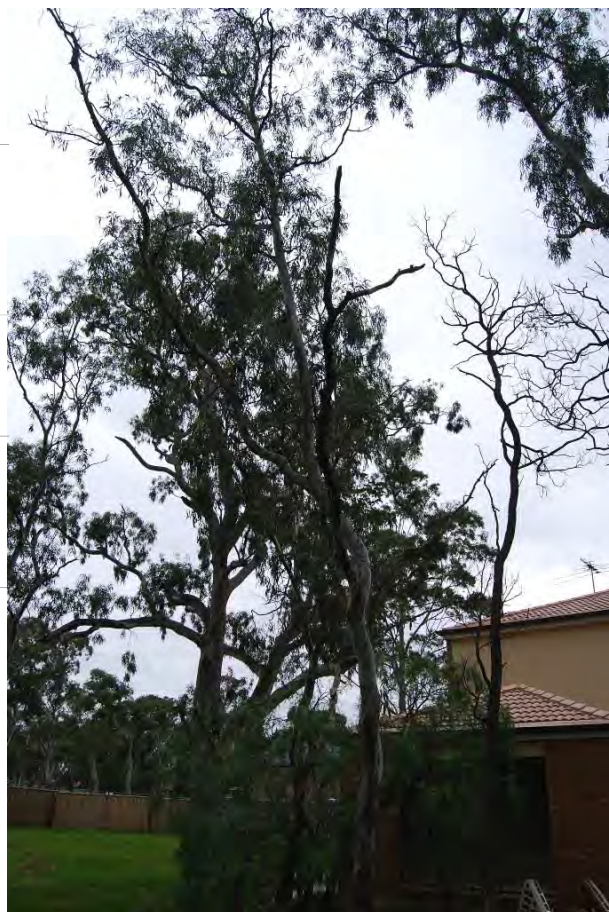
Tree Number: 109

Comments Mulch, existing root and canopy damage

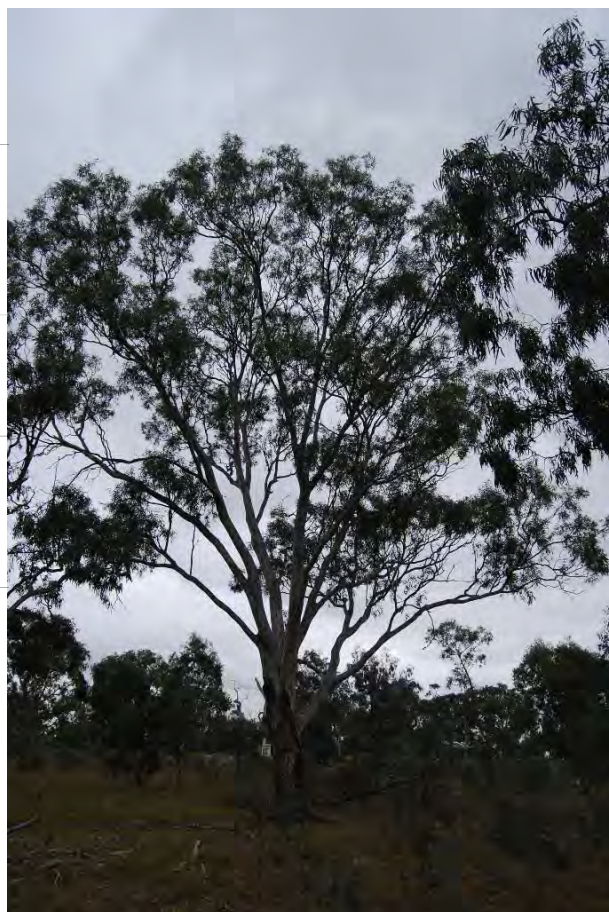
Tree Number: 133

Comments Basal decay

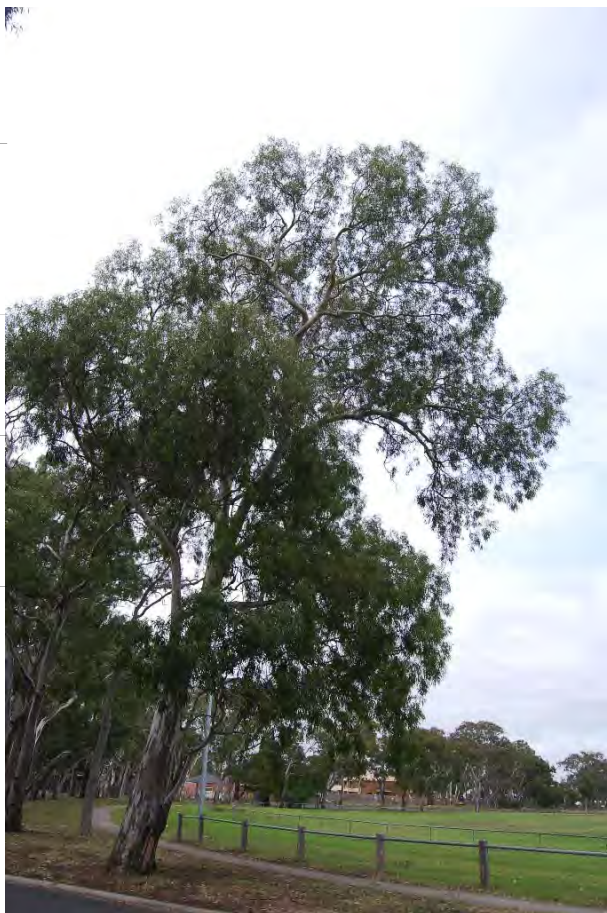
Tree Number: 151

Risk Category: High

Comments Small conk on trunk, monitor

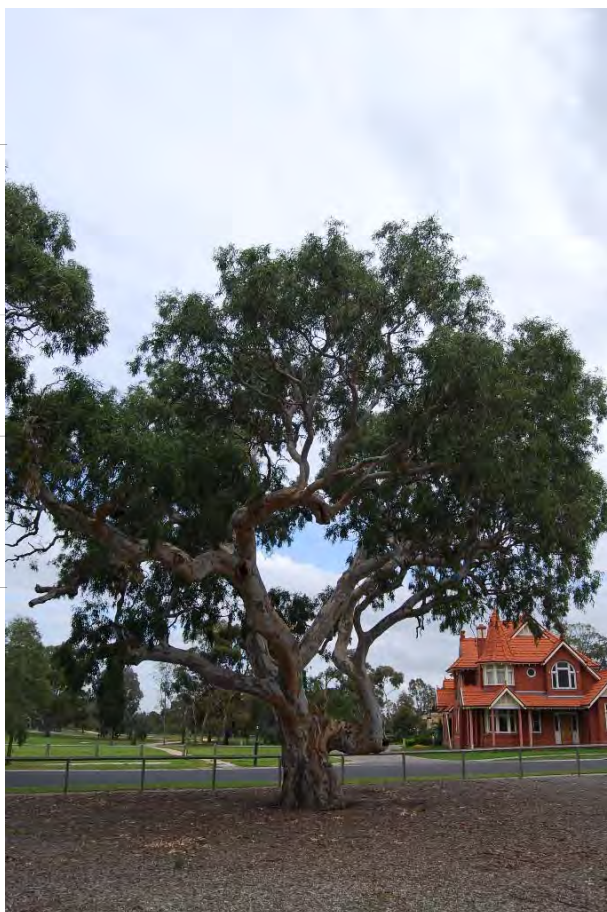
Tree Number: 157

Risk Category: Very high

Comments Habitat prune, bollard

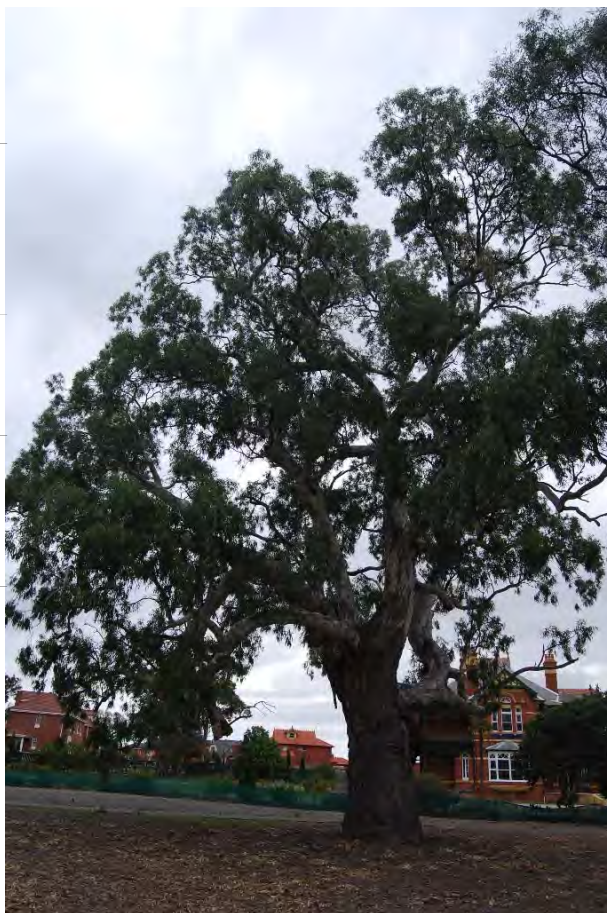
Tree Number: 158

Health: Good **Structure:** Hazardous **Form:** Good

Risk Category: High

Comments Bollard

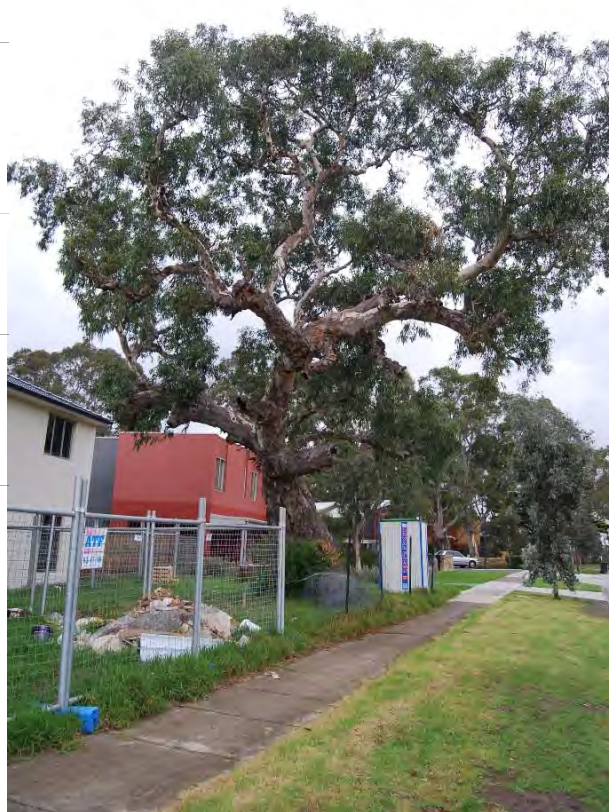
Tree Number: 163

Risk Category: Very high

Comments Maintain habitat stubs, exclude targets

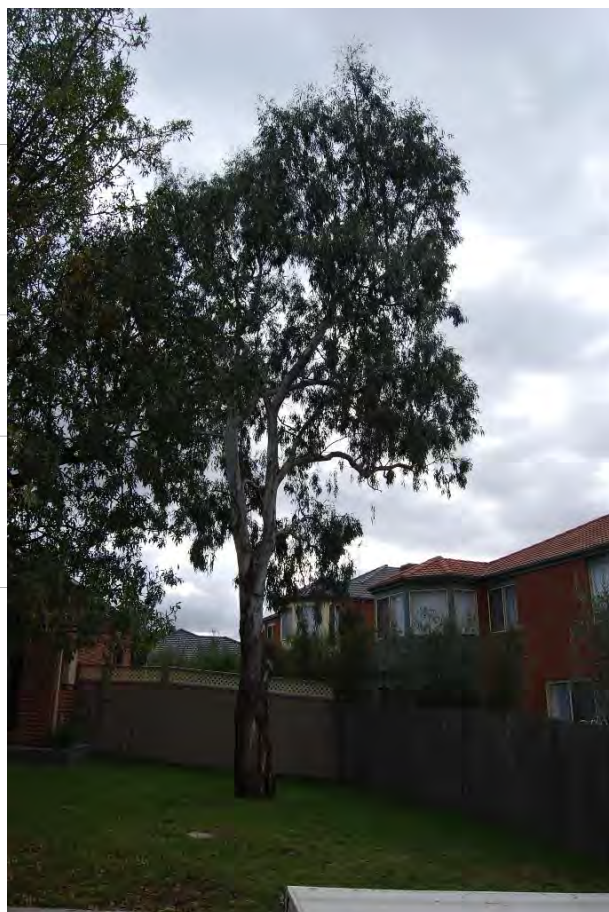
Tree Number: 164

Comments: Monitor wound on lower stem

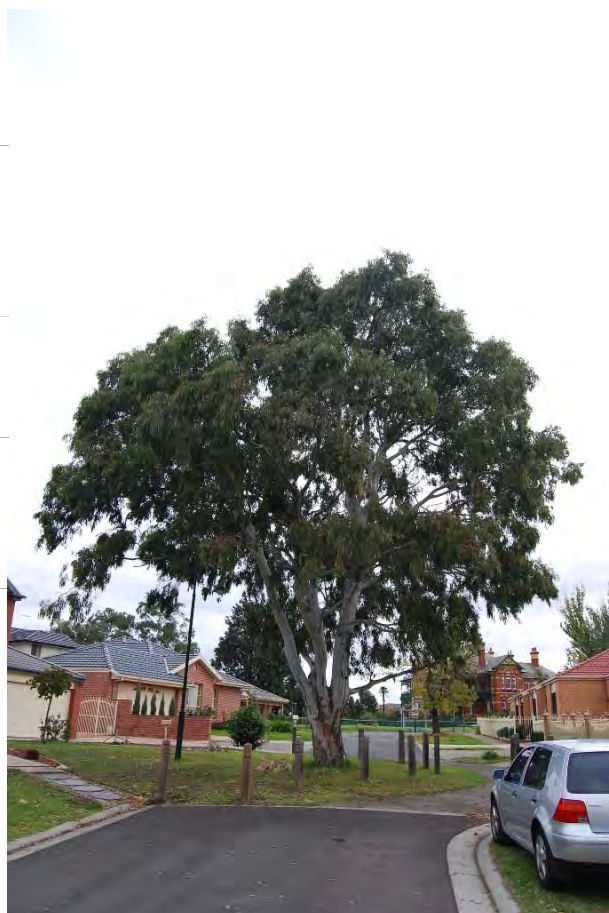
Tree Number: 165

Comments: Southern limbs

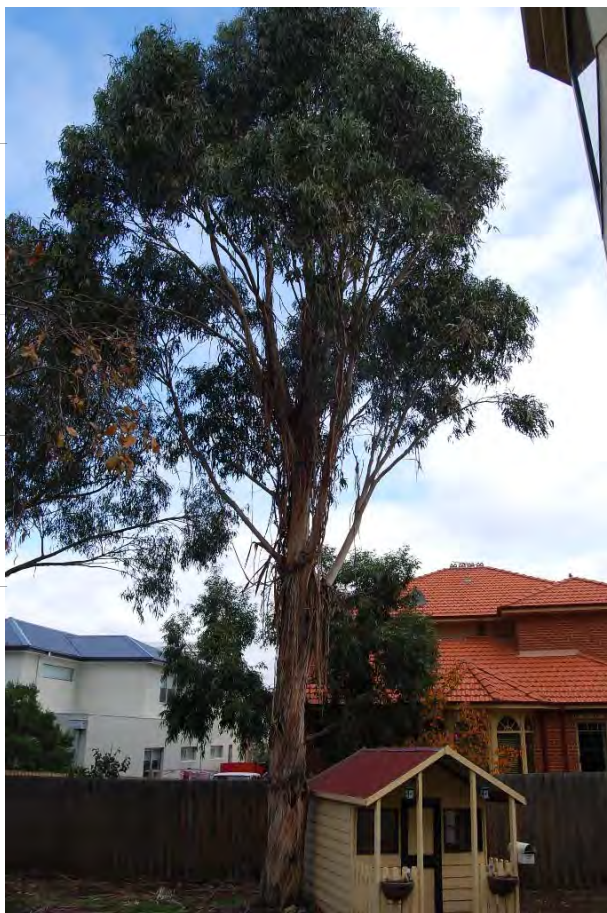
Tree Number: 193

Comments Minor trunk decay

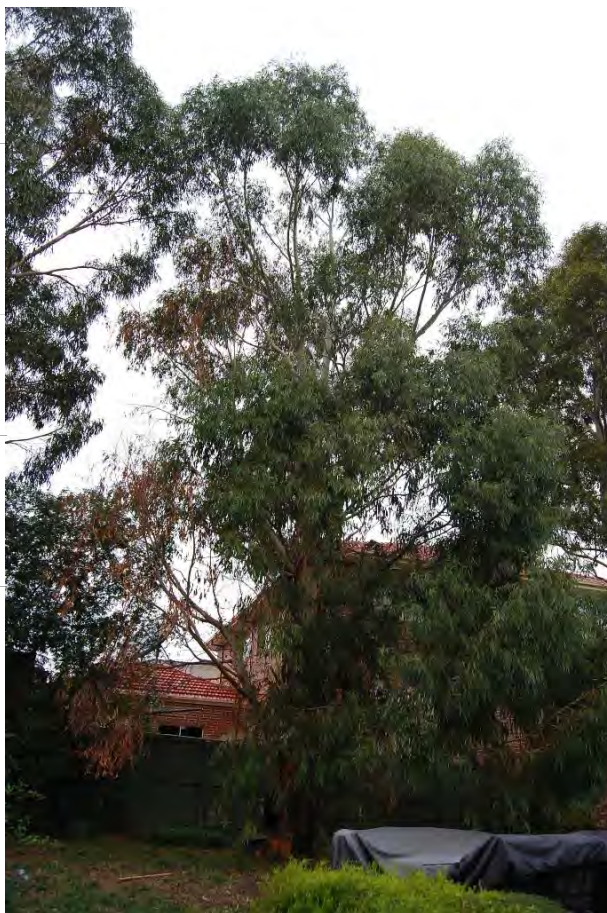
Tree Number: 199

Comments Some branch dieback

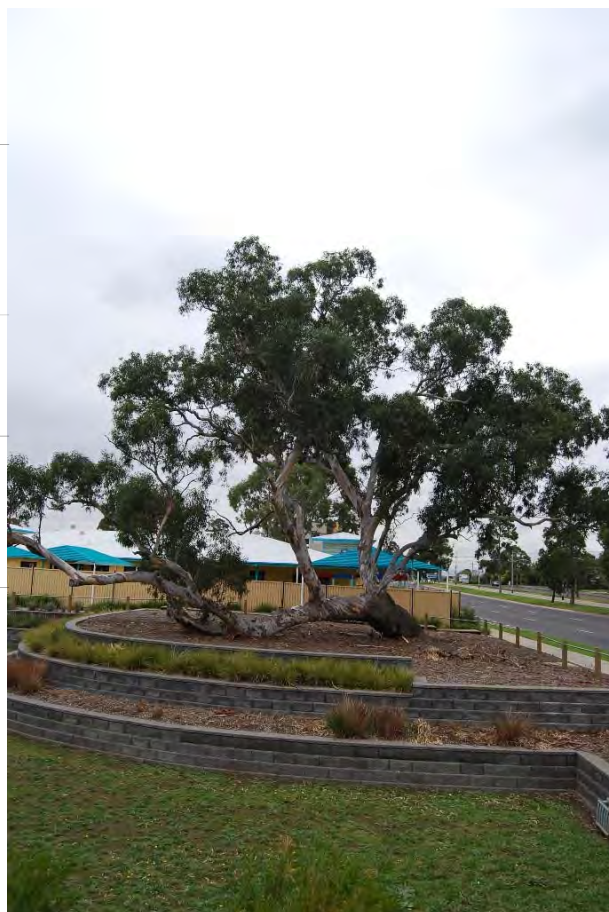
Tree Number: 223

Comments Reduce over footpath

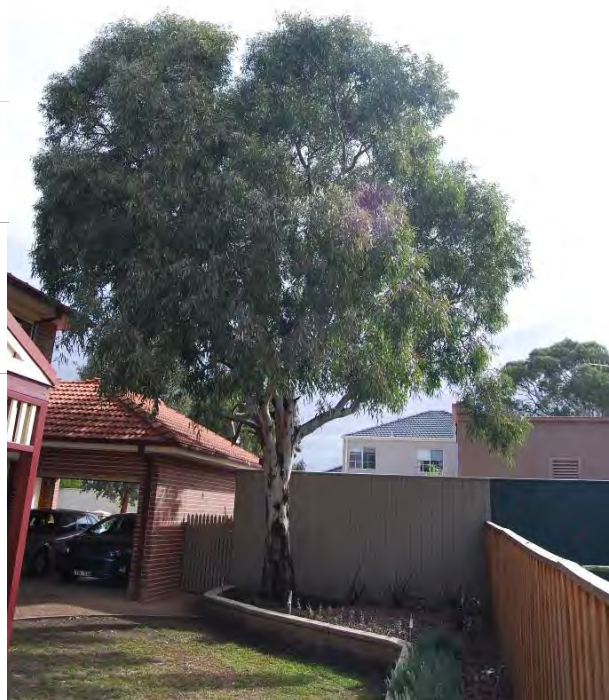
Tree Number: 230

Comments Mildly lopped

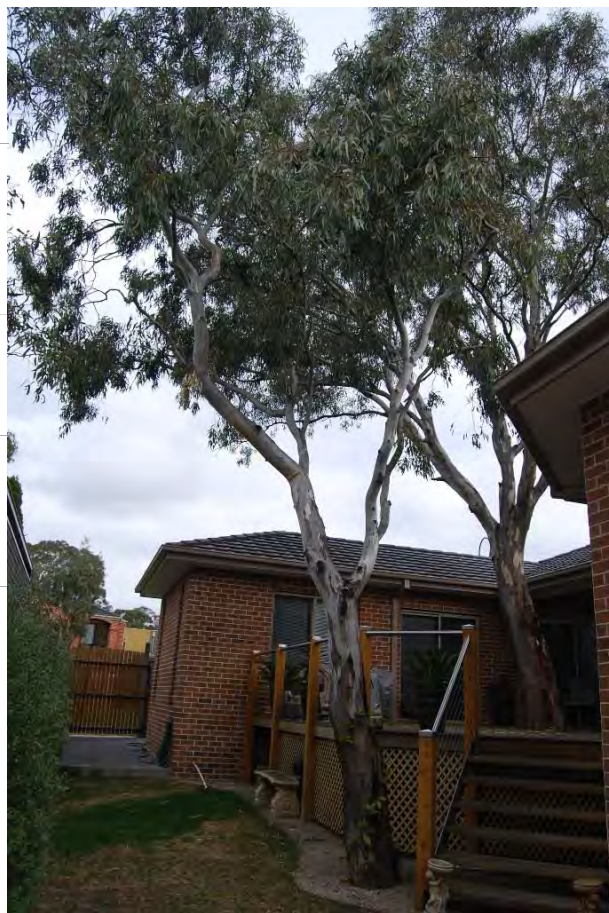
Tree Number: 282

Risk Category: Very high

Comments: Weight reduce southern stem over house

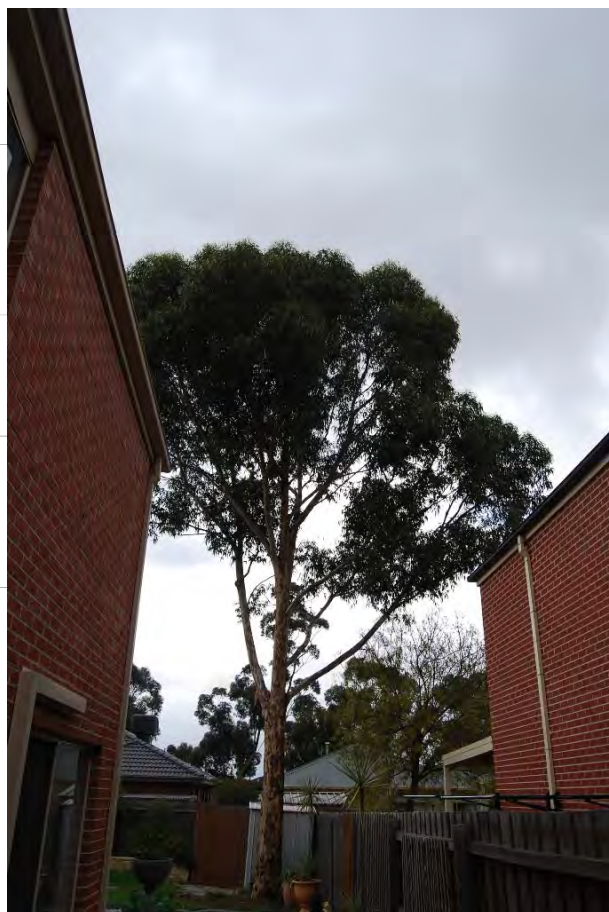
Tree Number: 289

Risk Category: Moderate

Comments Remove broken branches.

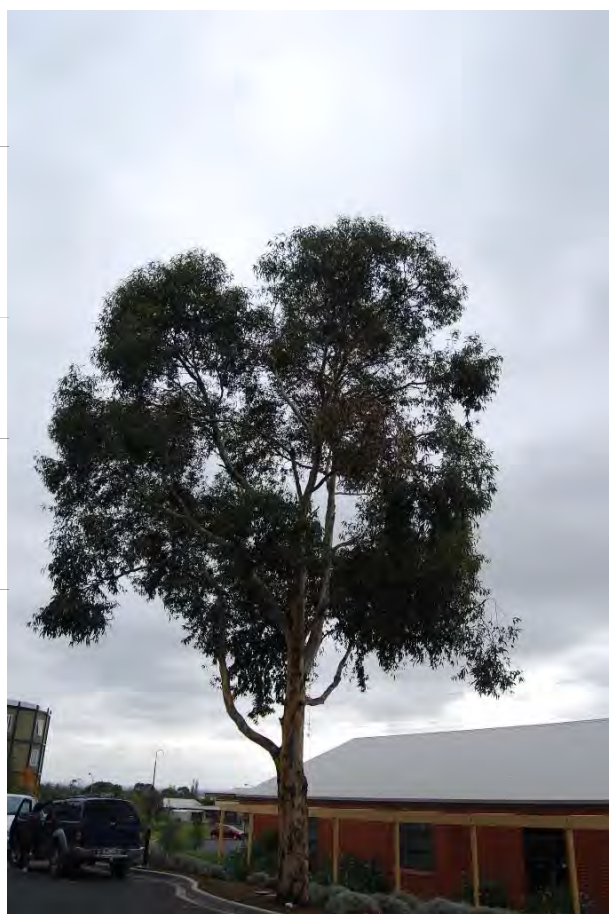
Tree Number: 290

Comments: Has been lopped

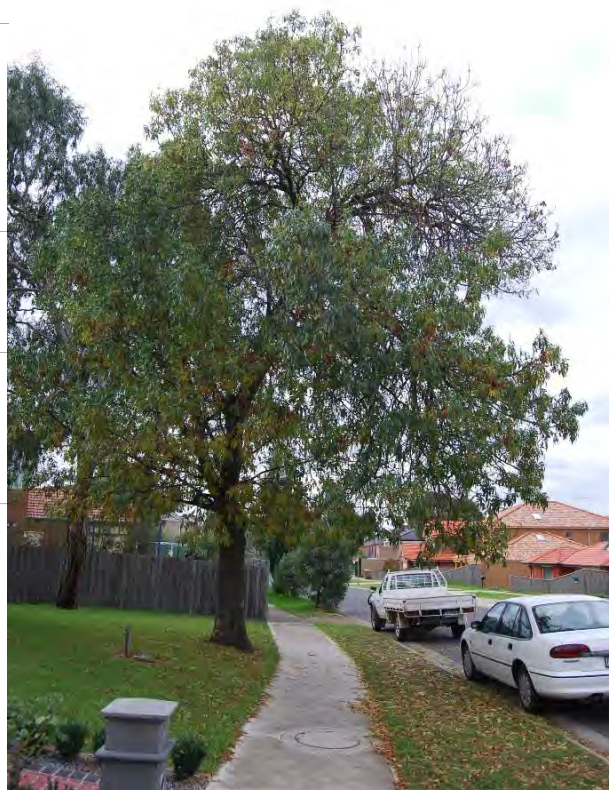
Tree Number: 321

Risk Category: Moderate

Comments Possibly some decay

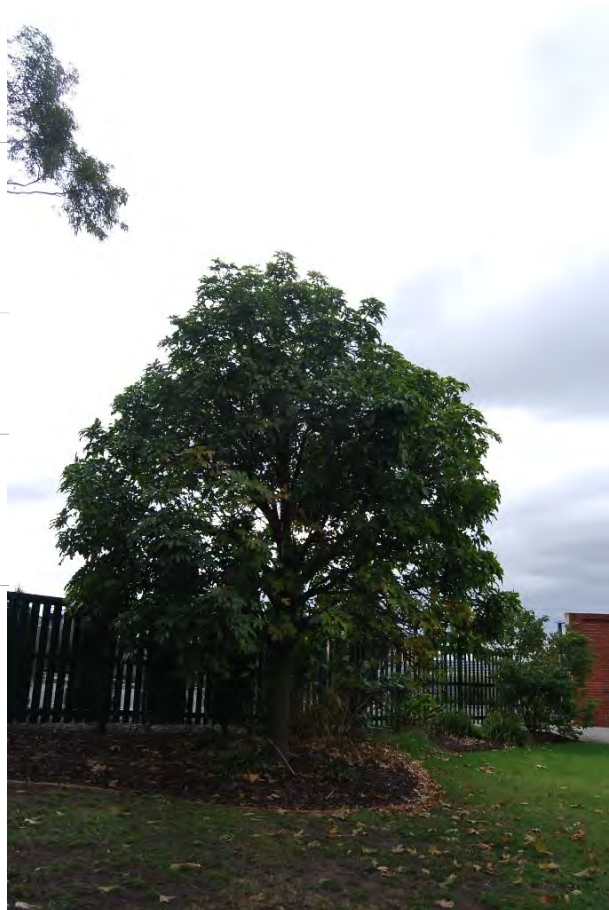
Tree Number: 328

Comments Possible root damage from recent pavement works

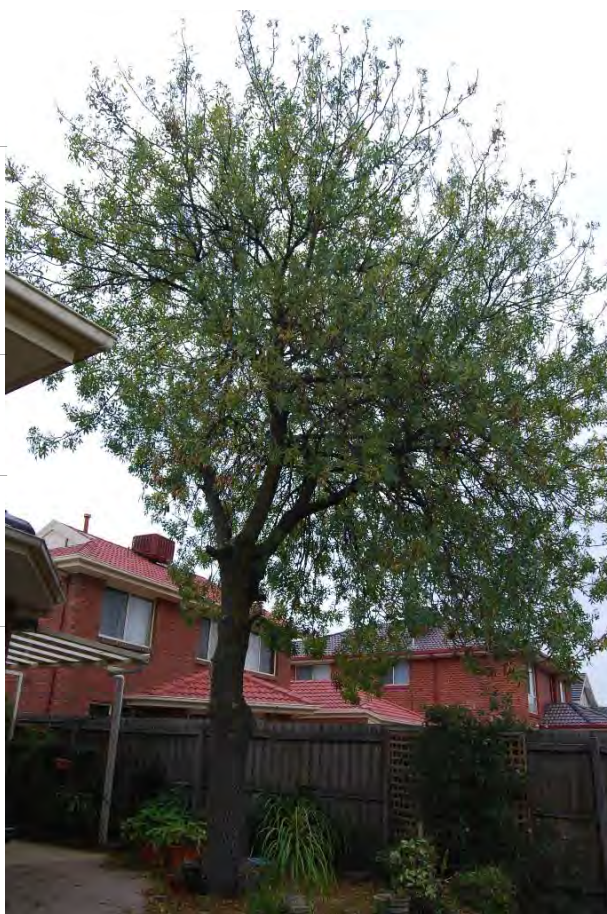
Tree Number: 347

Risk Category: Moderate

Comments Prune epicormics

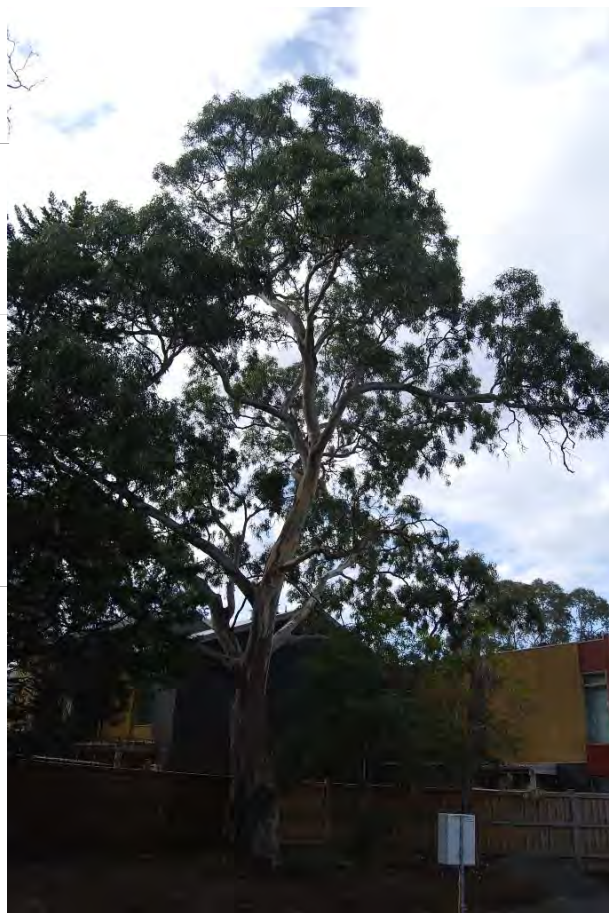
Tree Number: 390

Comments Broken branch

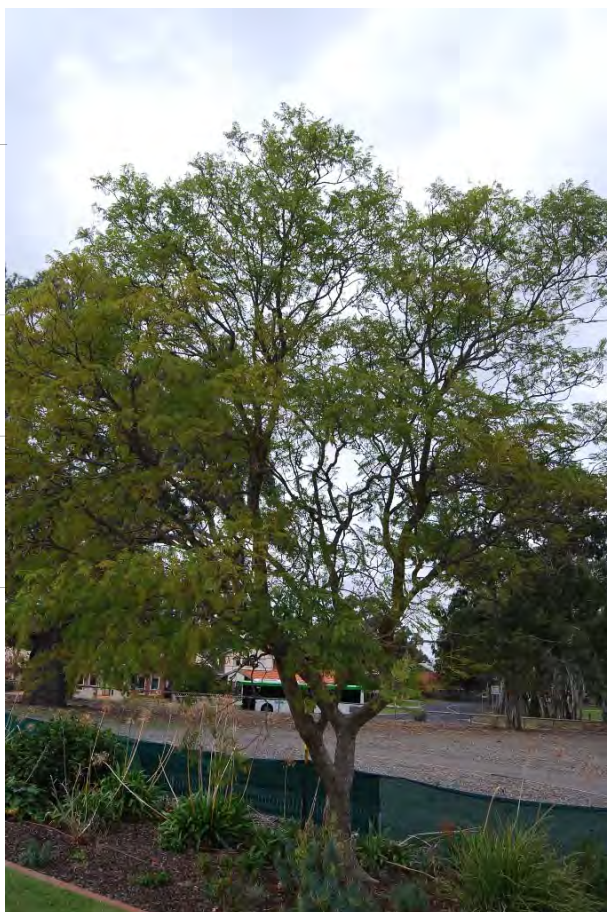
Tree Number: 395

Comments Multistemmed habit, inspect every 2-3 years
