Tree Assessment
for
Darebin City Council

Assessment of Trees for VPO Update in Mount Cooper
Estate, Bundoora.

3 December 2009

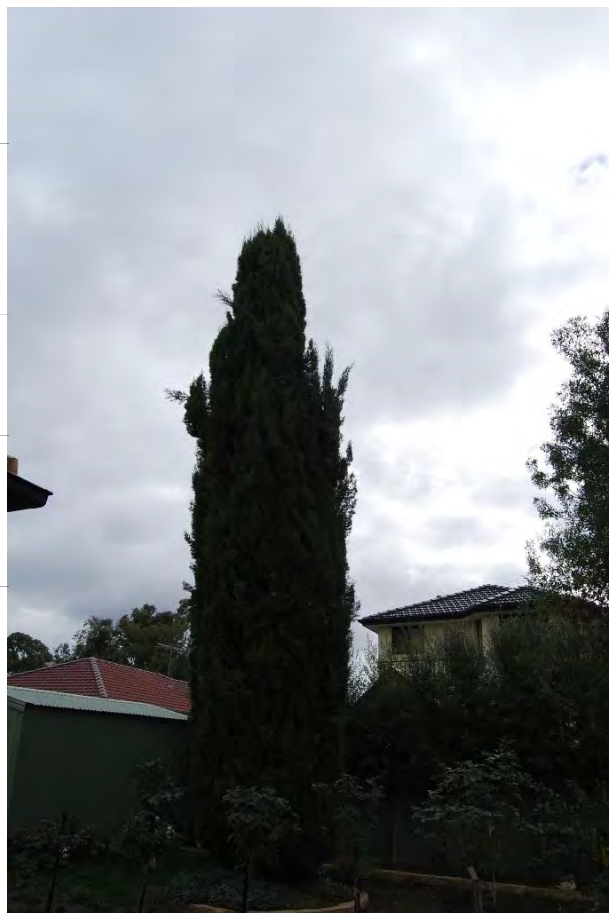
Tree Number: 410

Height: 20 - 25 **Width:** 17 - 20 **DBH (cm):** 80
Health: Fair **Structure:** Hazardous **Form:** Poor

Risk Category: Moderate

Comments Ringbark for habitat stump

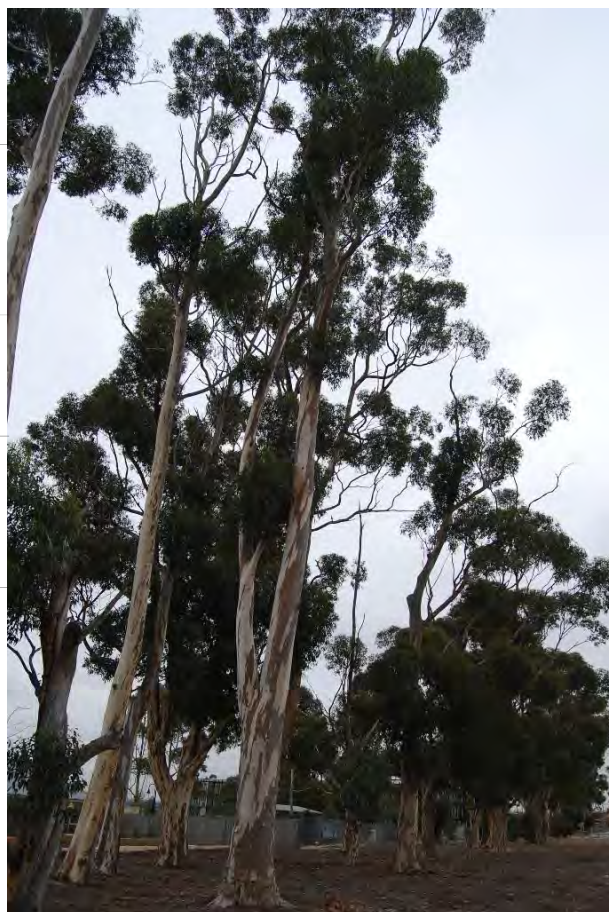
Tree Number: 420

Health: Fair **Structure:** Hazardous **Form:** Poor

Risk Category: Low

Comments Ringbark for habitat stump

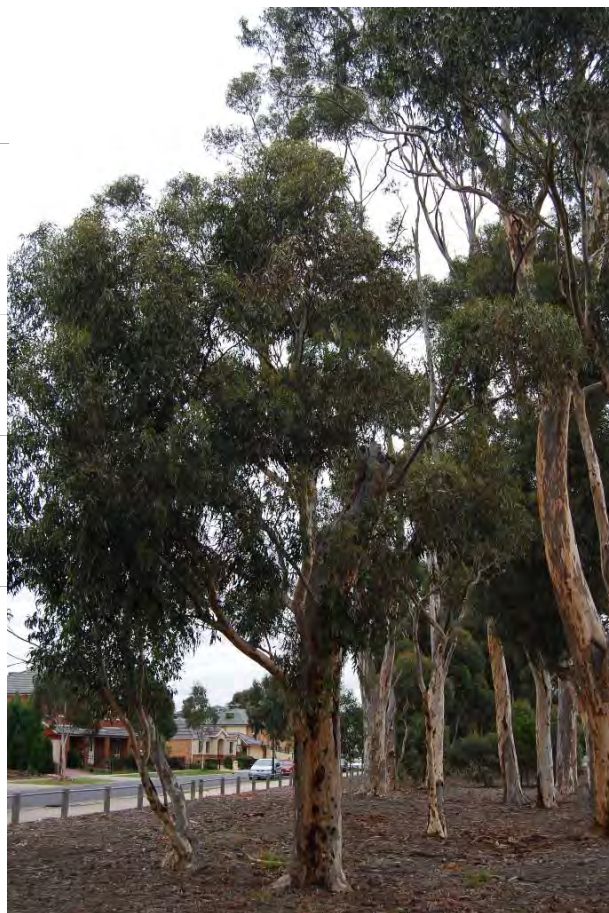
Tree Number: 422

Height: 15 - 20 **Width:** 9 - 12 **DBH (cm):** 80
Health: Poor **Structure:** Hazardous **Form:** Poor

Risk Category: Moderate

Comments Ringbark for habitat stump

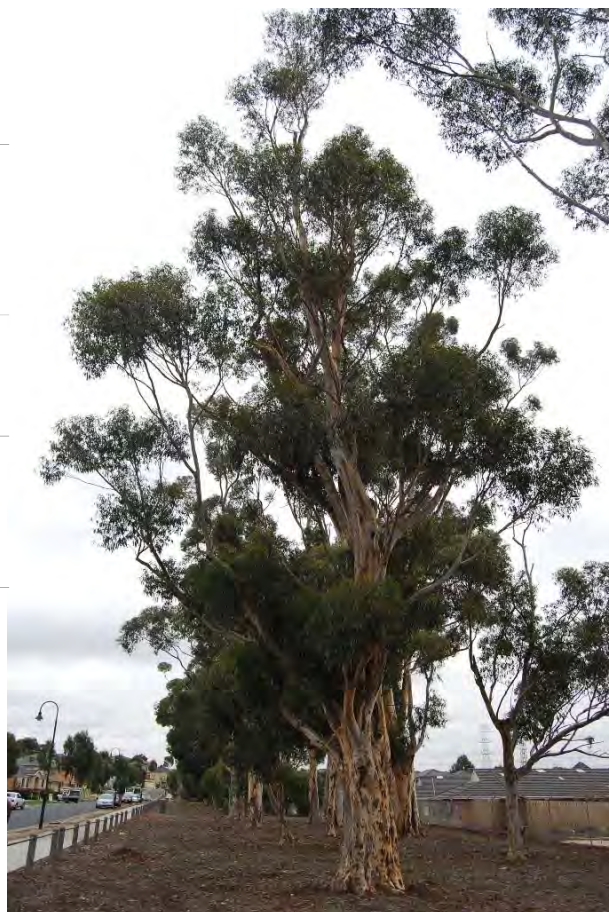
Tree Number: 423

Height: 10 - 15 **Width:** 9 - 12 **DBH (cm):** 55
Health: Fair **Structure:** Hazardous **Form:** Poor

Risk Category: Moderate

Comments Major stem decay

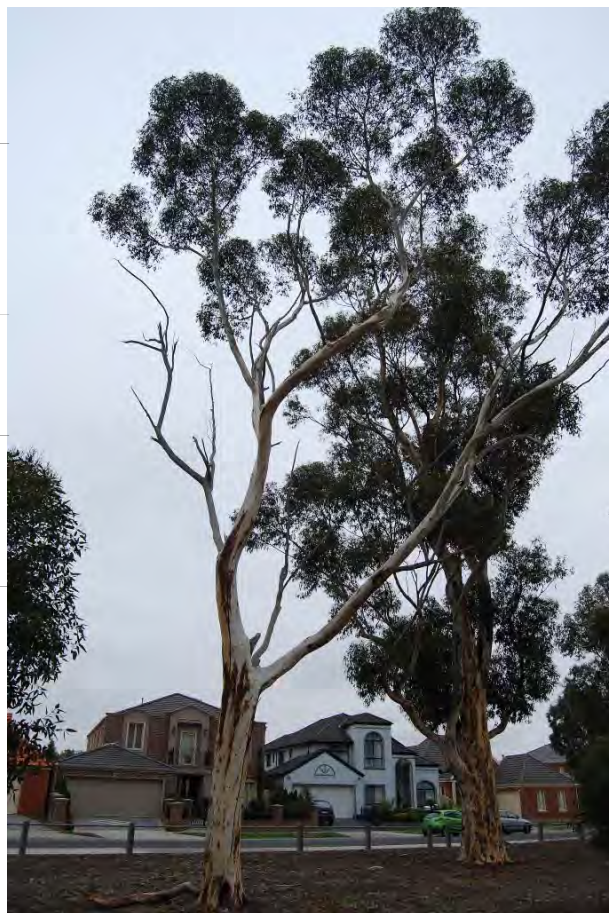
Tree Number: 428

Health: Poor **Structure:** Hazardous **Form:** Poor

Risk Category: High

Comments Prune back from footpath

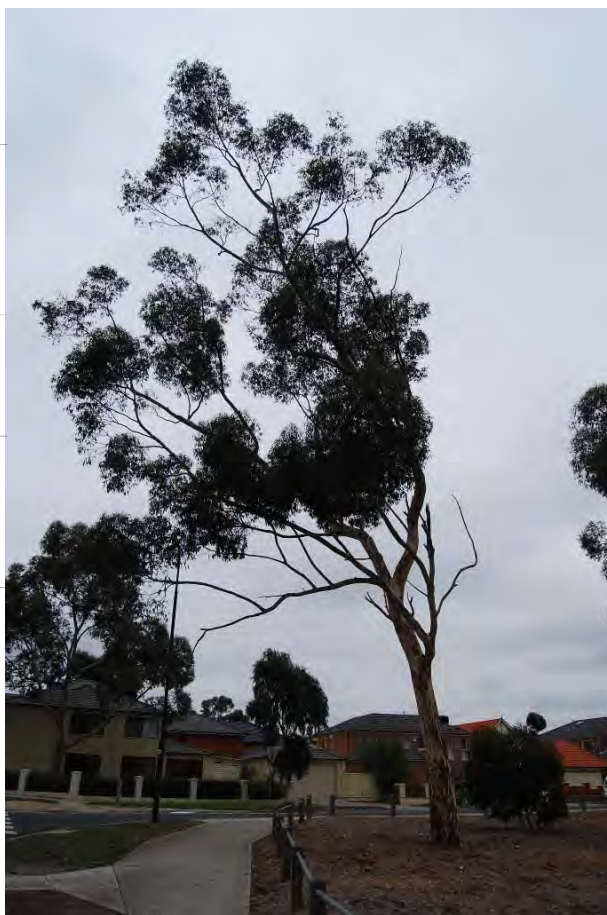
Tree Number: 439

Height: 20 - 25 **Width:** 13 - 16 **DBH (cm):** 85
Health: Fair **Structure:** Hazardous **Form:** Poor

Risk Category: High

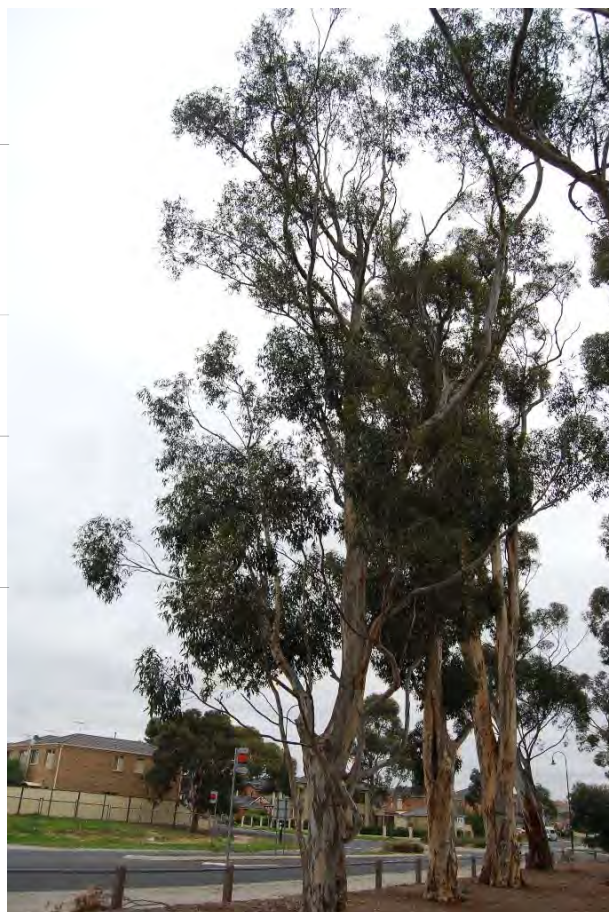
Tree Number: 445

Height: 20 - 25 **Width:** 13 - 16 **DBH (cm):** 105
Health: Fair **Structure:** Hazardous **Form:** Poor

Risk Category: High

Comments Ringbark and retain as habitat, many hollows

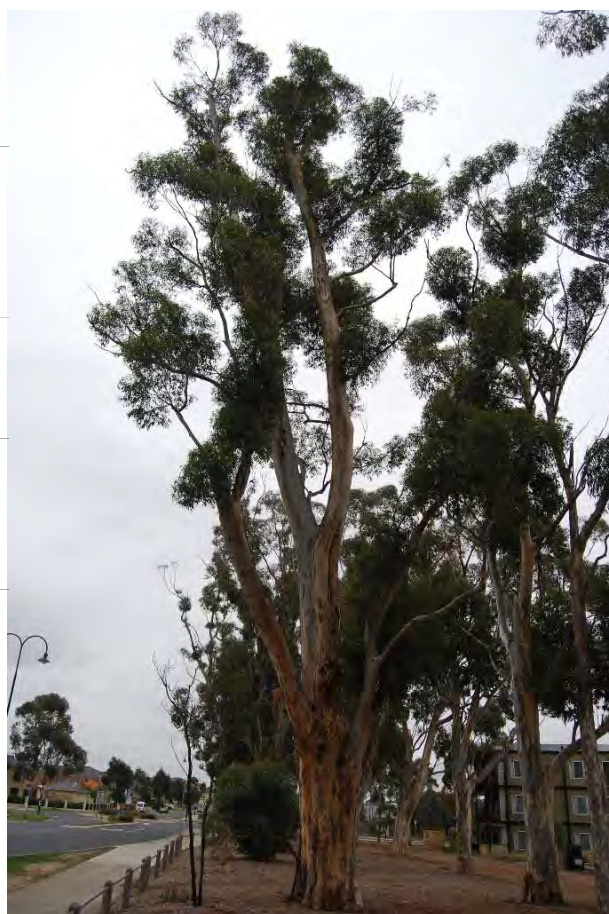
Tree Number: 462

Comments Lopped

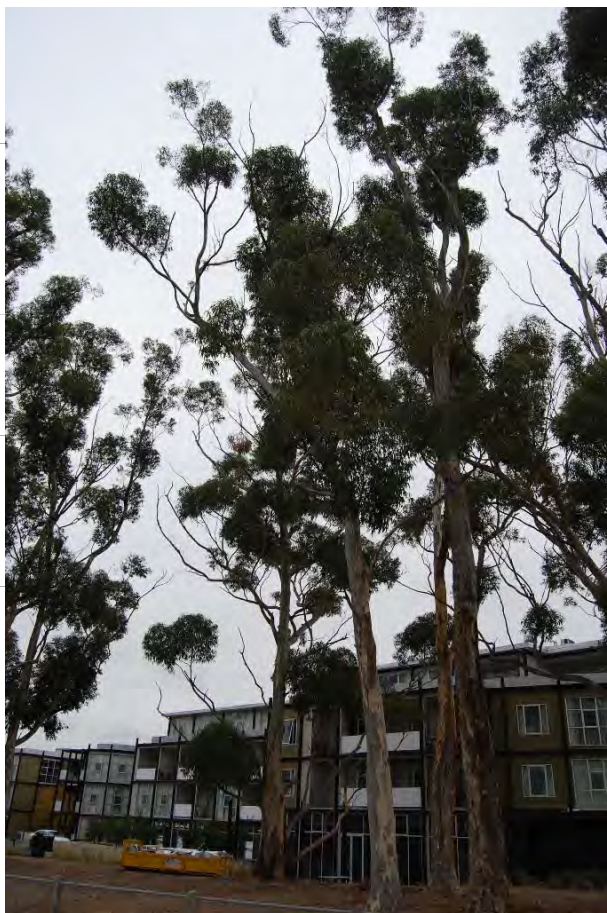
Tree Number: 472

Height: 20 - 25 **Width:** 13 - 16 **DBH (cm):** 80
Health: Fair **Structure:** Hazardous **Form:** Poor

Risk Category: High

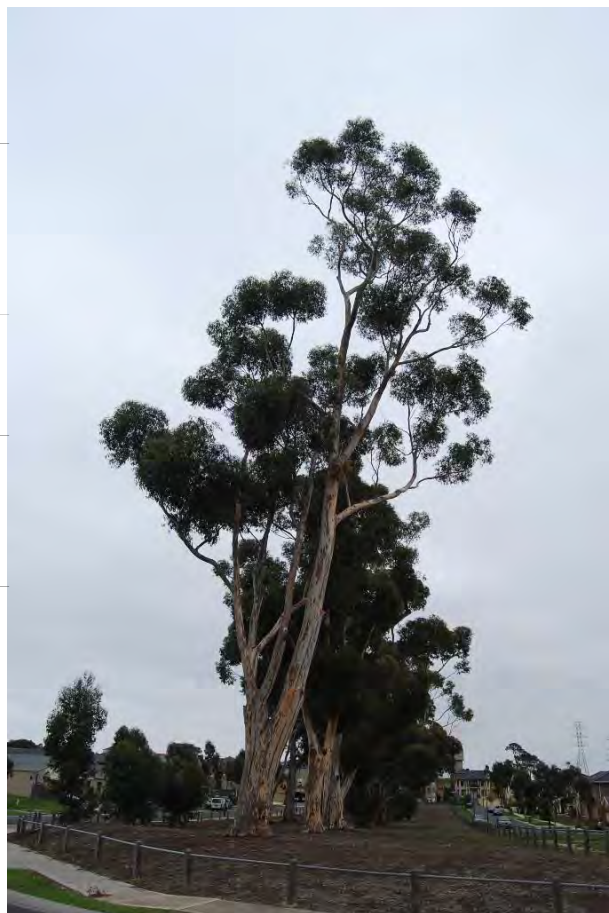
Tree Number: 509

Height: 10 - 15 **Width:** 5 - 8 **DBH (cm):** 70
Health: Good **Structure:** Hazardous **Form:** Poor

Risk Category: Moderate

Comments Ringbark for habitat stump

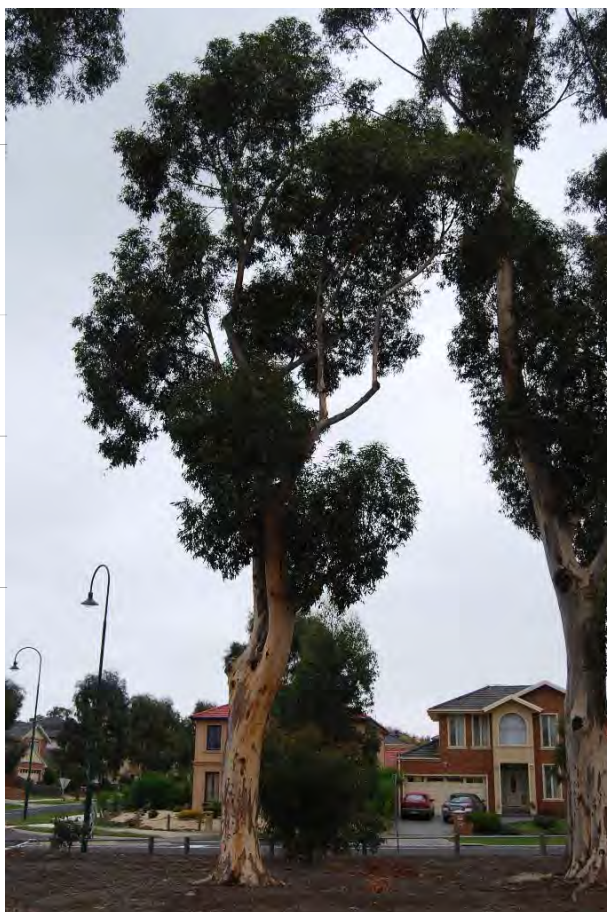
Tree Number: 510

Height: 20 - 25 **Width:** 13 - 16 **DBH (cm):** 100
Health: Fair **Structure:** Hazardous **Form:** Poor

Risk Category: High

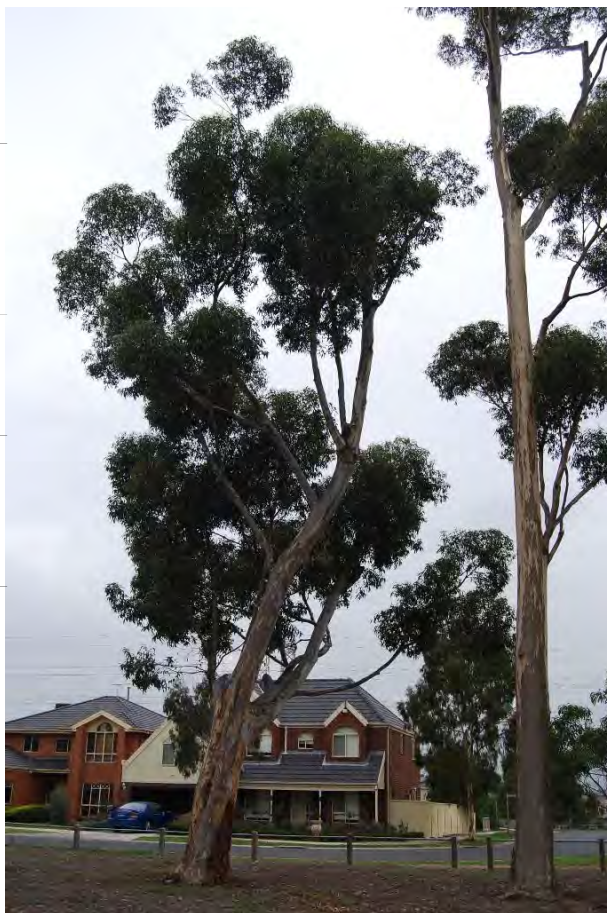
Tree Number: 516

Height: 20 - 25 **Width:** 13 - 16 **DBH (cm):** 90
Health: Fair **Structure:** Hazardous **Form:** Poor

Risk Category: High

Comments Ringbark for habitat stump

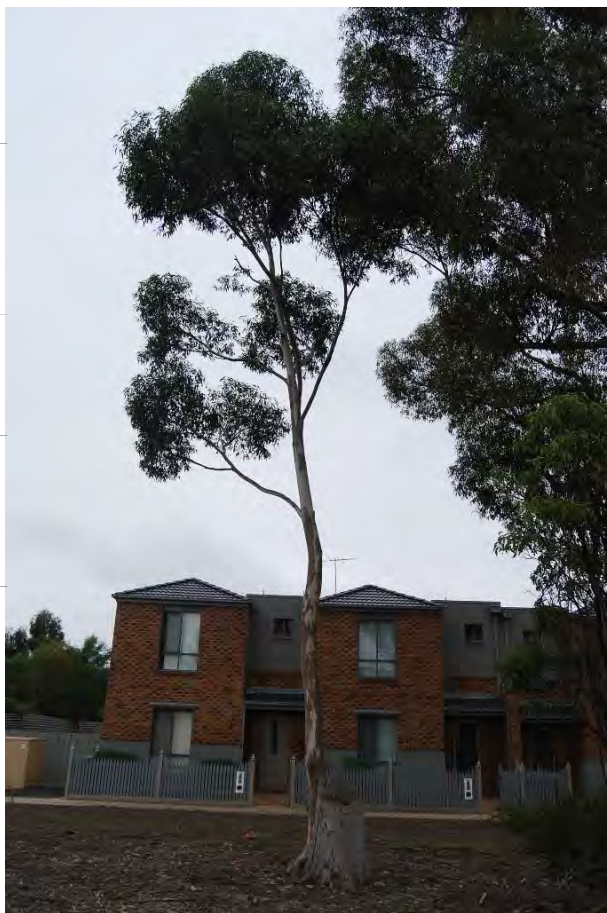
Tree Number: 522

Height: 5 - 10 **Width:** 5 - 8 **DBH (cm):** 55
Health: Fair **Structure:** Hazardous **Form:** Poor

Risk Category: Moderate

Comments Ringbark for habitat stump

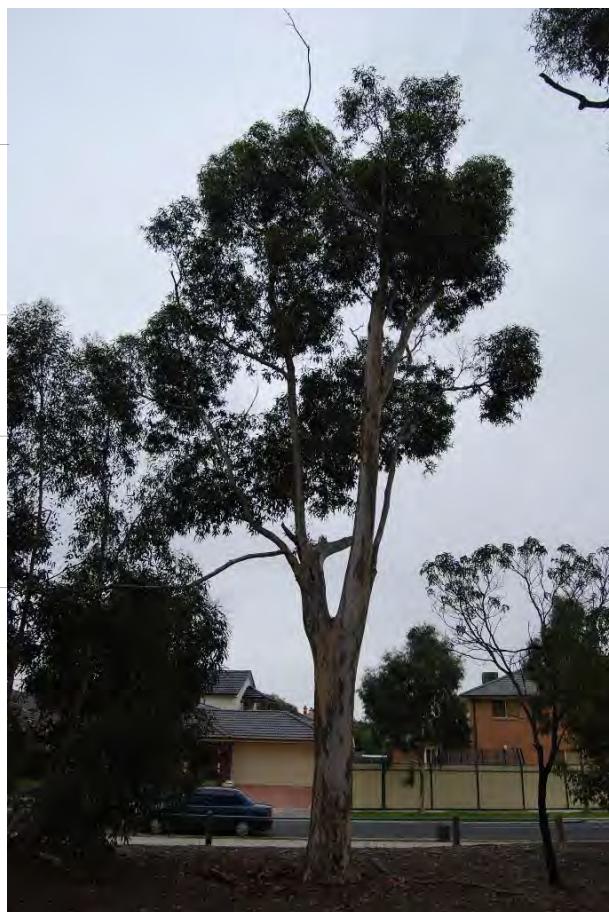
Tree Number: 525

Height: 20 - 25 **Width:** 13 - 16 **DBH (cm):** 90
Health: Fair **Structure:** Hazardous **Form:** Poor

Risk Category: Low

Comments Ringbark for habitat stump

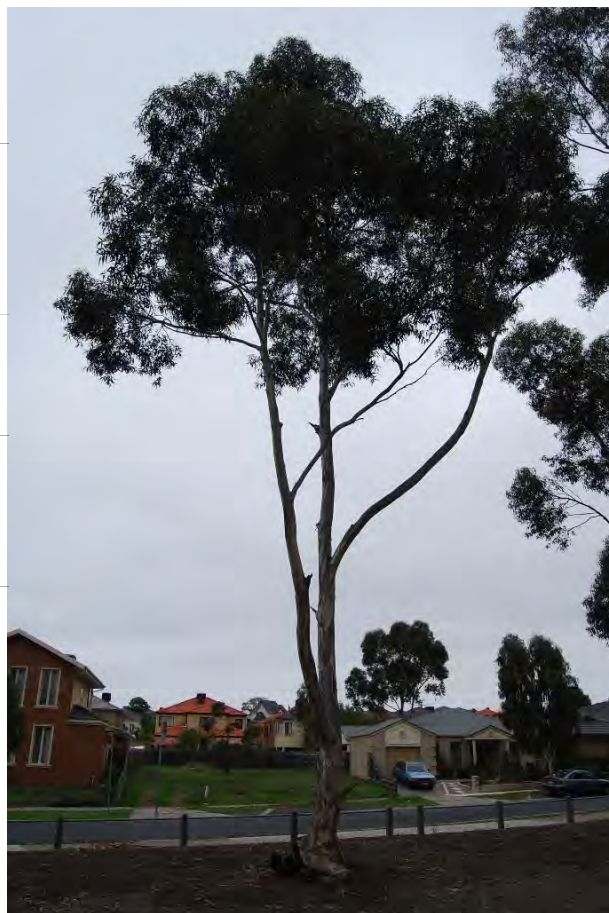
Tree Number: 534

Height: 10 - 15 **Width:** 5 - 8 **DBH (cm):** 80
Health: Fair **Structure:** Hazardous **Form:** Poor

Risk Category: Moderate

Comments Significant habitat tree

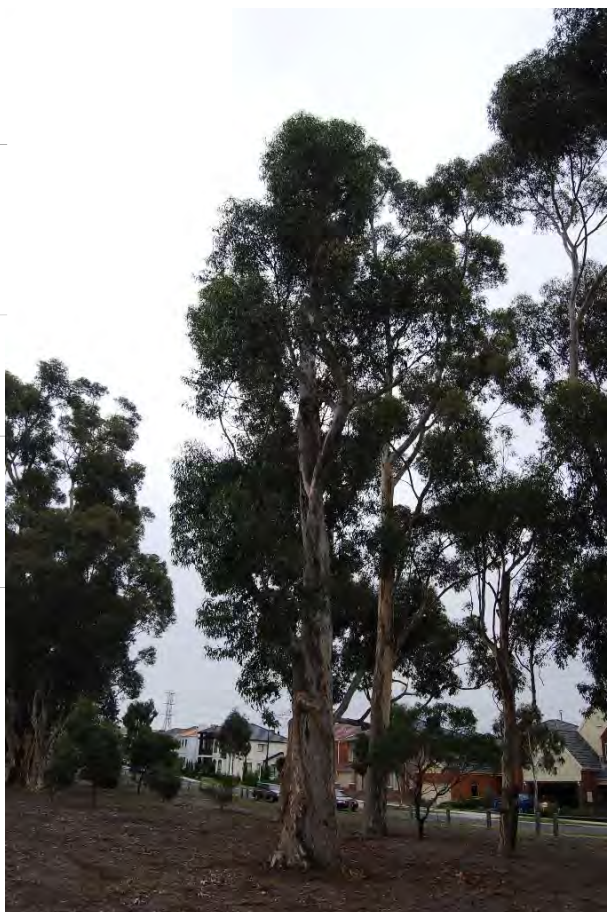
Tree Number: 538

Height: 20 - 25 **Width:** 17 - 20 **DBH (cm):** 90
Health: Fair **Structure:** Hazardous **Form:** Poor

Risk Category: High

Comments Prune back from path

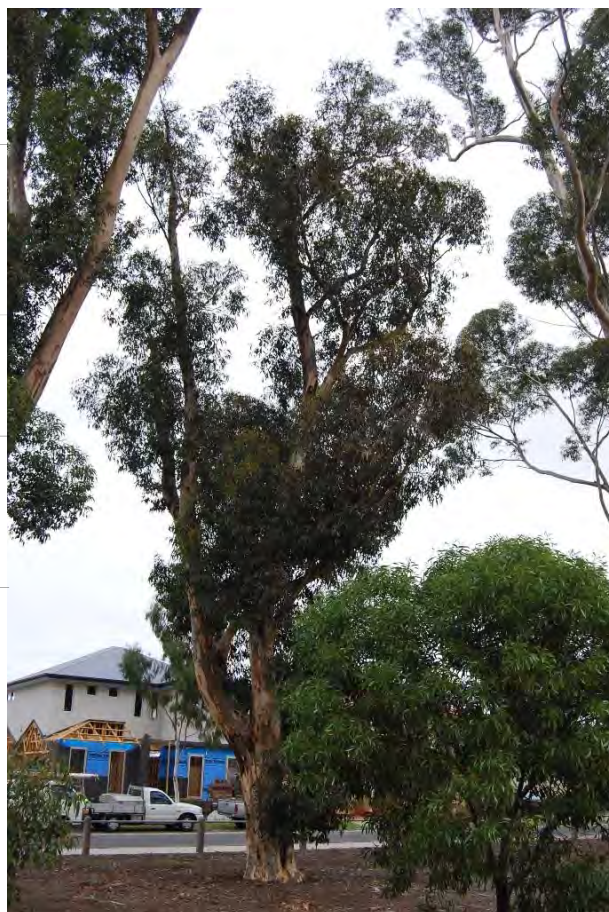
Tree Number: 541

Height: 20 - 25 **Width:** 17 - 20 **DBH (cm):** 100
Health: Fair **Structure:** Hazardous **Form:** Poor

Risk Category: Moderate

Comments Ringbark for habitat stump

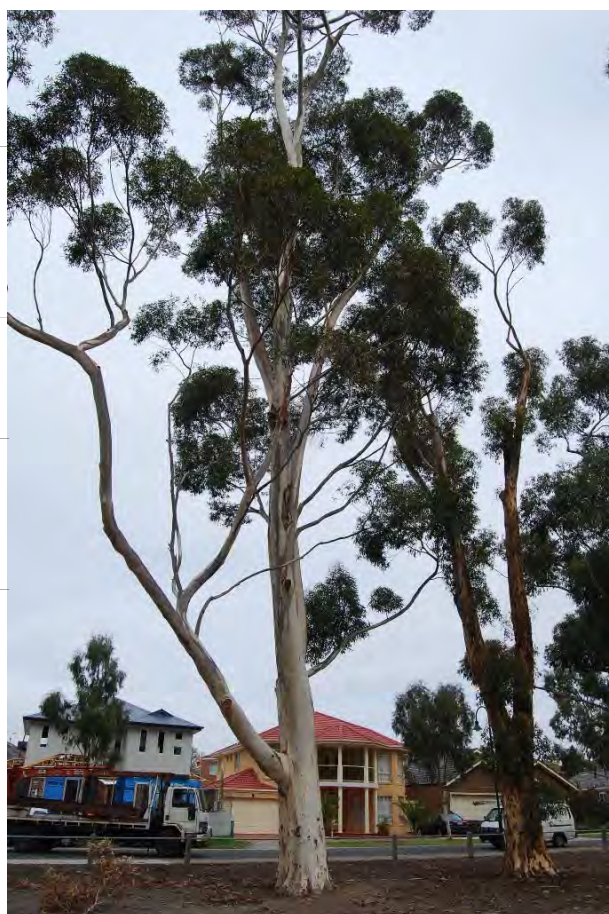
Tree Number: 542

Height: 10 - 15 **Width:** 13 - 16 **DBH (cm):** 100
Health: Poor **Structure:** Hazardous **Form:** Poor

Risk Category: High

Comments Ringbark for habitat stump

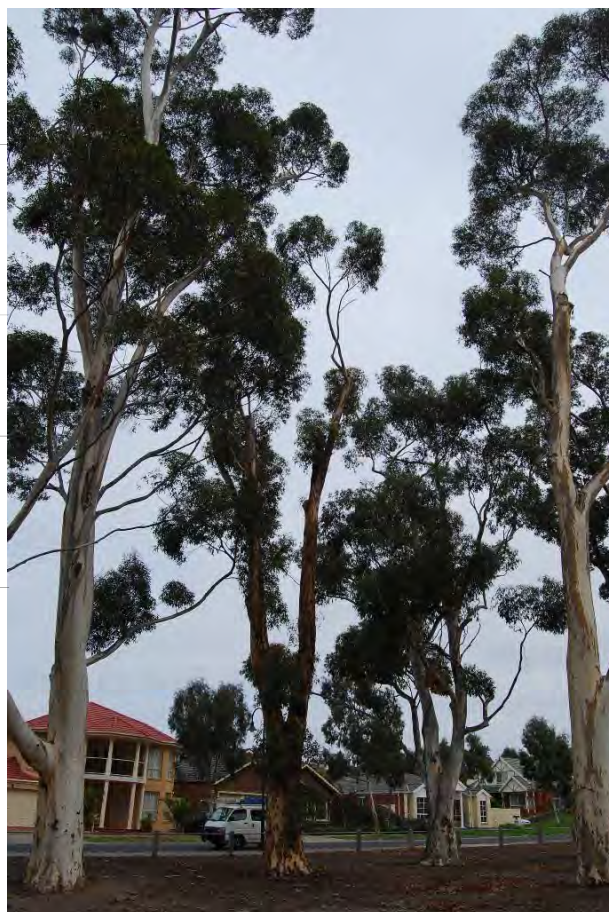
Tree Number: 543

Height: 10 - 15 **Width:** 13 - 16 **DBH (cm):** 90
Health: Fair **Structure:** Hazardous **Form:** Poor

Risk Category: High

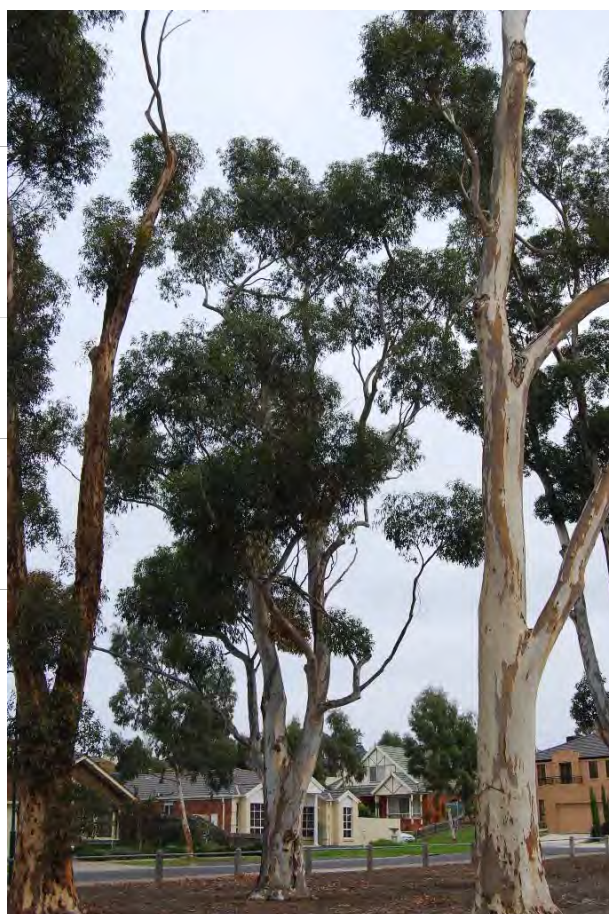
Tree Number: 546

Height: 20 - 25 **Width:** 13 - 16 **DBH (cm):** 100
Health: Fair **Structure:** Hazardous **Form:** Poor

Risk Category: Low

Comments Ringbark for habitat stump

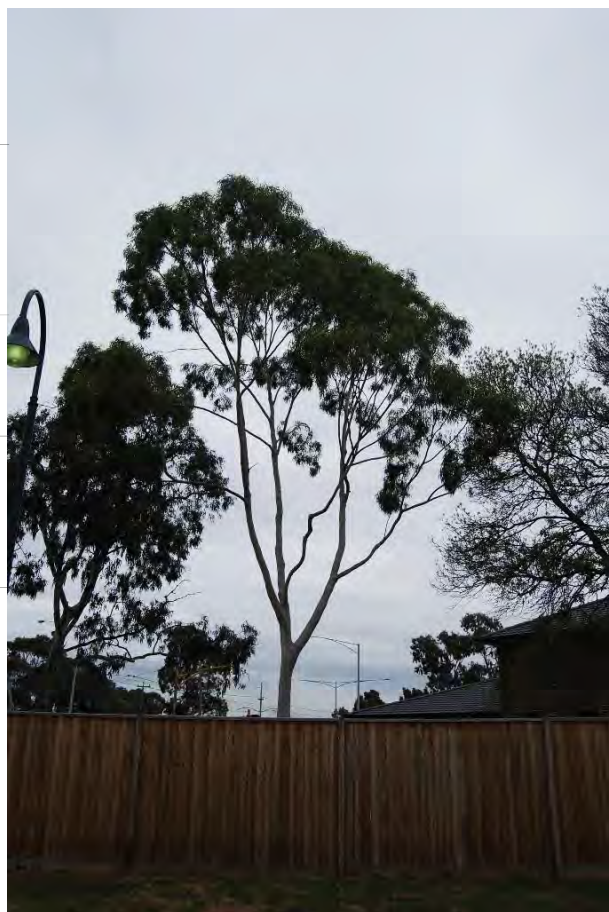
Tree Number: 557

Risk Category: Low

Comments Clean up broken stub.

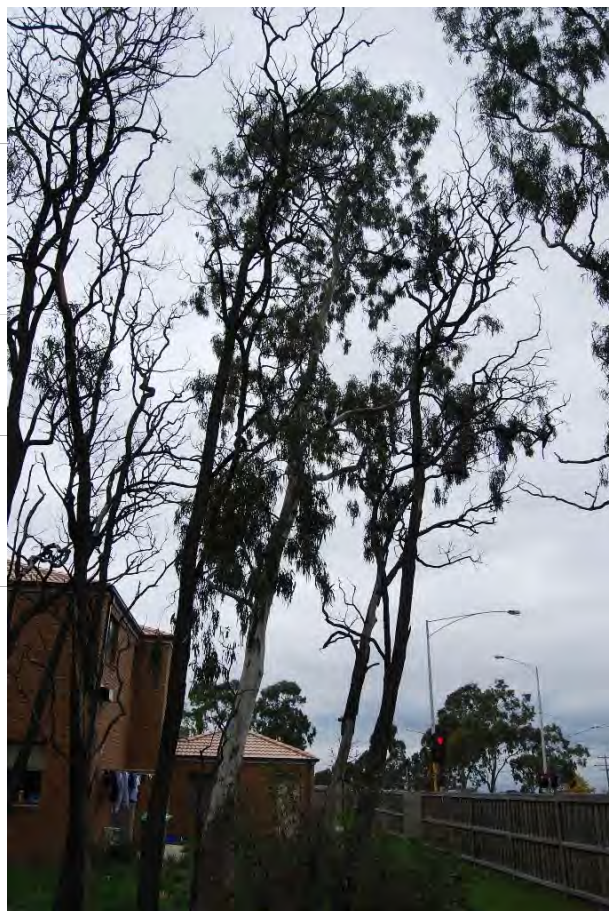
Tree Number: 565

Risk Category: High

Comments Exclude, remove hanger

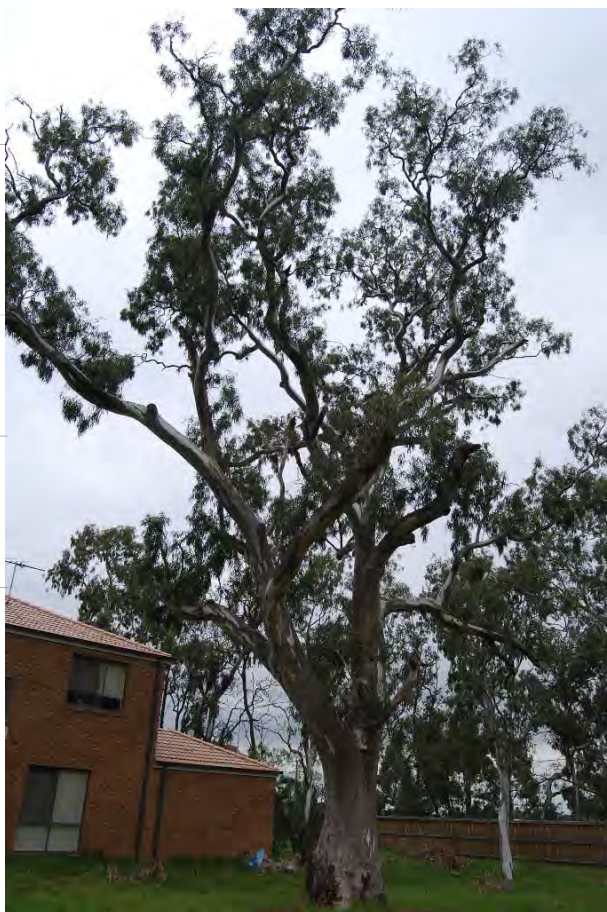
Tree Number: 566

Risk Category: Moderate

Comments Prune eastern branch at 8m

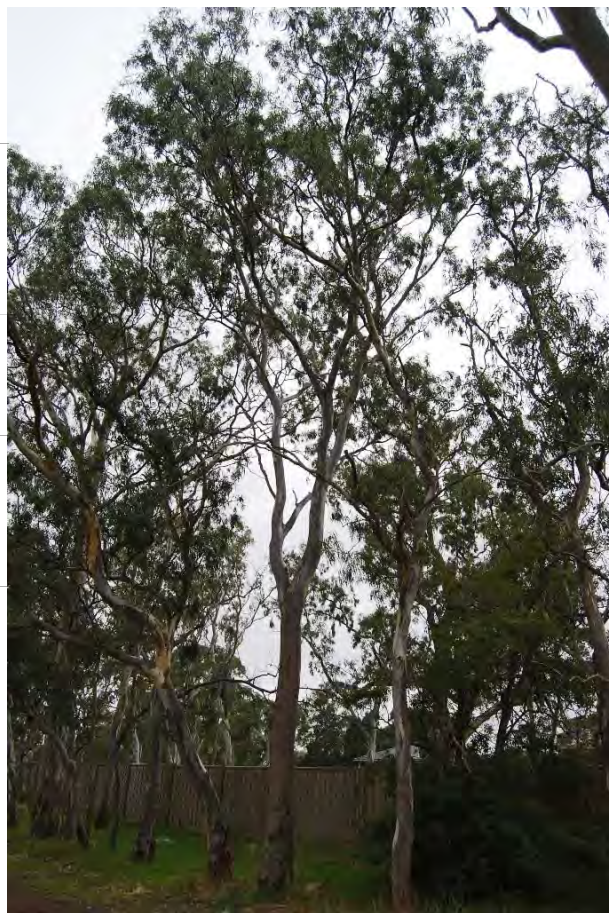
Tree Number: 572

Height: 10 - 15 **Width:** 5 - 8 **DBH (cm):** 135
Health: Dead **Structure:** Hazardous **Form:** Fair

Risk Category: Very low
